Failure analysis of a steam turbine casing

G. DAS

National Metallurgical Laboratory, Jamshedpur - 831 007.

FAILURE ANALYSIS OF A WELD REPAIRED LOWER TURBINE CASING AFTER 5 YEARS OF SERVICE

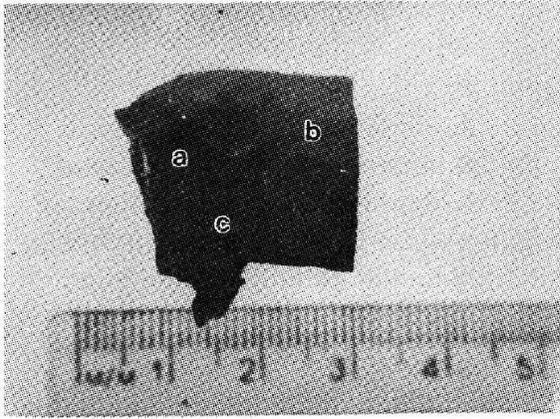
The cut piece from the lower turbine has been shown in Fig. 1. There was a hole perceptible by the naked eye observed on the top surface of the weldment (Fig. 1) associated with the piece. Microcracks were also found to be nucleated from the hole (Fig. 2). Scanning electron microscopic (SEM) analysis showed the presence of cracks along the grain boundary on the austenitic microstructure of the weld metal (Fig. 3). Microstructure of the weld metal showed fine cellular/dendritic morphology, typical of as solidified structure (Fig. 4). Precipitates (purely

Fig. 1 : Cut portion, showing weld region (a), base metals (b) and pre-existing hole (c)

Considering the above findings and correlating with the data available in the literature, it is concluded that the crack originated in the weld metal due to improper choice of the welding electrode and perhaps the welding process. The present weld material should be removed completely and the proper weld repair should be done to exploit the remaining life of the base metal which is yet to degrade.

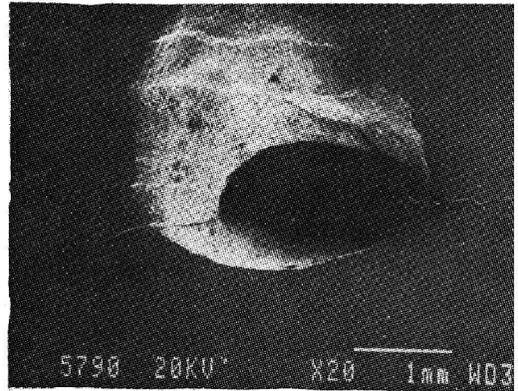
Fig. 2 : Microcracks nucleated from the hole

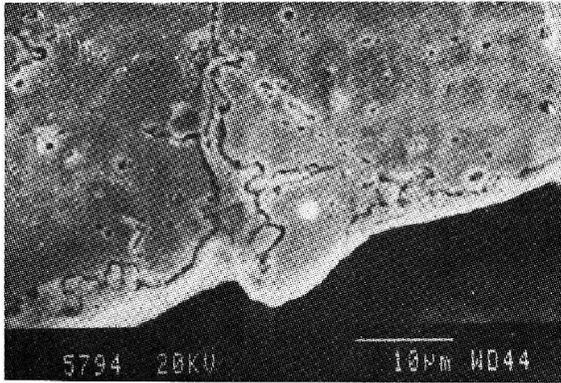
Fig. 3 : Cracks along the grain boundary and precipitates of Cr & Mo carbides

those of Cr carbides) along the grain boundary were identified. Some of the precipitates, also along the grain boundary, indicated the presence of Mo also (Fig. 3).

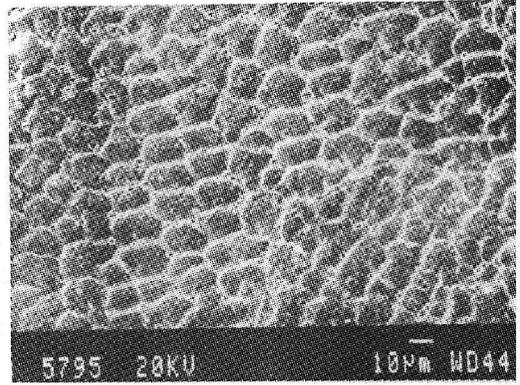
Fig. 4 : SEM micrograph of weld metal, showing cellular morphology

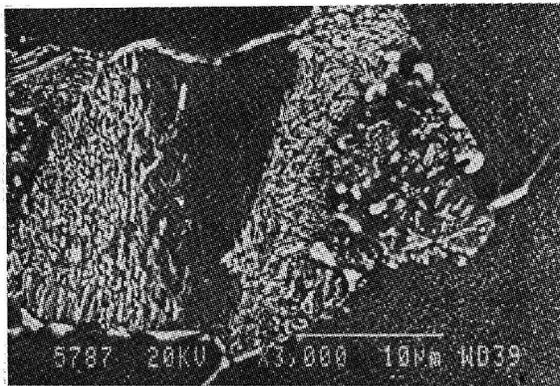
Fig. 5 : SEM micrograph of base metal, shows ferrite grains and precipitates in the pearlitic region

Base metal showed ferritic grain and carbide precipitation along the grain boundary (Fig. 5). The carbide was found to contain Cr, Mo, Mn and Fe. They remained in the original perlitic regions. The extent of spheroidization was not yet complete. Table 3 [7] showed the extent of degradation ('5' being the most degraded and '1'; being the original) of materials under service condition in relation to observed microstructure.

Considering the above classification the present microstructure will be under class III. Although, a few pores and cavities were observed randomly in the grain boundary the damage due to creep was not found to be significant (Fig. 5). Since the specimen belonged to a casting, to much importance was not given on cavities which were possibly present since inception.

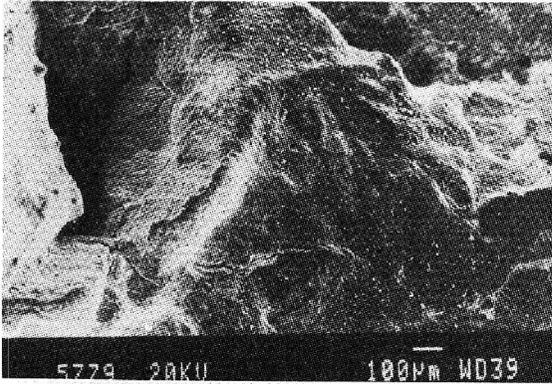
Fractographic observation showed that the crack had propagated only in the weld region originating from the defects in the weld metal such as voids, cavities which had possibly developed during weld repair operation (Fig. 6). Thermal fatigue appears to be main mechanism responsible for the crack growth deteriorating the life of weld zone (Fig. 7). Striations observed could be taken as the signature of the thermal fatigue or thermo-mechanical fatigue which is not uncommon for thick casting used for casing of turbines. Secondary cracks identified in the fractographs indicated intergranular type of fracture resembling the presence of embrittled microstructure (Fig. 8).

Fig. 6 : Cracks propagated in the weld zone possibly from pre-existing hole

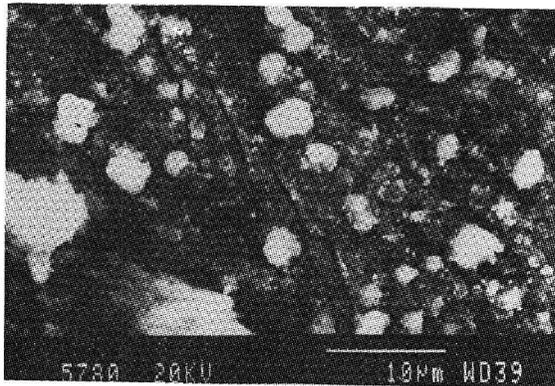
Fig. 8 : Secondary cracks identified in the fractograph.
