# Failures due to hydrogen embrittlement

N. K. MUKHOPADHYAY

National Metallurgical Laboratory, Jamshedpur - 831 007.

## **FAILURE ANALYSIS OF COLD DRAWN WIRE OF HIGH C-STEEL**

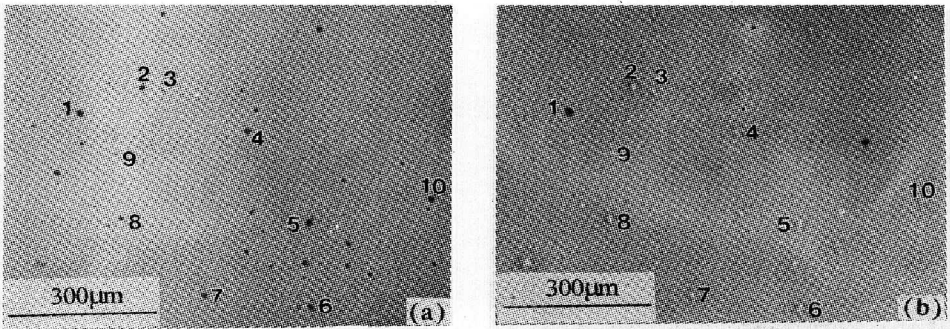
The polished and unetched sections under optical microscope shows the presence of pores or holes (Fig 2a). The abundance of the pores in many places is recorded as high as 6% from quantitative image analysis and minimum 2% through out the sample. The size of the holes is estimated to be of various sizes with a maximum range of 20 $\mu$ m and of nearly spherical shape. Pores and indusions are distinguished by changing focussing condition. Fig. 2b shows the pores are bright but not the inclusions in overfocussed condition. The coalescence of pores has led to the formation of cracks aligning along the rolling/drawing direction. The inclusions of calcium and potassium aluminosilicate were also identified. In some cases, the inclusions are also found to be lying within the pores which makes the quantitative analysis of pores alone difficult. However, from the various reading, it can be mentioned that pores and inclusions both are present but the pores are more than the inclusions (Fig. 2).

Fig. 2 : Optical micrograph of unetched wire drawn sample, (a) transverse section shows abundance of pores in focussed condition, (b) overfocussed condition showing pores as illuminated spots and inclusions as dark spots. The correspondence between (a) and (b) can be noted.

The pores or holes which are found to be abnormally high in the present sample must have originated during solidification of continuous cast billet because of improper degassing. The pores or holes are generally segregated near the central line of the ingot. During later stages of hot working, pores segregated in a localised region may coalesce and lead to the formation of the cracks. Subsequently when these hot rolled wire rods are further reduced in diameter (say, below 5mm) by cold drawing the presence of the cracks and holes may create problem leading to imperfections and even failure of the wire. The situation is more vulnerable in the presence of alumino-silicate type inclusions which are observed in the present investigation enhances the rate of failure because of their non-plastic nature. The pores may be due to the gas evolution (possibly hydrogen in the present case) during solidification. If proper degassing treatment is not maintained, the gas content will obviously lead to the problem. During soaking treatment, the gas entrapped in the holes gets a chance to diffuse out of the holes and the empty hole may subsequently get welded during hot rolling. The present investigation obviously points out to either improper degassing treatment or insufficient soaking treatment. The control of calcium-alumino-silicate inclusions as they are non-plastic requires to be minimised to avoid the failure.

- inclusions seem to be responsible for the present failure.
2. Insufficient soaking treatment and improper control of degassing practice appears to be main cause for the abundance of the pores. More soaking time may reduce the problem. The optimum solution between the degassing and soaking treatment can be found out after some more detailed investigation.

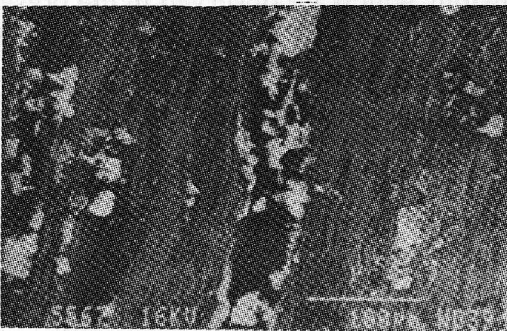
Surface of the wire containing seams and chips were investigated under SEM. Fig. 3 shows the surface cracks containing inclusions. The inclusions by EDX analysis confirmed the same type as mentioned earlier. The inclusions can also be identified near the chips.

Fig. 3 : SEM of surface cracks showing the presence of mostly calcium aluminosilicate type of inclusions.

3. The content of the alumino-silicate particles should be brought down to reduce failure rate. The role of non-plastic inclusions during drawing operation is always harmful to enhance the failure rate. The optimum level of inclusions along with the pores needs to be established to avoid the problem.

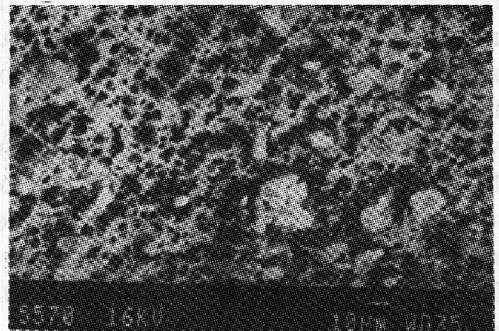
Fractured surfaces of the wire which failed during drawing operation can be observed in (Fig. 4). Inclusions are located in the interface of fibrous and radial zones of the fractured surface. However, the presence of the inclusions are not significant in the fibrous zone. In addition to the above features, the preexisting and unwelded pores can be found from detailed analysis of the fractograph, which has led to dimpled fracture typical of ductile fracture.

Fig. 4 : SEM fractograph of wire failed during operation, exhibiting dimples and indicating ductile fracture. Inclusions can also be observed.

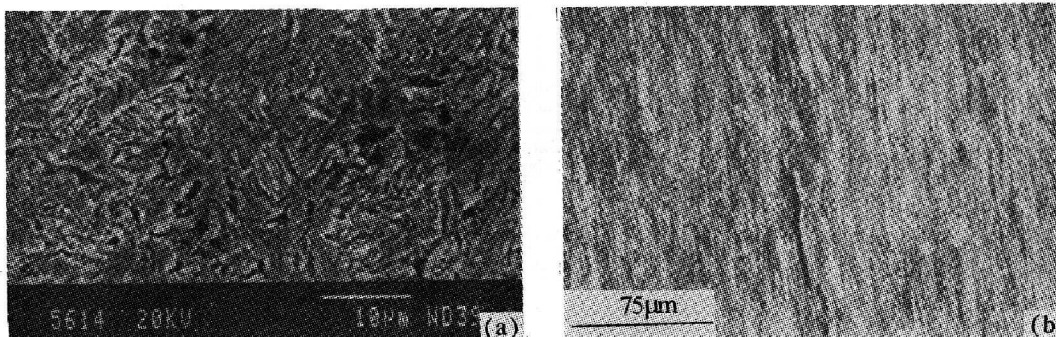
The etched surface near the chips was observed under optical and SEM. The fine pearlitic microstructure on the transverse section has been noticed (Fig. 5a).

Fig. 5 : (a) SEM photograph of transverse section showing pearlitic microstructure; (b) optical micrograph of longitudinal section depicting the presence of pearlitic microstructure and cracks along the drawing direction

Elongated pearlitic structure and cracks along the drawing direction has been observed in the longitudinal specimen (Fig. 5b). The hardness data of the sample has been found around 400 VHN which indicates the high degree of cold working of the material.

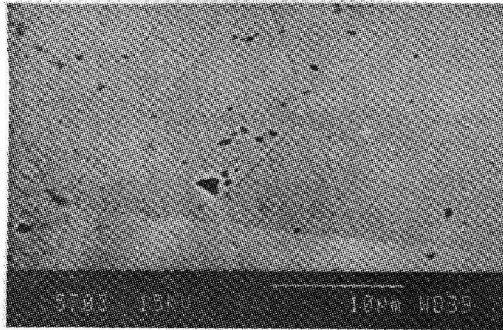
The wire rod samples were polished, with diamond paste in the final stage, and were examined under optical microscope. Typical features, from representative areas, are shown in Fig. 6. In addition to the few inclusions that are observed, a number of pores were present in most of the areas that were examined. It may be noted that the inclusions and the pores could be distinguished, from each other, by varying the focusing plane, as their planes of foci are different which has already been demonstrated in Fig. 2(a,b). It is also observed that some of the pores have coalesced to form a crack like defect.

*Fig. 6 : SEM photograph of unetched wire sample exhibiting pores and inclusions*

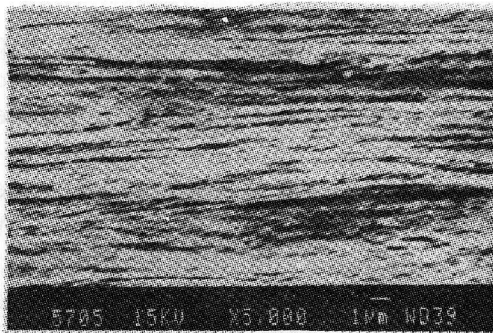
Some of the polished and etched samples were examined under scanning electron microscope (SEM). Fig. 7 presents the typical features that are expected in a cold drawn steel wire rod, viz. fibrous appearance comprising of elongated ferrite and cementite lamella (pearlite).

Fig. 7 : Microstructure featuring typical fibrous nature comprising elongated ferrite and cementite lamella (pearlite)

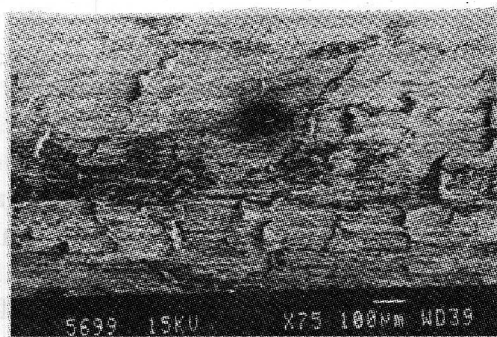
The longitudinal fracture surfaces of the failed surfaces, examined under SEM showed, again, fibrous appearance with secondary cracks (Fig. 8). A look at a

Fig. 8 : Subsurface secondary cracks, observed in splitted surface of failed wire, indicative of hydrogen damage

crack embedded in the material supports the failure to be termed as delamination. Comparing with the microstructural features (Fig. 7), it appears that the delamination has taken place either along the prior austenite grain boundaries i.e. along the interface of the pearlite colonies. The presence of some non-inclusion hard particles segregated randomly on the fracture surface are observed. EDX survey carried out on these tiny particles indicated them to be cementite. The formation of globular cementite during drawing occurs by the densification of cemented through wrinkling or buckling, and also by carbon diffusion accelerated due to deformation [15,16].

Based on the investigations carried out, and the observations thereupon, it appears that the cohesive strength of the boundaries/interfaces was reduced by the presence of atomic hydrogen which ultimately leads to sharp splitting because of the presence of high tensile residual stresses in the central region of the wires developed during the drawing operation.
