## **Catastrophic Carburisation in Petrochemical Industry**

**S. R. SINGH**

*National Metallurgical Laboratory, Jamshedpur - 831 007*

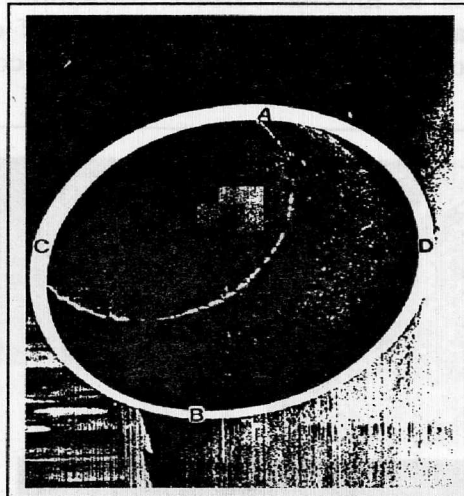
The failed tube was cut in transverse direction. A photograph of the tube is shown in Fig. 1. Wall thickness of tube was non-uniform having maximum thickness of 6.8 mm (hereafter referred as region "A") and minimum thickness of 3.6 mm (hereafter referred as region "B"). These two regions were diametrically opposite and outer

diameter across it was 170 mm while outer diameter perpendicular ("CD") to it was 168 mm. Inner surface of the tube has dull black appearance with sooty deposits. These dimensional measurements showed that the tube had undergone 1% expansion in direction "AB", where wall thinning was maximum while there was no appreciable deformation perpendicular to "AB", *i.e.*, "CD". These observations indicate that the failure would have taken place due to non-uniform wall thinning.

*Fig. 1: A photograph of transverse section of tube showing maximum and minimum wall thickness regions marked "A" and "B" respectively. Non-uniform wall thinning can be noticed.*

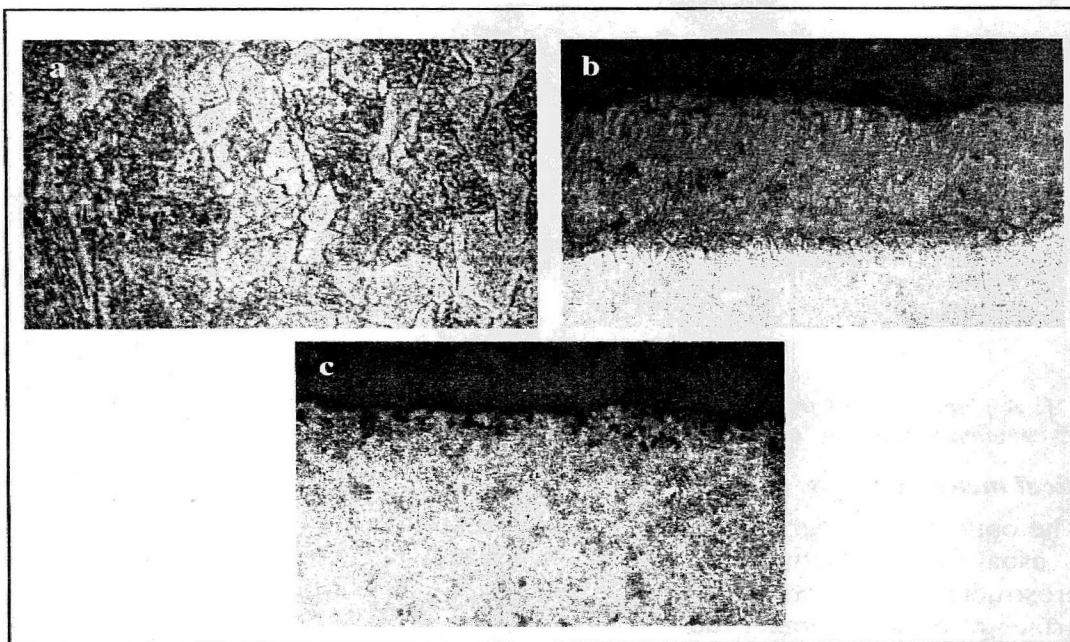
The optical metallography of transverse section of the tube revealed that the matrix has usual microstructure consisting of ferrite and tempered bainite. A typical microstructure is shown in Fig. 2a whereas Figs. 2b & 2c showed matrix/scale interface of outer and inner tube surfaces respectively. The scale at outer tube surface (Fig. 2b) is thicker, compact and undamaged with no significant changes in subsurface matrix microstructure, while the scale at inner tube surface (Fig. 2c) showed thinner/broken scale with altered subsurface microstructure of base metal. The thin scale in Fig. 2c was out of focus. These observations indicate that there was breakdown of protective scale which lead to the alteration of subsurface matrix microstructure at the inner wall of tube.

*Fig. 2: Optical micrographs of transverse section of tube showing, (a) ferrite and tempered bainite in the matrix, (b) outer tube scale interface, (c) inner tube scale interface.*

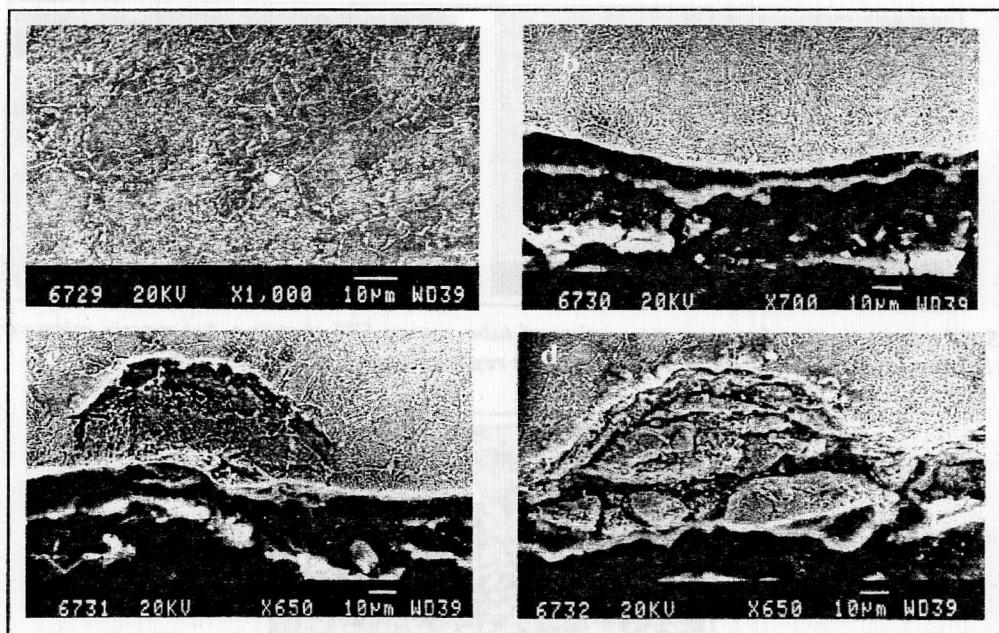
Transverse section metallography samples from region "A" undergone minimum wall thinning were examined by SEM. All the microstructures were recorded in secondary electron imaging mode, although, backscattered images were also analyzed for better perception. Fig. 3a showed typical ferrite and tempered bainite microstructure of the matrix far away from both the surfaces. The inner tube surface/matrix microstructure (Fig. 3b) revealed the duplex nature of oxide scale

Fig. 3: SEM micrographs of transverse section of tube region "A" showing, (a) ferrite-tempered bainite microstructure of the matrix, (b) inner tube surface-matrix interface, (c) pitting initiation at inner tube surface, (d) pitting after complete breakdown of scale.

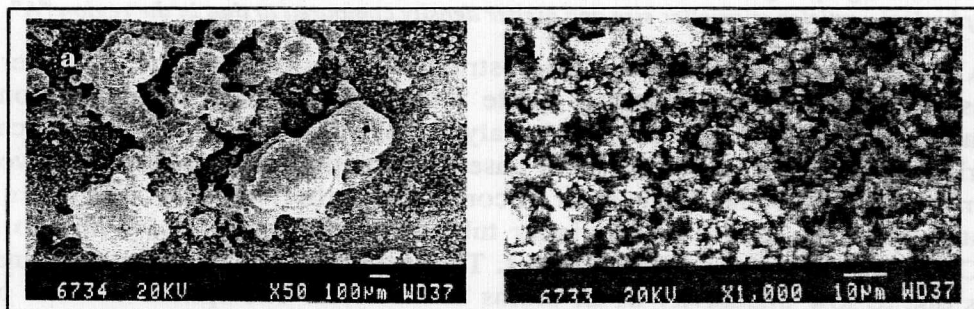
The longitudinal section of inner tube surface from region "A" having sooty deposits was also examined in as received condition. Figure 4a revealed that the deposits consist of spherical particles dispersed on irregular shaped particles/soot, which is devoid of any whisker growth (Fig. 4b).

Fig. 4: SEM micrographs of as received longitudinal section of inner tube surface of region "A" revealing, (a) spherical particles dispersed on irregular shaped particles, (b) higher magnification of irregular shaped particles.

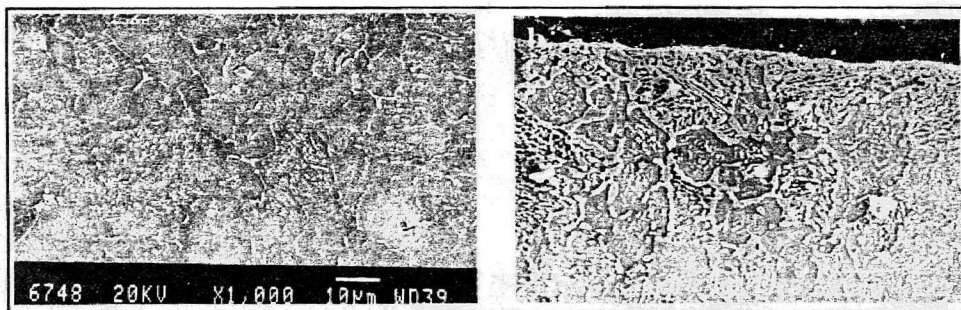
Transverse section metallography samples from region "B" were also examined. SEM micrographs from unaltered matrix and subsurface region of inner tube wall are shown in Fig. 5a & b respectively. Coarsening of grain boundary precipitates as well as increase in number density of precipitates in the subsurface region has taken place. Also the pitting in region "B" is absent. This indicates that the uniform metal wastage

Fig. 5: SEM micrographs of transverse section of tube region "B" showing, (a) matrix microstructure, (b) altered microstructure in the subsurface region (inner wall of the tube).

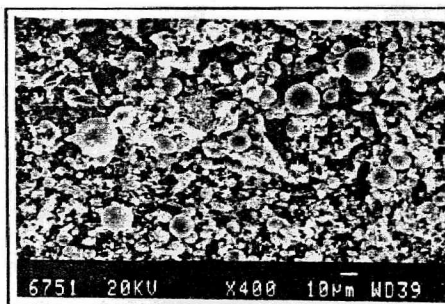
by catastrophic carburisation was operative in the region "B". SEM micrograph (Fig. 6) from as received longitudinal surface showed higher number density and smaller size of spherical particles are dispersed on the surface while there is a significant reduction in irregular sooty deposits in region "B" (compare it with Figs. 4a & b recorded from region "A").

Fig. 6: SEM micrograph of as received longitudinal section of inner tube surface of region "B" showing spherical particles of smaller size and higher density compared to that in the region "A".
