## SOME CHARACTERISTIC SERVICE FAILURES OF RAILS.

S.C. De, B. Met. (Sheffield)

T.V.N. Kida, B.Sc., (Met), A.I.M.

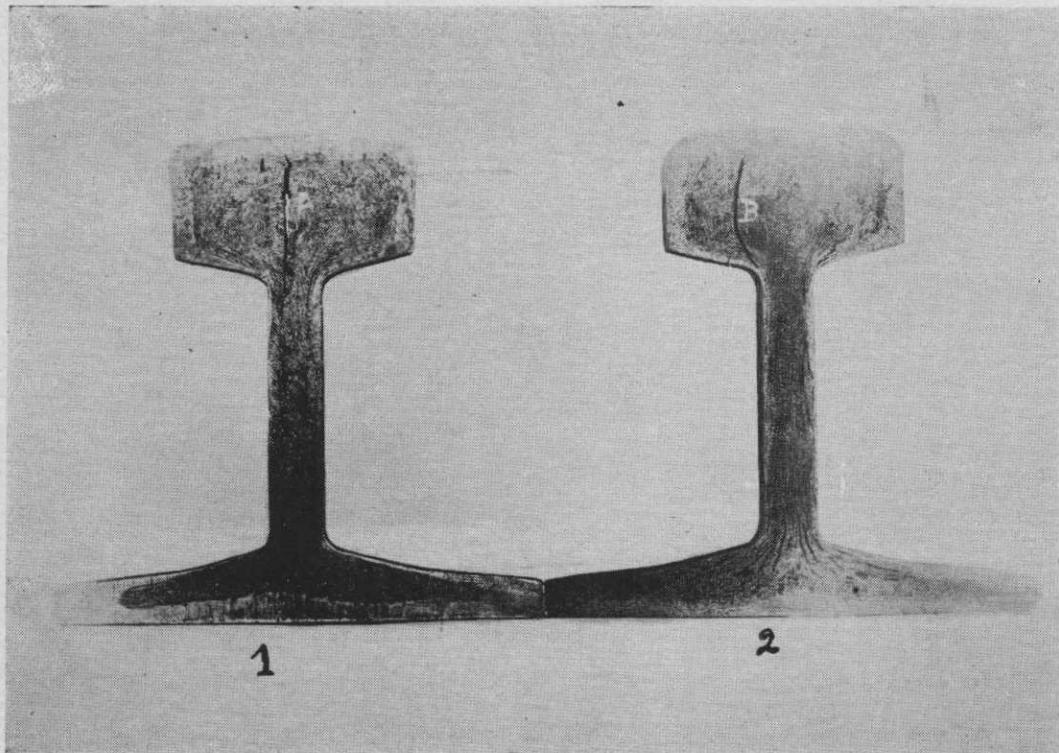
FIG. 1 Failure of three 90 lbs, F. F. rails due to segregation.

hardness values of the rails shown in Fig. 1 are given below:—

Identification No. (Fig 1)	C.	Si.	Mn.	S.	P.	Hard- ness on standard position* V.P.H.
	Percent					
Rail—1.	0·31	0·036	0·62	0·124	0·178	178
Rail—2.	0·41	0·031	0·73	0·094	0·145	174
Rail—3.	0·32	0·072	0·70	0·10	0·044	156

270 V.P. H. was recorded on rail table surface near the split.

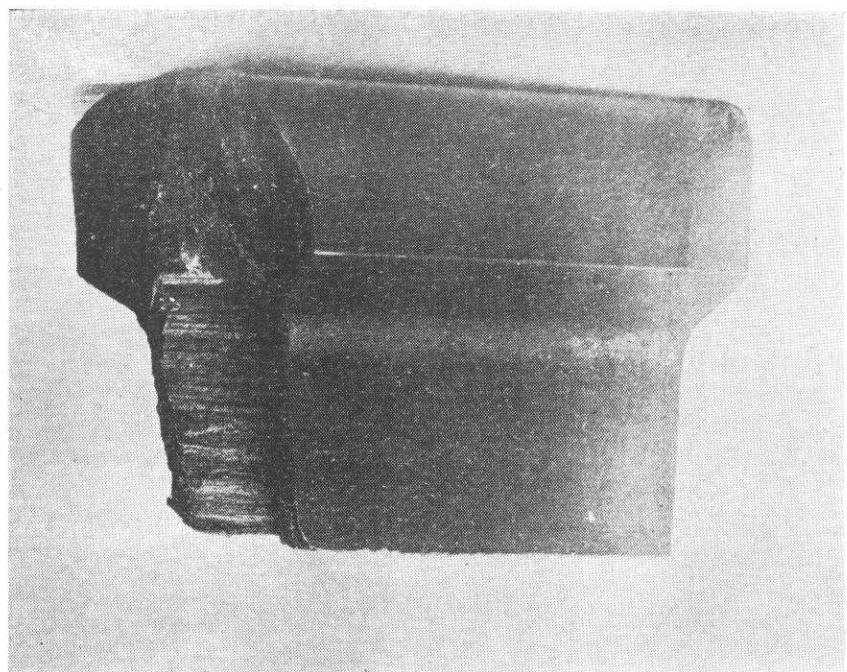
Figs. 2 and 3 show a 90 lbs. foreign rail with a primary pipe in the web. It was reported that 13½ inch long rail table from one end with a portion of flange was found lying on the ballast when a train was passing (see Fig. 2). A major disaster was averted by a P.W.I. who happened to be in the engine when he heard a loud and unusual knock of the bogie wheels at a rail joint, and stopped all traffic immediately. The fracture of the rail showed pipe and non-

FIG. 2 Primary pipe web of a 90 lbs rail.

metallic inclusion. The rail end was hot sawn, and on enquiry it was found that the rail was laid in track for  $1\frac{1}{2}$  months only.

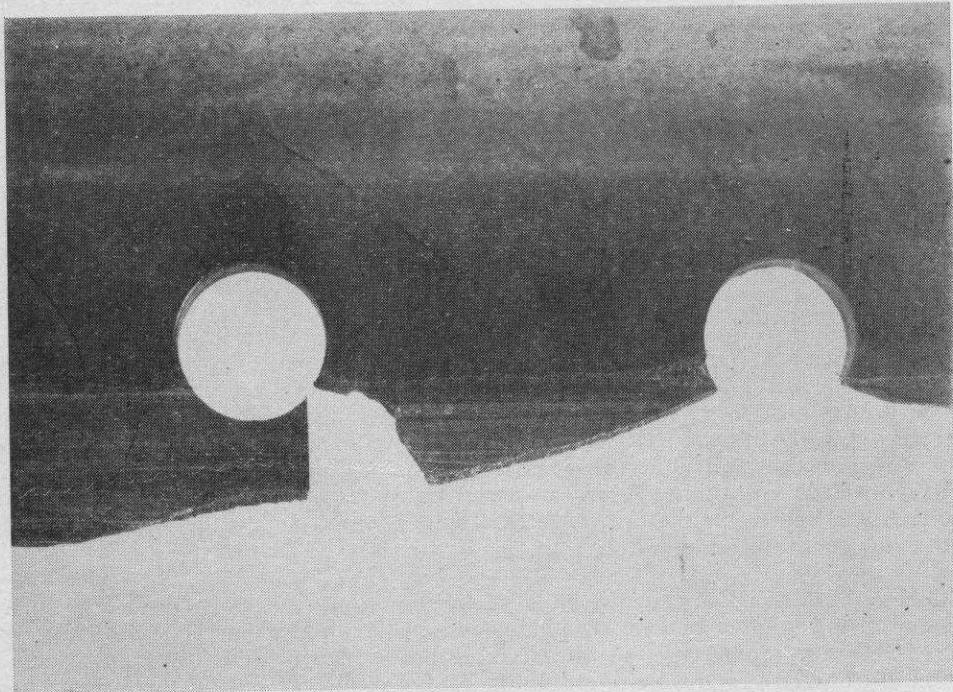
FIG. 3. Primary pipe web of a 90 lbs rail.

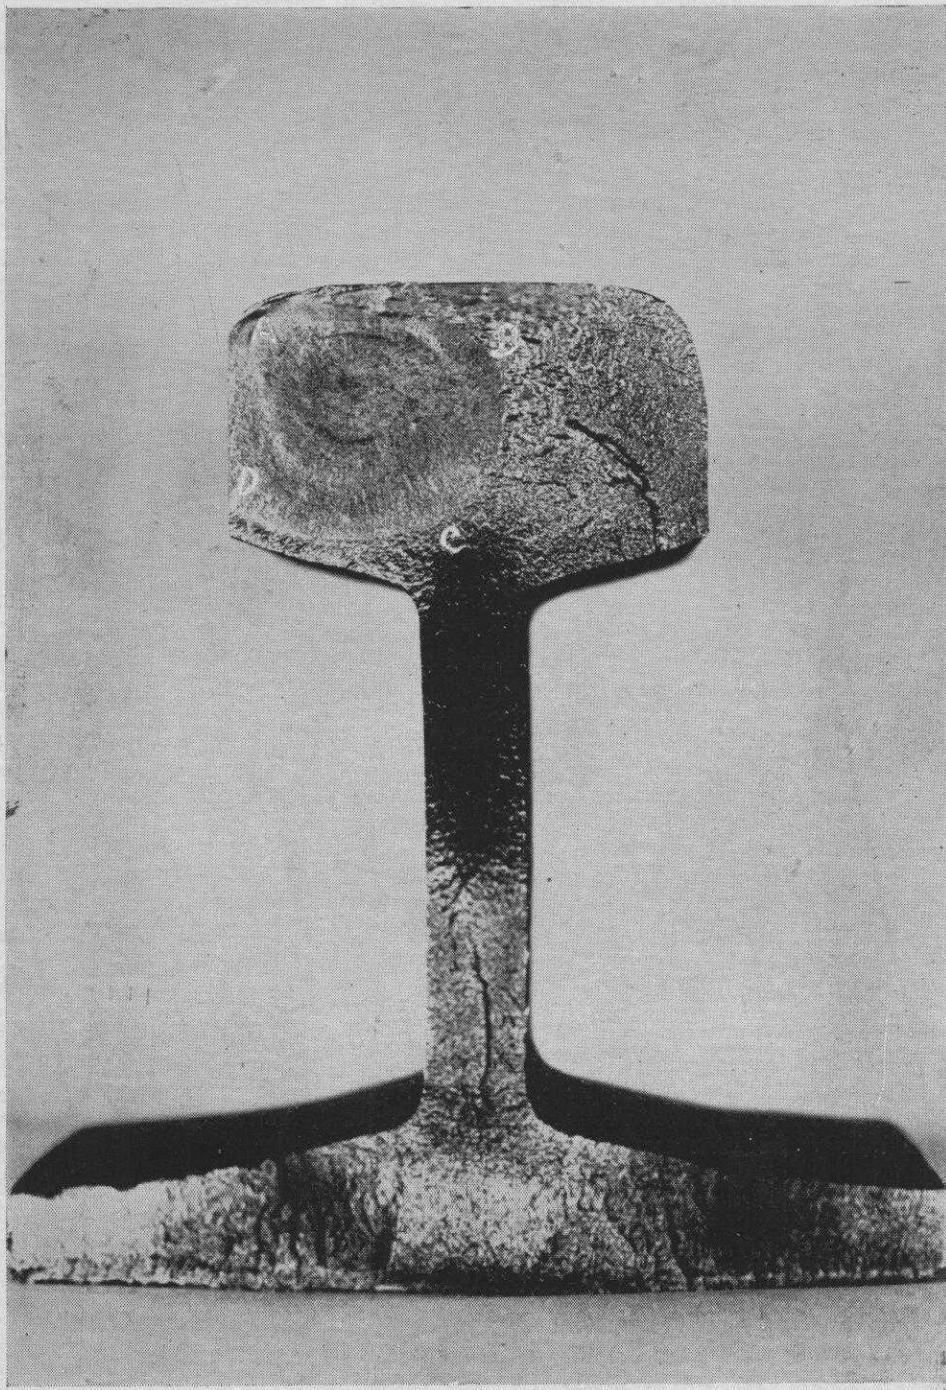
FIG. 4.  
Transverse fissure in a 90 lbs F.F. rail.

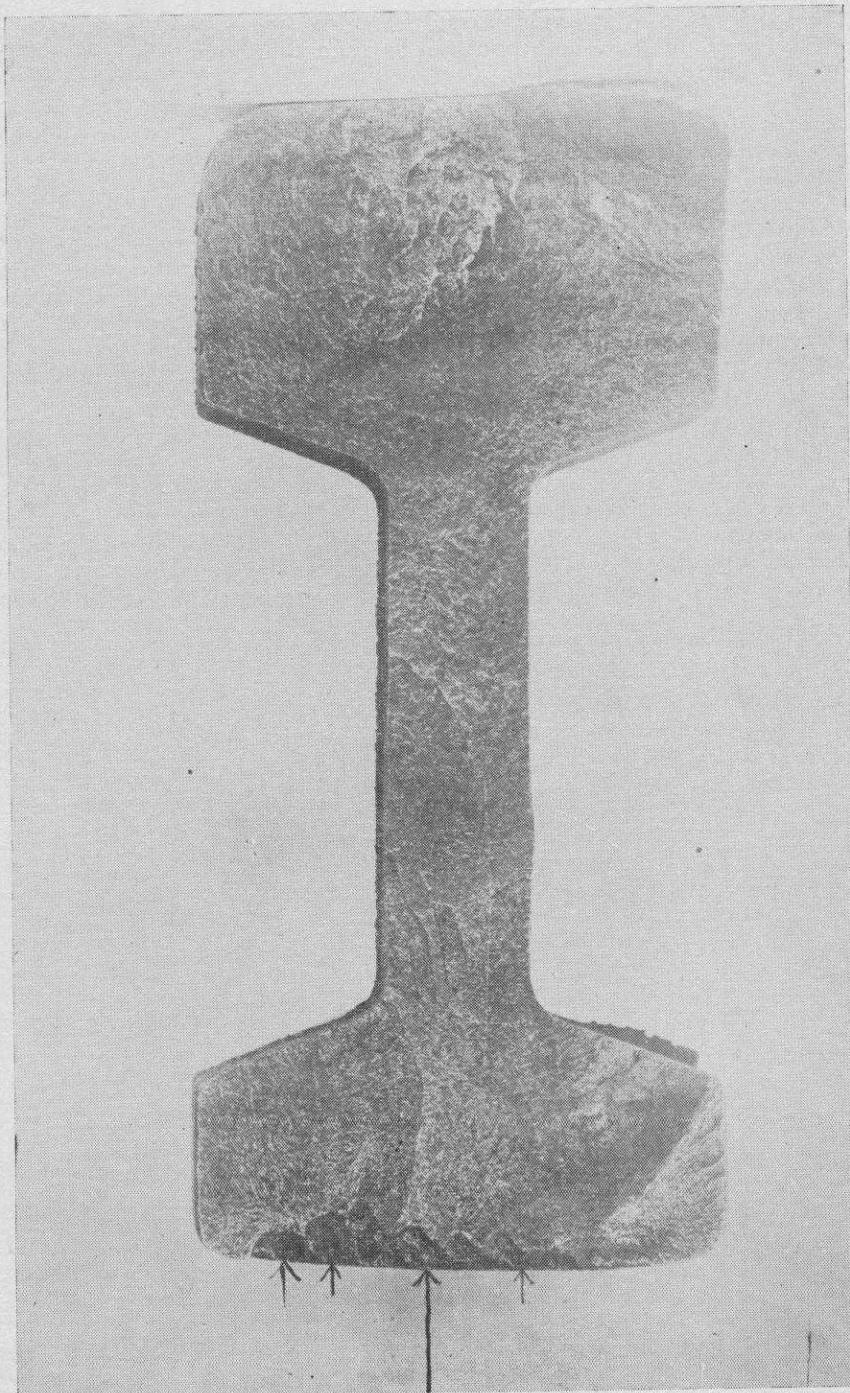
The fracture of the rail revealed characteristic fatigue failure (Fig 5) originating from deep craters on the bottom surface of the rail. Micro examination of the steel near the crater showed three distinct structural changes in the metal, viz., (a) thin decarburised area, (b) tempered martensite without any free ferrite, and (c) medium size grains of sorbopearlite with ferrite at the grain boundaries.

The cause of failure of the rail is attributed to craters which acted as stress raisers, and finally caused failure in the rail. One of the possible reasons for the crater formation is due to rail becoming anode of an electric arc. To verify this an experimental arc was set up on the foot of a 2" long rail piece cut from the bull head rail with a pressure of 90 volts and current 500 amps.

FIG. 5 A broken 100 lbs bull head rail showing craters formed due to electrical short circuit. Failure started from these craters.

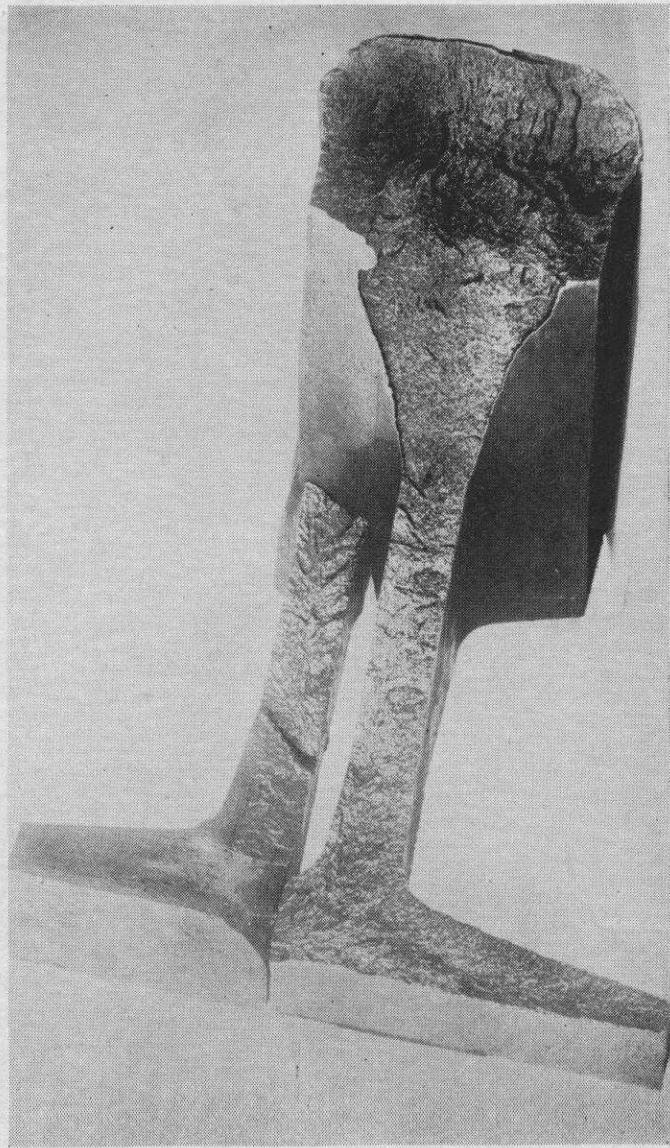
Fig. 6 illustrates a typical case of a failure of Vee joint of splice and point rails. Fracture has started from the sharp angle formed by machining of the flange shown by an arrow. Fig. 7 illustrates a fracture on the foot of stock rail starting from the sharp angle left by machining. The foot of the rail should have been rounded off as shown by the dotted line. Chemical and physical investigations showed that both the rails conformed in every respect the conditions laid down by the I.R.S. specification for steel rails. Falling weight test on these rails were also satisfactory.

FIG. 6 Failure of a Vee joint due to mechanical defect.
