SOME SERVICE FAILURES ARISING FROM VARIOUS TYPES OF CORROSION

R.F. Cotton, B.Sc., and A.W. Franklin, M.Sc., A.I.M.

SYNOPSIS.

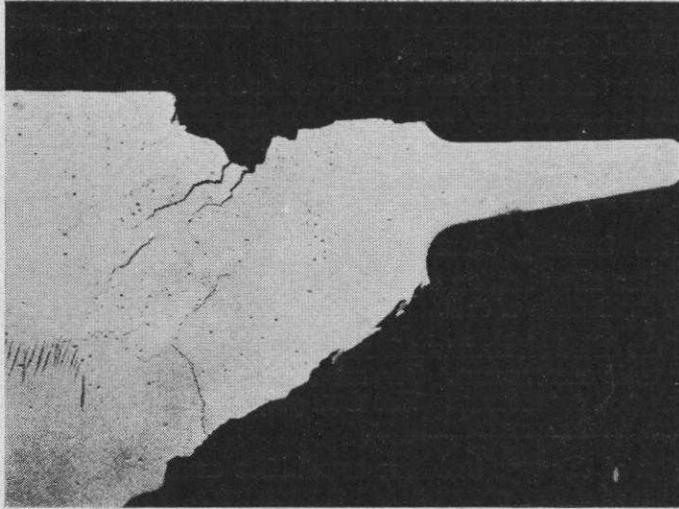
columns at an oil refinery. The caps were deep-drawn from stainless-steel sheet; slots had then been punched out of the rim, which was afterwards flared out. The failures occurred in caps on *the top tray* only of the columns, where they were exposed to reflux containing small proportions of ammonium hydroxide and ammonium chloride, at a temperature of about 110°C.

Stress-corrosion was suspected, and microscopical examinations of one of the failed caps showed branched cracks, both inter- and transcrystalline, which are typical of this form of failure in stainless steel (Figures 1 and 2). As shown in Figure 1, severe cracking had occurred around the slots and this also extended to the radius between the wall and the flat top of the cap.

Figure 1
STAINLESS-STEEL BUBBLE CAP
Piece of failed cap, showing stress-corrosion crack

The manufacturer of the bubble caps was recommended to use steel of type, B, and to apply the final annealing treatment to the finished caps. Since final annealing became standard practice, by design or coincidence no further failures have occurred.

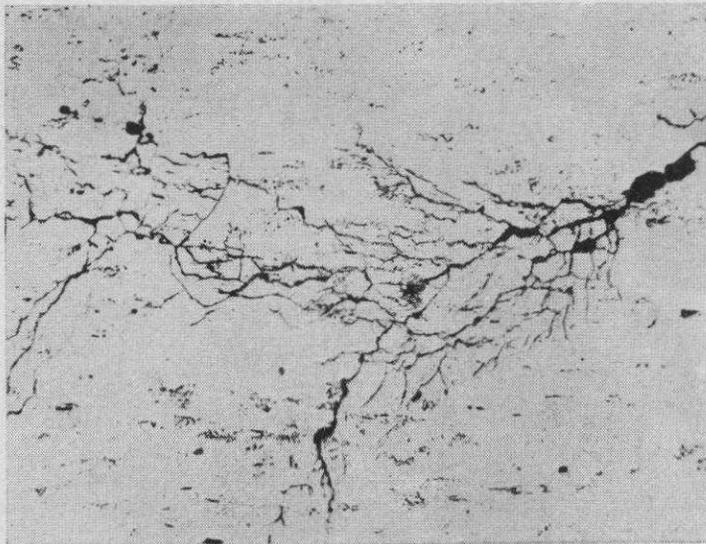
Figure 2
STAINLESS-STEEL BUBBLE CAP
Stress-corrosion crack (x 100)

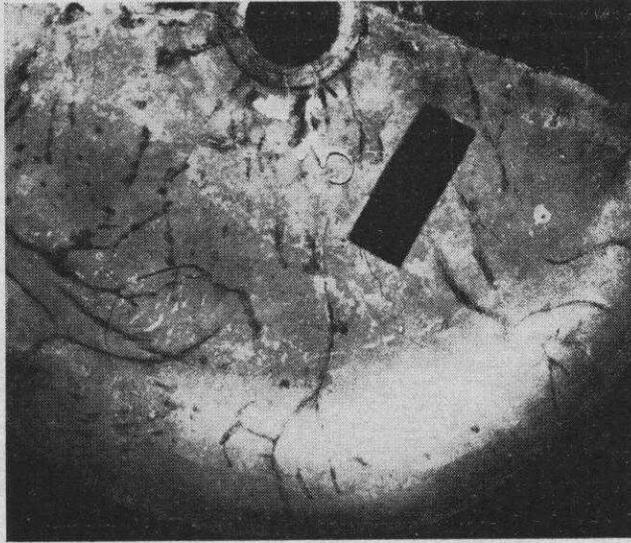
In this solution branched cracks typical of stress-corrosion failure gradually developed in all but the specimens which had received the final annealing treatment. The extent of the cracking, the time until the first appearance of cracks, and the resonance on testing for "ring" at the end of the exposure, are summarised in Table 2. The cracks appeared mainly on the curved region between the wall and the flat top, as seen in Figure 3. Since they were not obviated by the annealing applied before flaring, it would appear that this intermediate annealing treatment was inadequate.

An interesting feature of this investigation was the close similarity between the cracks produced in the laboratory test and those which occurred during service. Not only did they occur in the same positions on the caps, but their appearance under the microscope was very similar.

Figure 3
STAINLESS-STEEL BUBBLE CAP
Top view, showing cracks produced during laboratory stress-corrosion test

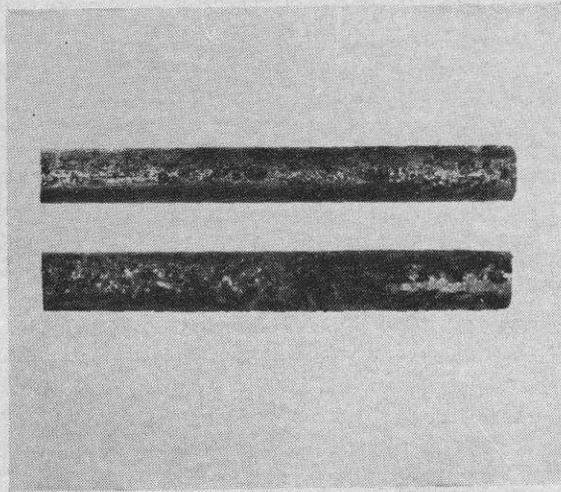
A number of nickel-chromium alloy tubes were separated by asbestos from other tubes during their final heat-treatment. When they were taken from the furnace it was noticed that very heavy scaling had taken place where the tubes had been in contact with the asbestos. The heavily attacked sides of two tubes are shown in Figure 4. This material normally has but a thin uniform oxide skin after heat-treatment. Micro-examination of transverse sections through the tubes showed that, beneath the layer of scale, a layer of the metal contained corrosion products resembling those formed by sulphur attack. At the most heavily scaled part of the tubes the wall thickness had been reduced by about 8%, and penetration of the corrosion, mainly along the grain boundaries, extended to a depth of equal to a further 8% of the original wall thickness.

The presence of sulphides was confirmed by chemical spot tests on the micro-section and also by chemical analysis of a sample of scale removed from one of the tubes, which had a sulphur content of over 1%. It was concluded that sulphur present in the asbestos had caused the corrosion. The amount of sulphur present must have been considerable, since parts of the tube wall which had not been in direct contact with the asbestos showed some signs of sulphur attack.

Figure 4
CORRODED NICKEL-CHROMIUM ALLOY TUBES
