Engineering Failure Analysis 8 (2001) 521–528

Failure analysis of high temperature studs

Studs in the interceptor valve of a 110 MW unit failed after a service life of 148,700 h. The studs were operated under a steam pressure of 35 kg/cm² and a temperature of 535°C. The studs were fractured at one end of the threaded end. Various techniques were employed to analyse the failure of the studs. It has been concluded that the failure of the studs was due to reverse temper embrittlement. The failure was delayed due to the presence of Mo and V. To reduce the tendency to this kind of failure, the following steps were recommended: (a) reduce the phosphorus content in the steel to a low level or (b) reduce the grain size to about 10 µm. © 2001 Elsevier Science Ltd. All rights reserved.

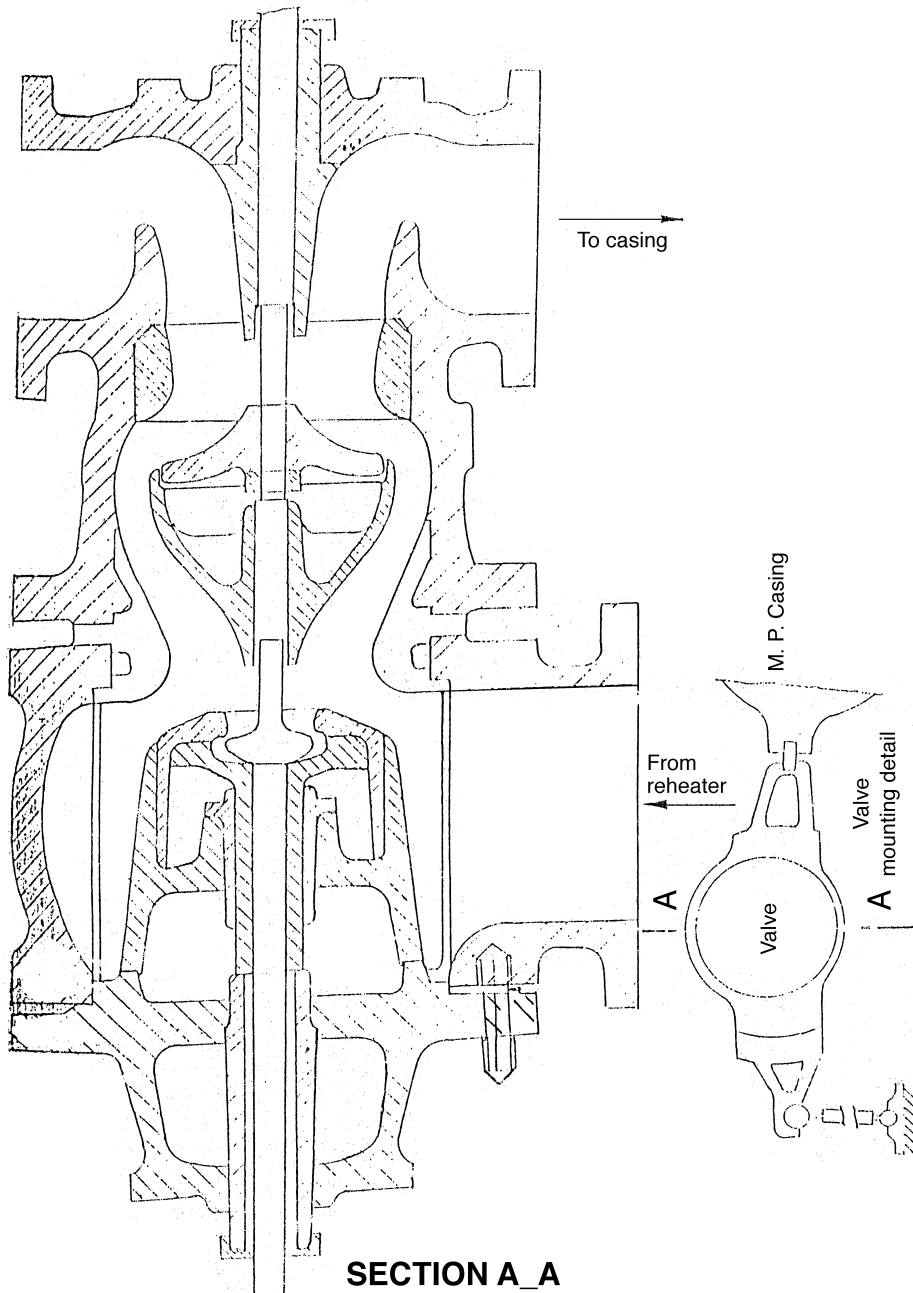
In the present paper, failure of studs in the interceptor valve of a 110 MW unit which were found broken during overhauling was investigated [7]. The position of the studs in the valve is shown in Fig. 1. The studs completed a service life of 148,700 h. The studs were operated under high quality superheated steam subjected to maximum pressure of 35 kg/cm² and temperature of 535°C. Stud was fractured from one end of the threaded end as shown in Fig. 2.

Fig. 1. Schematic diagram showing the position of the stud on the valve.

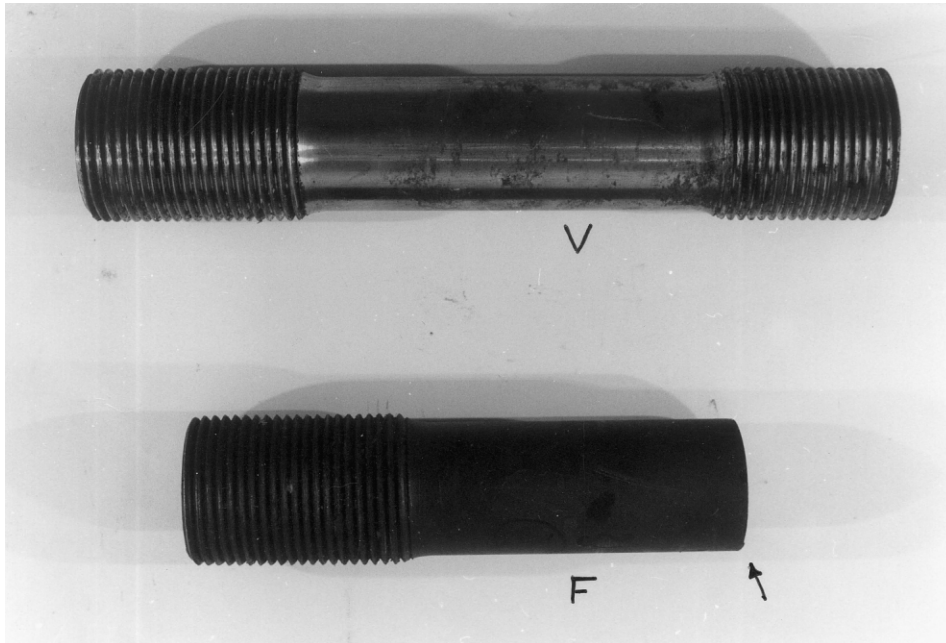
Fig. 2. Photograph of the virgin stud (V) and the failed stud (F) (arrow indicates the point of fracture).

It is therefore recommended: to use low phosphorus steel; to use 2.25CrMoV steel; to replace the studs after any one of the same batch has failed.

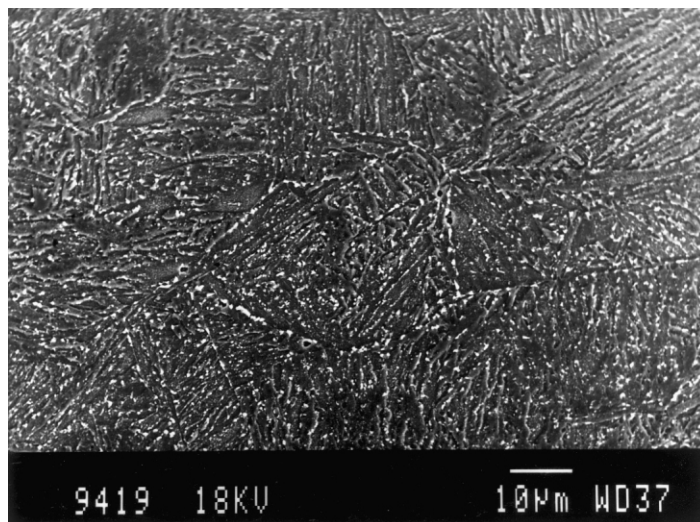
Samples were taken from the fractured end of the failed stud for metallographic investigation. As mentioned earlier, the fracture took place from one of the threaded ends. Samples of the new stud were also taken just below similar thread ends. Standard metallographic technique was employed for sample preparation and they were etched with Nital reagent. SEM micrograph shows tempered bainitic structures in both cases (Fig. 3). Some of the prior austenite grain boundaries have carbides rich in Cr and Mo. This kind of microstructure is quite common for this grade of steel.

Fig. 3. Micrograph of the failed stud.

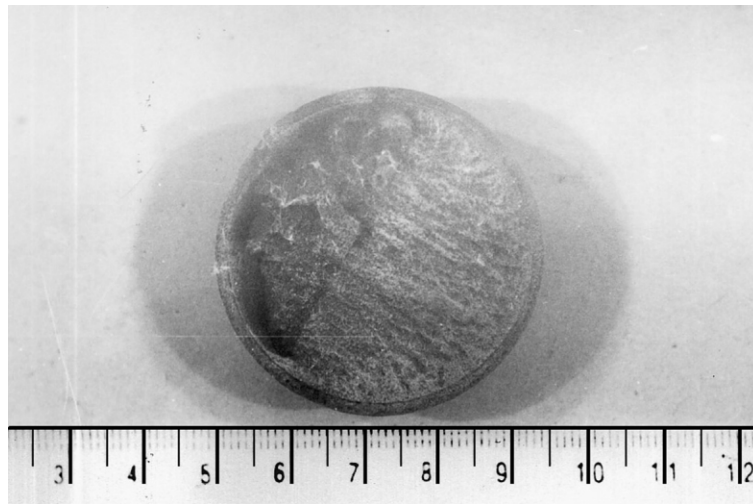
The fracture surface of the failed stud was fully covered with iron oxides. Thus, evidence of fracture morphology could not be obtained. However, the oxide scales on the fracture surface were removed with active reagents (pickling solution). The macrophotograph of the fracture surface is shown in Fig. 4. The total fracture area can be divided into two zones: slow propagation zone (A) and fast fracture propagation zone (B). Within zone A, it can be visualised that cracks might have initiated from more than one point.

Fig. 4. Macrograph of the fracture surface of the failed stud.

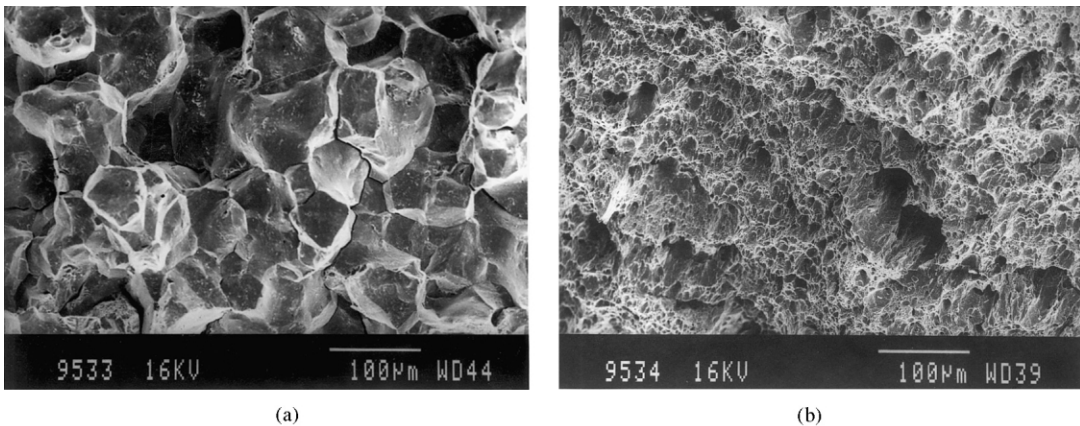
Fracture surfaces of the impact tested specimens were examined in SEM. The samples made from the failed stud showed complete intergranular brittle fracture morphology (Fig. 5a); whereas the sample from the new stud showed ductile dimple morphology (Fig. 5b). The differences in the impact energy values in conjunction with the different fracture morphology indicates that the failure took place due to intergranular embrittlement.

Fig. 5. (a) Fractograph showing the fracture surface of the impact tested specimen of the failed stud; (b) fractograph showing the fracture surface of the impact tested specimen of the virgin stud.

In the present steel, the level of phosphorus is 0.038, Mo is 0.84 and V is 0.35. The presence of V alters the carbide formation schedule and allows the material to be in service for 148,700 h before failing by embrittlement. Thus, the failure of the studs was delayed due to presence of Mo and V in the steel which did not allow P to segregate to the grain boundary. With slow and gradual changes in carbide composition, Mo was removed from the solution. Finally P was free to move to grain boundaries and fracture took place by grain boundary decohesion.
