## FAILURE INVESTIGATION OF A BOILER PIPE

U. GUPTA, S.N. TIWARI, R.N. SHARMA,  
R. NATH, V.K. TEWARI AND S. PRAKASH

Metallurgical Engineering Department,  
University of Roorkee, Roorkee (U.P.) 247667, India.

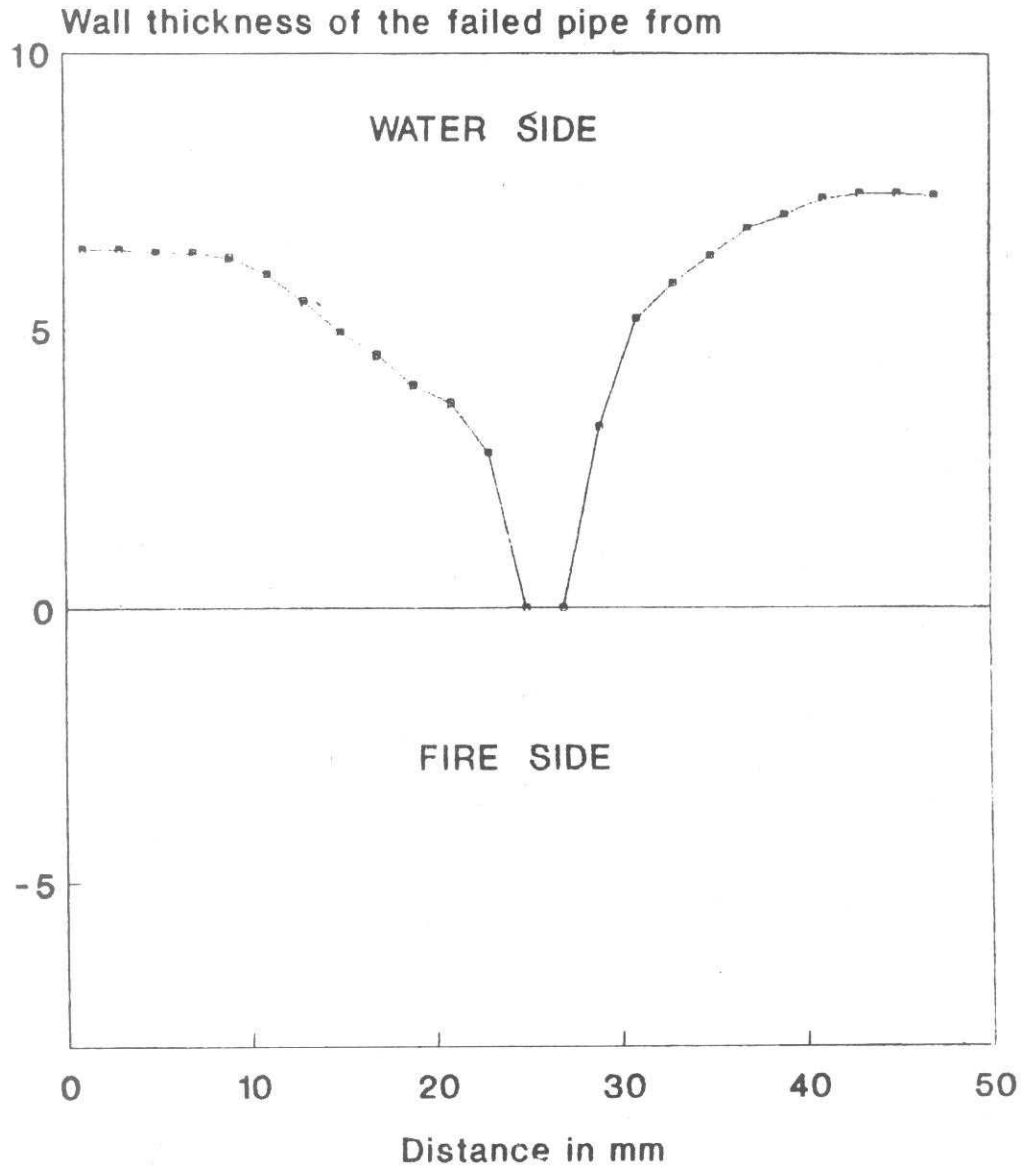
Figure - 1: Contour of the failed pipe from the water side

The contour of the damaged portion, obtained by measuring with spherometer on both sides, is given in Fig. 1. It shows the contour of the metal near the hole moving inwards from the water side.

The boiler pipe failed miserably due to combined effect of corrosion from both water and fire side. It is evident in Fig. 1 that damage has occurred mainly from water side. This may be attributed to the nature of water side scale being fragile and powdery hence it spalled and corrosion proceeded inside the material deeper and deeper till the pipe failed. The fire side scale was compact and hence was protective.

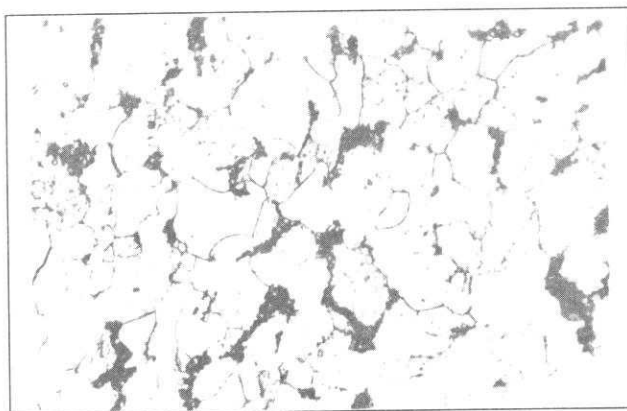
*Fig. 2 : Microstructure of the sample of damaged pipe from water side*

*Metallographic Studies* : Fig. 2 reveals the microstructures of sample from water side consisting of ferrite and pearlite. The inclusions are present at the grain boundaries and the micropores are visible throughout the structures. Fig. 3 reveals the microstructures of sample from fire side consisting of ferrite and pearlite. The grains are distorted but presence of black inclusions is also predominant. Fig. 4 shows the microstructure of the new original pipe revealing the inclusions around the grain boundaries.

Fig. 2, 3 and 4 show the presence of inclusions and the pores. The large number of inclusions present may act as differentially charged electrodes as compared to matrix thereby forming a differential cell which leads to higher rate of dissolution by aqueous corrosion. The micropores in the ferrite matrix cause pitting type corrosion. The SEM micrographs 5, 6, 7, 8 and 9 also confirm this mechanism of corrosion by showing the transgranular cracks in the scale. Some areas of the scale being spalled and there is clear indication of inclusions.

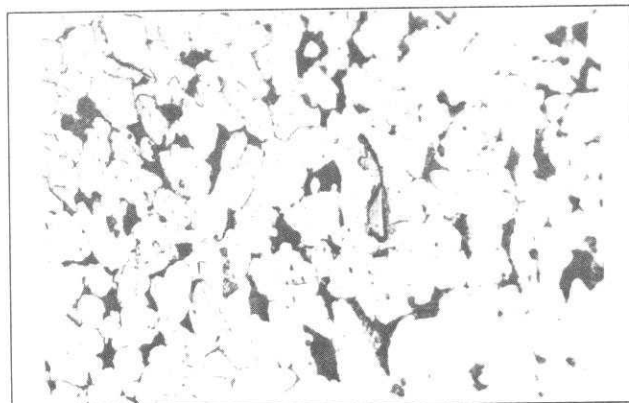
*Fig. 3 : Microstructure of the sample of damaged pipe from the fire side*

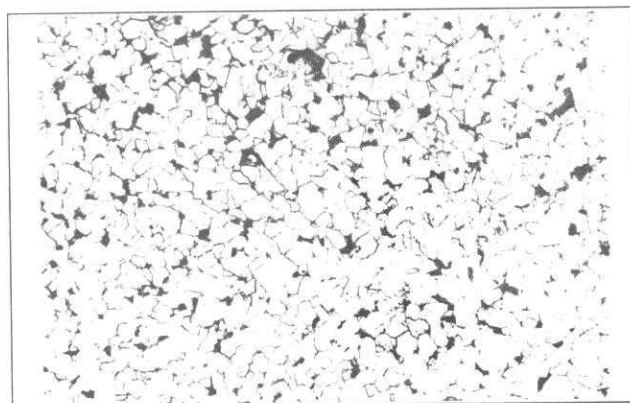
*Fig. 4 : Microstructure of the sample of new original pipe*

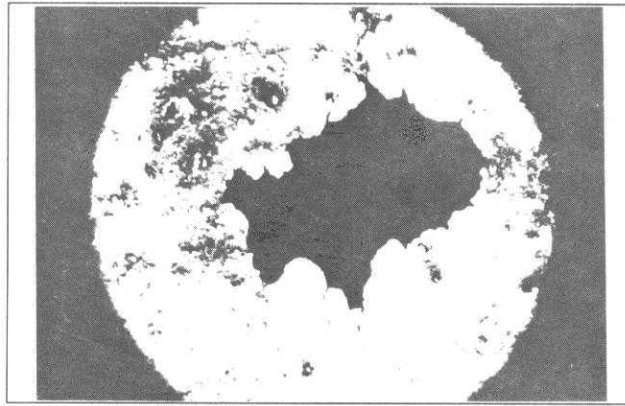
*Scanning Electron Microscopic Studies* : Fig. 5 shows the SEM micrograph of the sample

from water side having an irregularly shaped through hole and the cracks running outwards. Fig. 6 shows the magnified area of the periphery of the hole with a crack. Some transgranular cracks are also visible. Fig. 7 gives clear indication of the presence of inclusions. Fig. 8 shows the SEM micrograph of the sample from fire side. This clearly reveals that the scale has got cracks and some areas of the scale have spalled. Fig. 9 is the SEM micrograph of the new pipe showing slag stringer inclusion.

*Fig. 5 : SEM Micrograph of the sample of damaged pipe from water side(X10)*

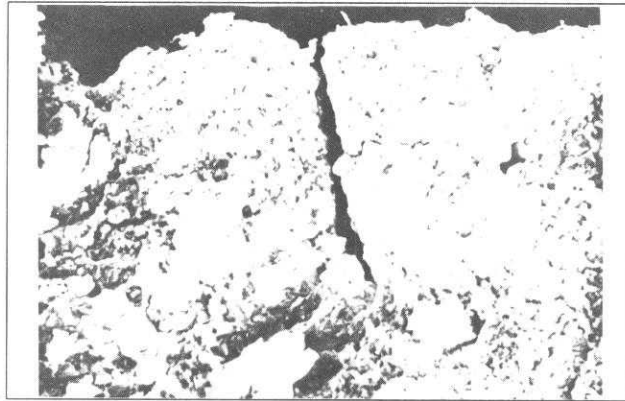
*Fig. 6 : SEM Micrograph of the sample of damaged pipe from the fire side (X160)*

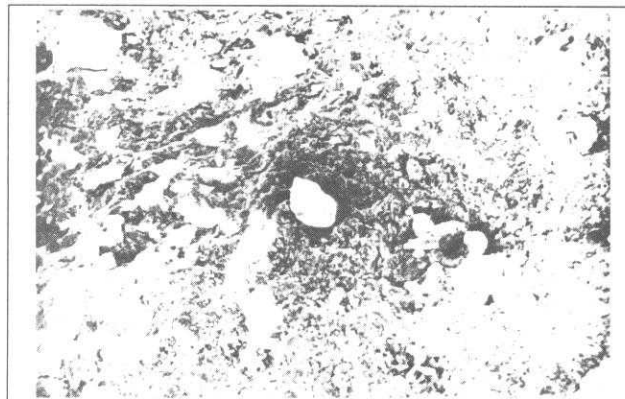
*Fig. 7 : SEM Micrograph of the sample of damaged pipe from the fire side (X80)*

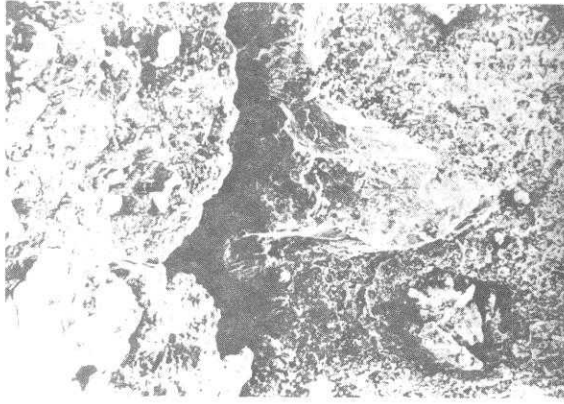
Fig. 8 : SEM Micrograph of the sample of damaged pipe from the fire side (X80)

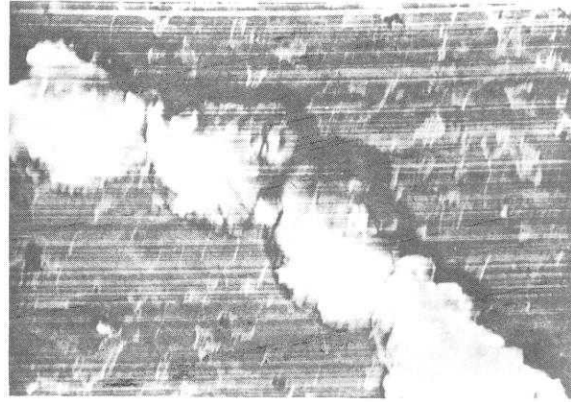
Fig. 9 : SEM Micrograph of new original pipe (X320)
