# CHARACTERIZATION OF CORROSION RELATED FAILURES

S. R. Singh

Materials Characterization Division

This paper deals with the characterization of corrosion related failures of structural steel components in the various environments of petrochemical industries. The case studies, pertaining to the failures due to, stress corrosion cracking in CO<sub>2</sub> environment, catastrophic carburization (metal dusting corrosion) in hydrocarbon environment, and corrosion fatigue in steam environment have been discussed.

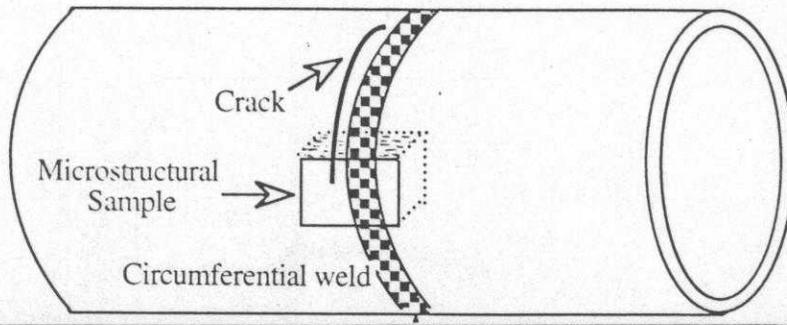
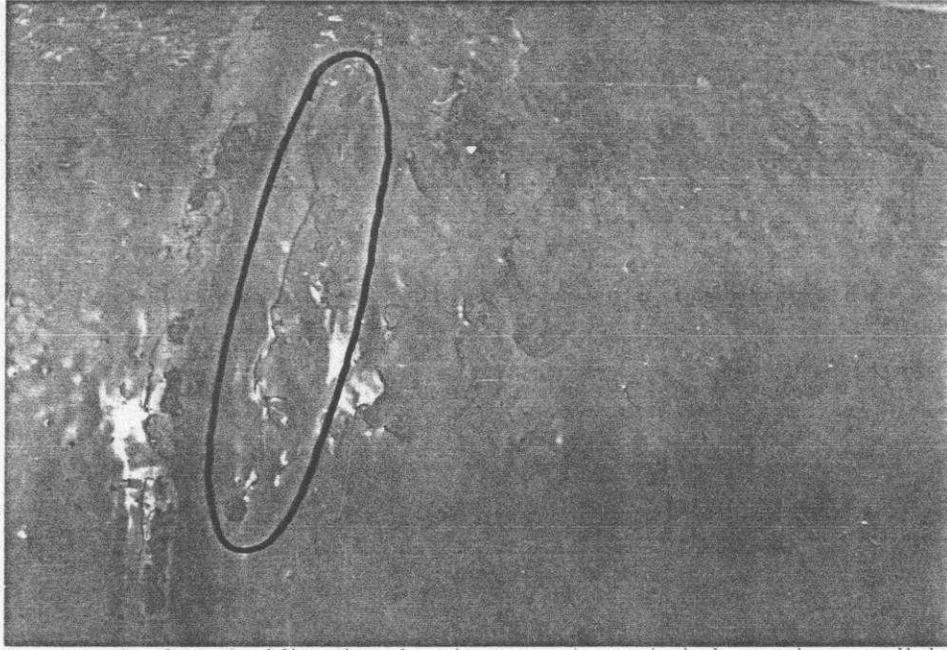
**§2.4.1. Visual examination & dimensional measurements:** The 6" dia header linepipes were having circumferential weld. The linepipes A & B showed cracks running parallel to weld while linepipe C was a sound tube. All the external surfaces of linepipes were protected by yellow paint. Figure 2 showed a photograph of cracked linepipe where the crack is marked by arrows. The extent of the cracks were about 3" - 4 ". The internal surface of all the tubes exposed to the carrier gases showed adherent brown deposit. The measured dia of the linepipes were 16.5 cm. The carrier gas internal pressure of 10 kg/cm<sup>2</sup> (0.98 MPa) would give rise to hoop stress (tangential stress),  $\sigma_{hoop} = 16.2$  MPa and longitudinal stress,  $\sigma_{longitudinal} = 8.1$  MPa. As the cracks were along the circumference, therefore, the longitudinal stress would be operative on cracks.

Fig. 2: Photograph of cracked linepipe showing a crack (encircled) running parallel to the circumferential weld.

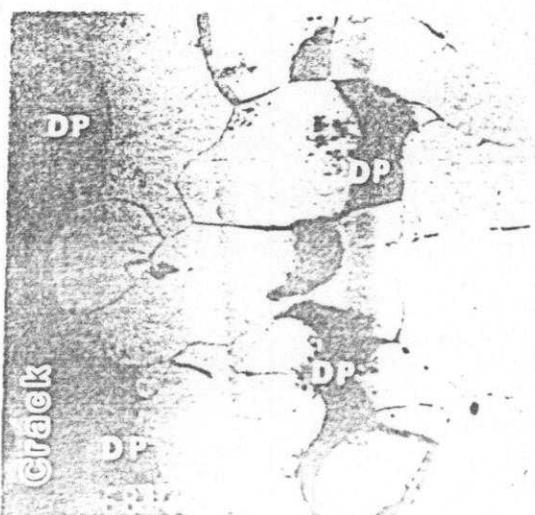
were about 2-3 mm away from the SCHAZ and in base metal. The base metal near crack contains grain boundary phases termed 'dark phase' (Fig. 3) because of its atomic number contrast in back scattered electron images. The composition of dark phase and nearby ferrite grains were determined by EDAX. This showed significant segregation of Si and Mn in the dark phase (Table 2). The microhardness of dark phase was much higher than the nearby ferrite grains (Table 3). All these observation showed hardening of grain boundary phase was due to segregation of Mn and Si. The dark phase was only observed in cracked samples. The absence dark phase in virgin sample indicates that its formation occurred during service exposure.

Fig. 3: SEM micrograph from cracked linepipe showing back-scattered electron image of 'dark phase' (marked DP).

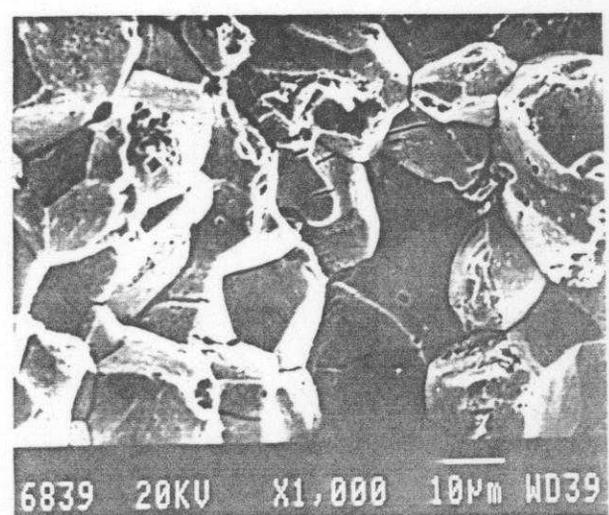
**§2.4.7. SEM Fractography:** Service cracked samples from linepipes A and B were examined for the fracture mode evaluation. The cracked surface showed brown deposits which hid the underlying fracture surface. The samples were treated with a specially developed solution which selectively dissolved the metal oxides leaving the lustrous metallic fracture surface unaltered. The resultant fractograph showed 100% intergranular (IG) fracture surface indicating brittle fracture mode due to grain boundary decohesion (Fig. 4). The branched cracking was manifested by the grain boundary cracks. The fracture surface of tensile tested sample showed IG fracture of varying degree in small region near the one edge and along the width of the gage length while rest of the area (major portion) showed dimple rupture (Fig. 5a,b). However out of nine samples tested, only three showed complete dimple rupture. The dimples were associated with MnS inclusions. The inner and outer surfaces as well as the thickness of linepipe were represented by width and thickness of tensile samples respectively. The IG fracture was initiated at one of the surface. Based on optical metallographic observations it was concluded that the IG fracture was originated from the inner surface of tube. The coverage of IG fracture surface in tensile tested samples varies in samples from the same linepipe. This was manifested by the varying degree of scatter in % elongation. A summary of fractographic observations is collated in table 6.

Fig. 4: SEM fractograph of service cracked linepipe A. showing intergranular (IG) brittle fracture.

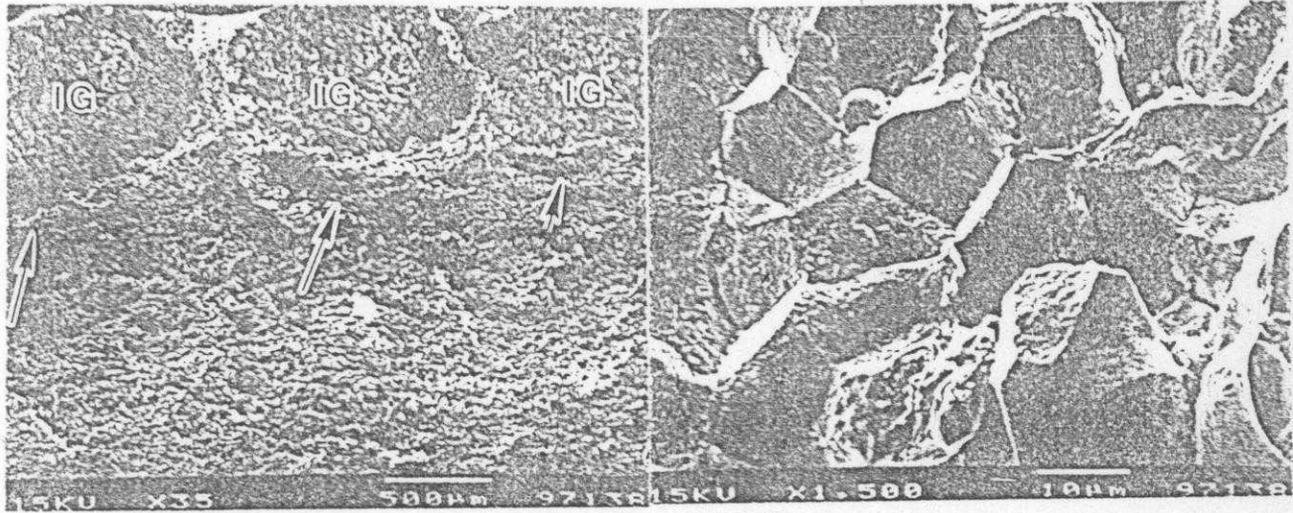
Fig. 5(a): SEM fractograph of tensile test sample C-1 showing three elliptical patches marked by arrows.

Fig. 5(b): higher magnification of patchy regions revealing IG brittle fracture while rest of the surface showed dimple rupture

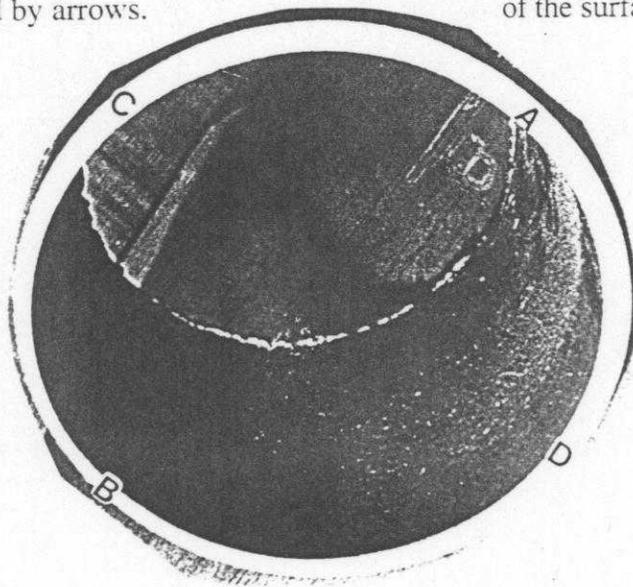
**§3.3.1. Visual examination:** The transverse section of failed tube is shown in Fig. 6. Wall thickness of tube was non-uniform having maximum thickness of 6.8 mm (region "A") and minimum thickness of 3.6 mm (region "B"). These two regions are diametrically opposite and outer diameter across it was 170 mm while outer diameter perpendicular ("CD") to it was 168 mm. Inner tube surface has dull black appearance with sooty deposits. Therefore the tube had undergone 1% expansion along "AB", where wall thinning was maximum while there was no appreciable deformation along "CD". These observations indicate that the failure would have taken place due to non-uniform wall thinning.

Fig. 6: Photograph of transverse section of tube showing maximum and minimum wall thickness regions marked "A" and "B" respectively. Non-uniform wall thinning can be noticed.

Addition of  $\text{H}_2\text{S}/\text{CS}_2$  gas stream acts as catalytic poison for decomposition of hydrocarbon, thereby decreasing the carbon activity and block the ingress of carbon to metallic surface which inhibit carburization process. The material replacement with 5Cr-1Mo/9Cr-1Mo can also results in reduced carburization.

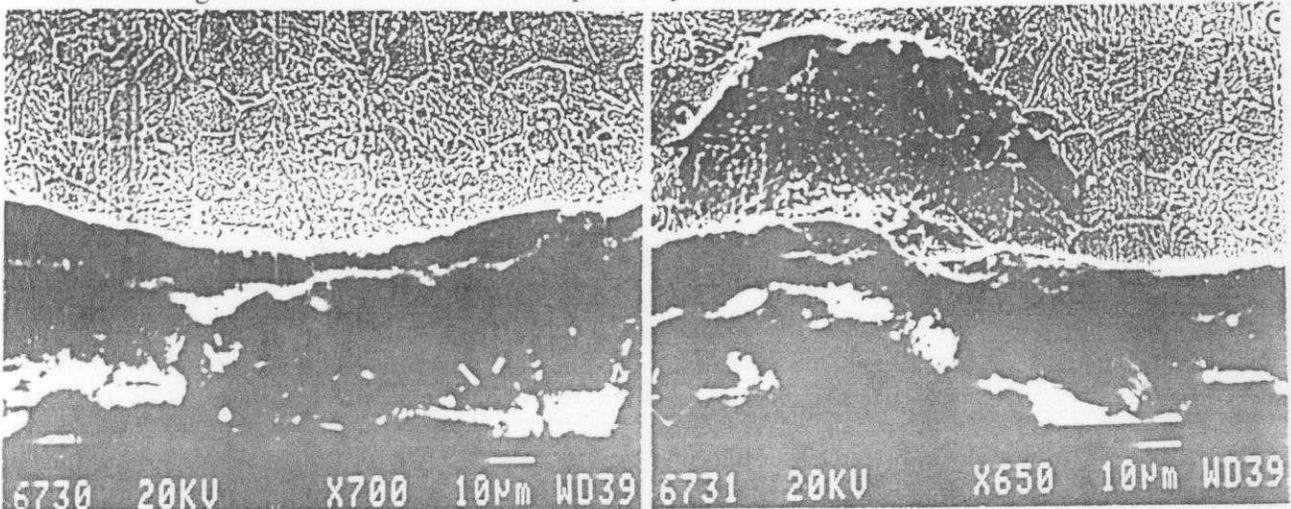
**§3.3.3. Scanning electron microscopy & composition analysis by EDAX:** The inner tube surface/matrix microstructure from transverse section of region "A" is shown in Fig. 7a, which showed the duplex nature of oxide scale consisting of thin inner wustite layer and thick outer magnetite/spinel layer. Ingress of carbon to subsurface region lead to general carburization manifested by intergranular as well as intragranular carbide precipitation/coarsening and initiation of pitting (Fig. 7b). The longitudinal section of inner surface showed (Fig. 8) spherical particles dispersed on irregular shaped particle/soot. SEM of transverse section from region "B" showed unaltered matrix microstructure (Fig. 9a) while subsurface region of inner tube wall showed (Fig. 9b) coarsening of grain boundary precipitates as well as increase in their number density. Also the pitting in region "B" was absent. This indicates that the uniform metal wastage by catastrophic carburization was operative in the region "B".

Fig. 7(a): SEM micrograph of transverse section of tube region "A" showing inner tube surface-matrix interface.

Fig. 7(b): SEM micrograph showing pitting initiation at the inner tube surface.

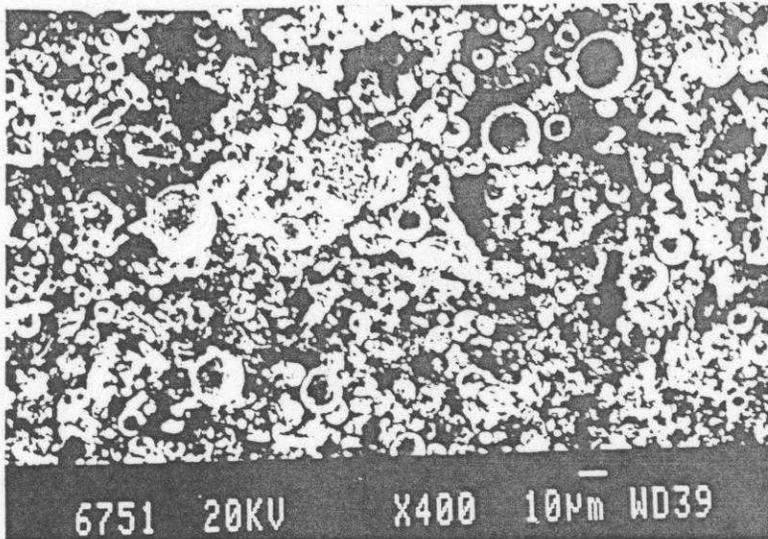
Fig. 8: SEM micrograph of as-received inner tube surface of region "B" showing distribution of spherical metal particles.

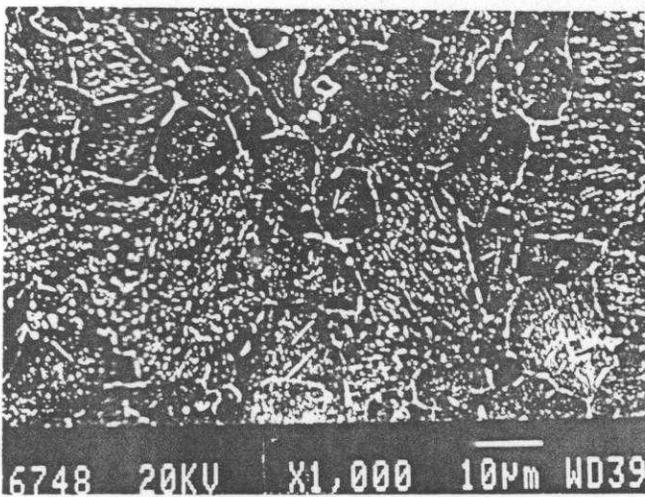
Fig. 9(a): SEM micrographs of transverse section of tube region "B" showing matrix microstructure.

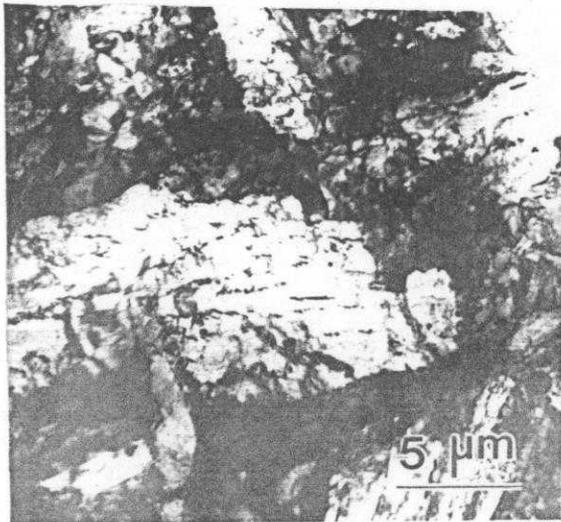
The general microstructure parent metal (PM) consisted of ferrite - bainite with intragranular precipitates of  $\epsilon$ -Cu and cuboid carbonitrides as well as intergranular  $M_3C$  and  $M_7C_3$ . Figure 10 showed a low magnification bright field (BF) micrograph.

Fig. 10: TEM micrograph of parent metal.

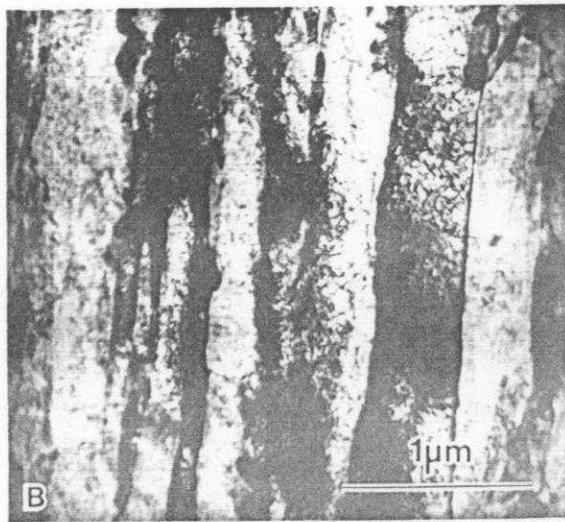
The microstructure of vortex breaker weld-1 showed (Fig. 11) mainly acicular ferrite with dislocation substructure within the ferrite plate and above mentioned precipitates. Figure 12 showed higher magnification view of a blocky ferrite grain revealing distribution  $\epsilon$ -Cu precipitates. The average size of these precipitates is about 40 nm and it showed no sign strain contrast around the precipitates. The electron diffraction analysis in conjunction with morphological observations indicates that the precipitates on packet boundaries are cementite.

Fig. 11: TEM micrograph of vortex breaker weld-1 showing mainly acicular ferrite with dislocation substructure.

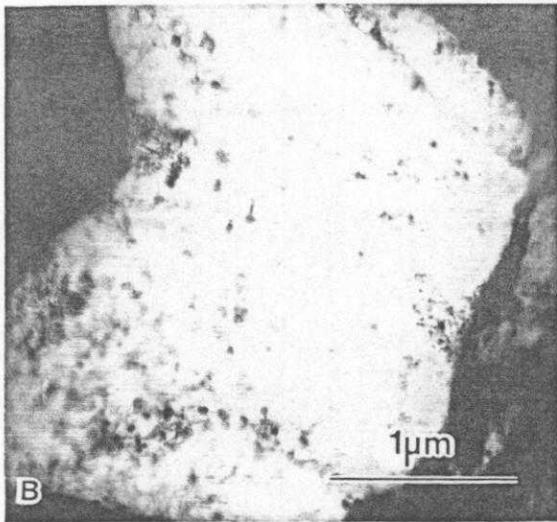
Fig. 12: TEM micrograph showing  $\epsilon$ -Cu precipitates in a blocky ferrite grain.

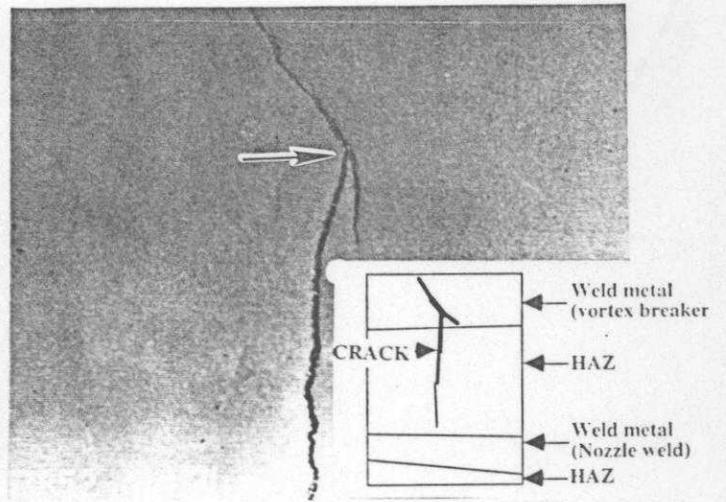
**§4.3.2. Scanning electron microscopy:** A low magnification SEM micrograph along with a schematic diagram of cracks in the sample 4BE is shown in Fig. 13. This sample covers the entire region of vortex breaker weld pool and nozzle weld pool with intervening HAZ. The crack initiated (marked by arrow) in vortex breaker weld pool and propagated toward ends A & B. The crack propagating towards the end B followed the two paths; the shorter length crack ended in the weld pool itself while the other longer crack propagated in the neighboring HAZ. A higher magnification montage of photographs is shown in Fig. 14. A localized parallel crack, marked "PC", parallel to main crack is indicated. The features associated with these cracks were indicative of corrosion fatigue crack.

Fig. 13: A low magnification SEM micrograph showing cracks along with its schematic drawing.

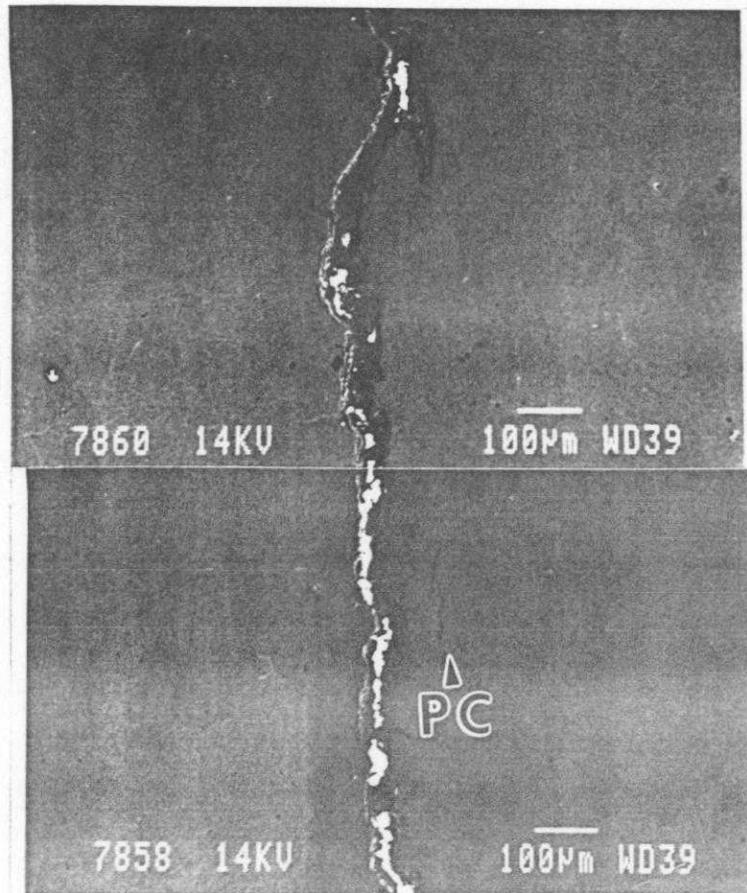
The branching of crack or parallel cracking associated with main cracks are indicative of stress corrosion cracking and corrosion fatigue respectively. The corrosion fatigue cracking results from combination of, i) vibration, ii) susceptible microstructure, and iii) corrosive environment. Such fine parallel cracking usually results from alternating stresses, possibly caused by pressure fluctuations or the effect of water hammer, as well as simple vibration. Repeated expansion and contraction as a result of considerable temperature fluctuations may show similar effects. Corrosion fatigue cracks which result from this cause, are often initiated at small corrosion spots and develop in a transcrystalline manner in contrast to the cracks resulting from stress corrosion which are mainly intercrystalline.

Fig. 14: A higher magnification montage of SEM micrographs showing main crack and localized parallel crack, marked "PC".
