POWER PLANT COMPONENT FAILURES
INVESTIGATION AND REMEDIAL MEASURES

U.C.BHAKTA

RESEARCH AND DEVELOPMENT CENTRE
NATIONAL THERMAL POWER CORPORATION LIMITED
A-8-A, SECTOR-24, NOIDA - 201 301 (U.P.)

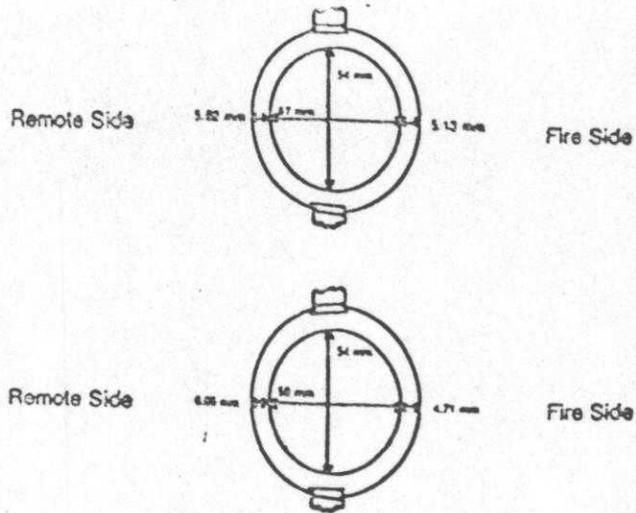
Microstructure of the water wall tube indicates the spherodisation in 60 MW shown in Photograph No.3. Oxide deposition has also been observed in all the units of 100/210 MW water wall tubes. Internal surface of a water wall tube of 60 MW unit of one station of SEB's shown in photograph No.4. Water wall tube thinning from the water side. It has been observed as shown in the Figure-III and overheating of these tubes has been observed.

Figure-III: Tube Thinning of Water Wall Tube from inside
In Unit No.4, 210 MW, Badarpur

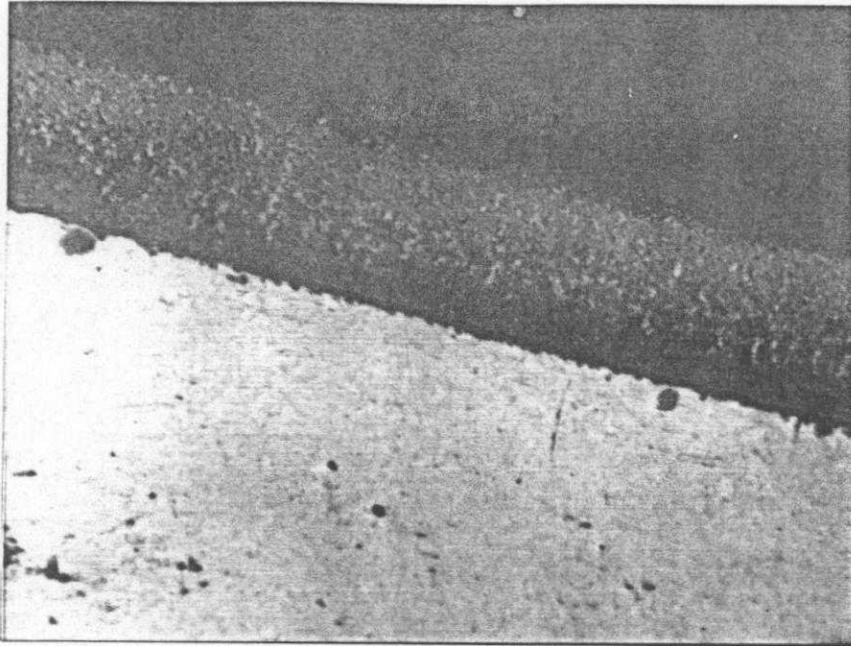
Photograph No.1: Porous, Cracked Internal Oxide Layer having Copper Deposition in Water Wall Tube, 210 MW, -

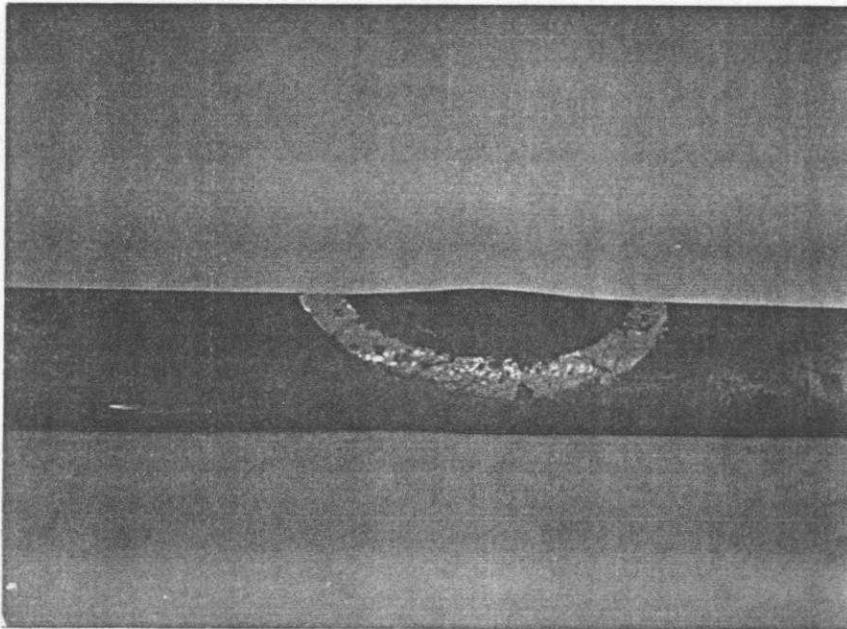
Photograph No.2a: Swelling of Water Wall Tube Due to Overheating Due to Presence of Internal thick Oxide,

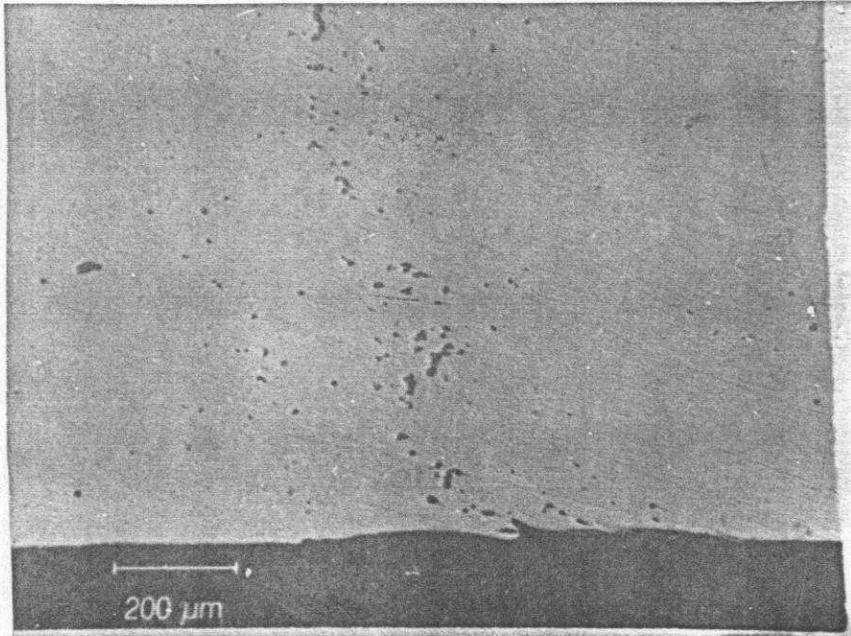
On load corrosion results from the local formation of concentrated alkaline or acidic solution at metal surface. In either case, corrosion rates of over 1 um/day are possible at 300 C and are several times higher 50 um/day at 400 C. These rates do not diminish with time even though layers of magnetite may be produced very thick. The magnetite formed in these condition is non protective. The salt concentration increase due to ingress or raw/cooling water into the feed water due to condenser leakage which deposited on the internal surface due to wick boiling phenomenon as shown in figure 1a. The salts are concentrated due to non porous in nature of internal oxide which produce the localised high/low pH. Due to the increase in the thickness of internal oxide, the temperature of steel increases due to decrease in heat transfer as shown in figure II. Frequent tube failures at our station^{new} have not been observed. The tube analysis reveals that it had the internal oxide thickness more than 200 microns as shown in photograph no.1. The tube swelling due to overheating can be seen in water wall tubes as shown in photograph No.2 a. A case of graphitisation has also been observed in 60 MW boiler Thermal unit in water wall as shown in the polished sample in photograph No.2b.

Photograph No.2b: Graphitisation in Water Wall Tube Due to Overheating
Unit No.3, 60 MW

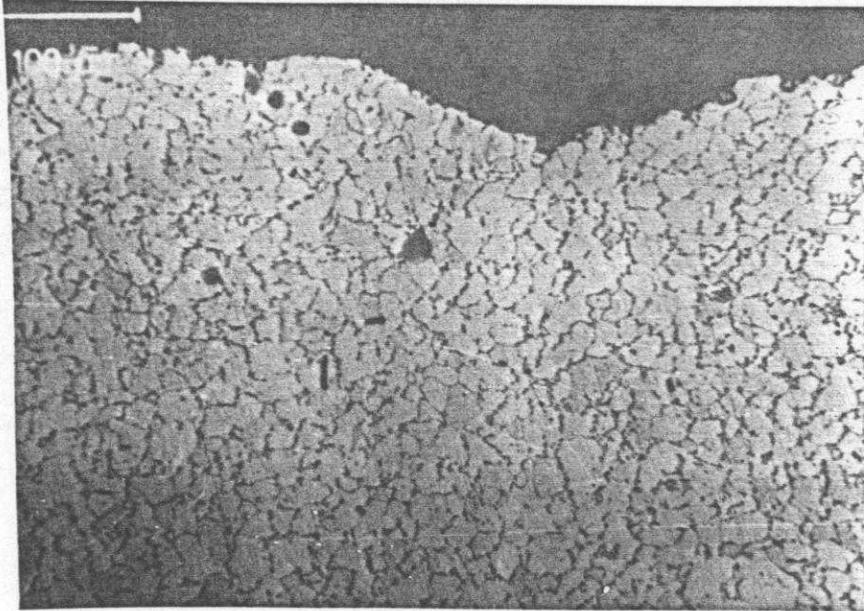
Photograph No.3: Microstructure Showing the Spherodisation in Water Wall Tube, Unit No.4, 60 MW.

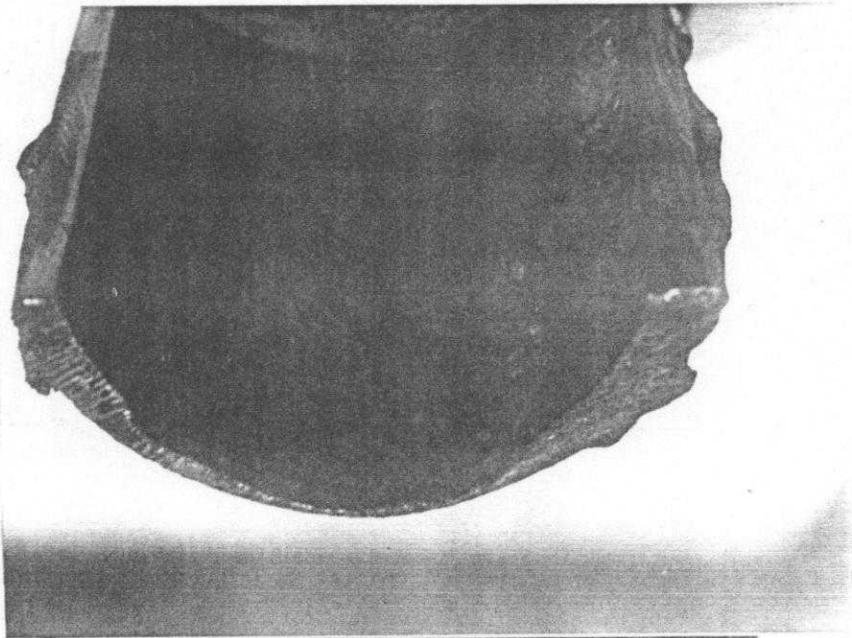
Photograph No.4: Internal Corrosion & deposition on the surface of Water Wall Tube facing flame, Unit-3, 60 MW.

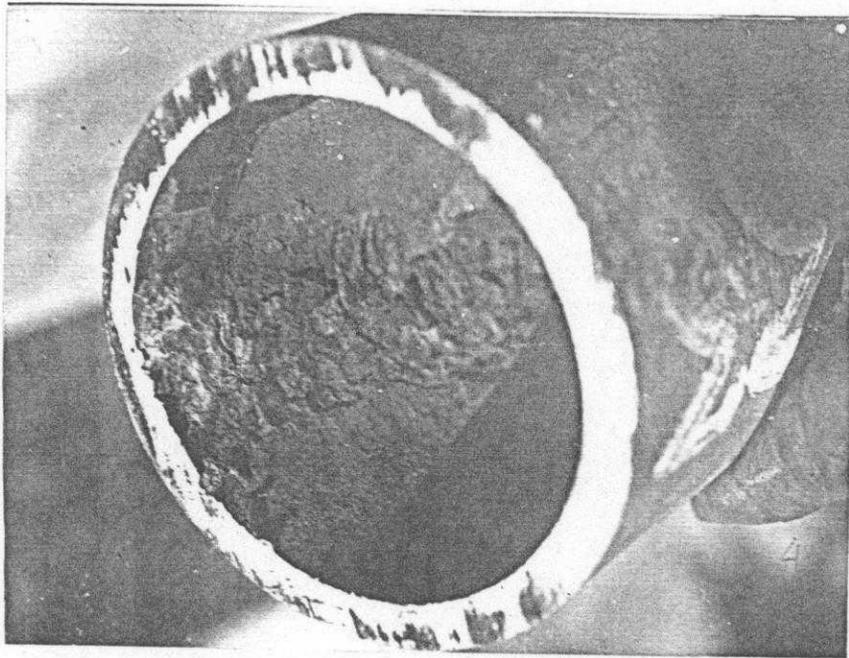
When a boiler is contaminated with dissolved oxygen and chloride in neutral or alkaline water, the protective oxide film may break down locally where oxygen is depleted and the metal becomes anodic to the surrounding surface. The dissolution of iron given ferrous chloride which hydrolyses to give an acidic solution as shown in Figure-V. An example of acidic corrosion has been seen in the 210 MW water wall tube as shown in photograph No.5. In this water wall, tube, the tube failed due to formation of localised acidic conditions and pit.

Photograph No.5: Acidic Corrosion Having Hard Adherent Deposit with Puncture, Unit-4, 210 MW,

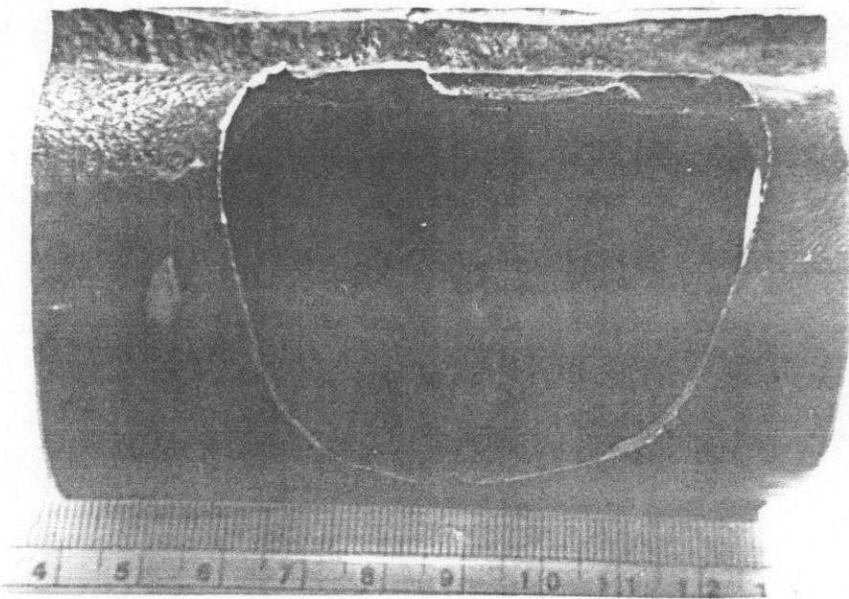
Hydrogen embrittlement of boiler tubes is often characterised by a detachment of portion of the tube. This type of fracture is often called a "Window" fracture which has been observed in 200 MW boiler as shown in photograph No.6. Microstructure of 100 MW, water wall failed tube shows the presence of cracks inside the metals as seen in Photograph No.7.

Photograph No. 6: Window Rupture of Water Wall Tube due to Hydrogen Embrittlement, 200 MW, Unit No.

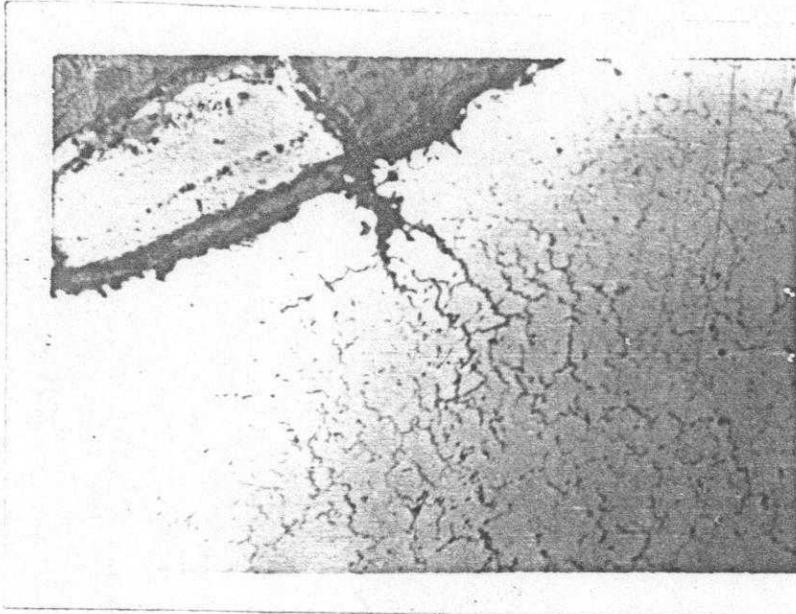
Photograph No. 7: Crack Developed in Side the Water Wall Tube,
Failed due to Hydrogen Embrittlement. (100 MW, Unit No. 1, B)

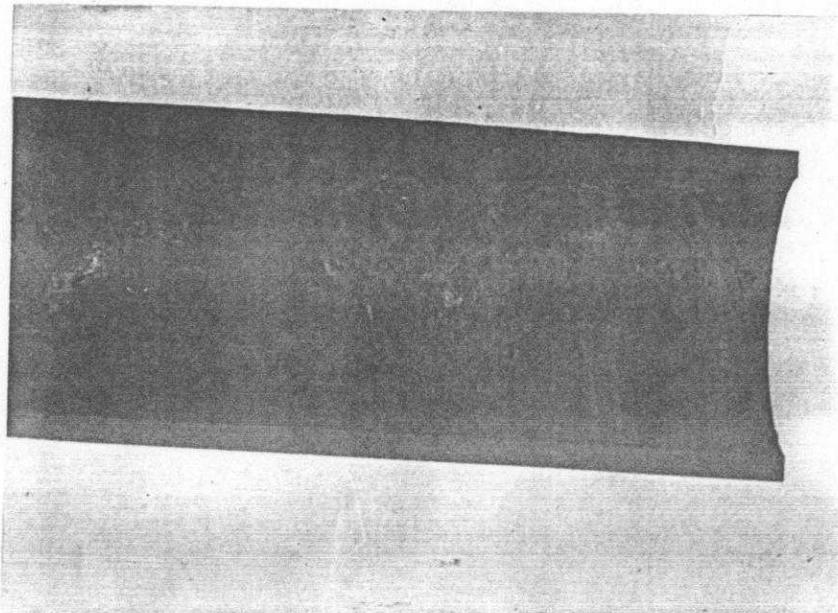
The typical example of caustic corrosion is shown in Photograph No.8 observed in 60 MW boiler. The most common type of caustic corrosion is caustic gouging which is generally found in high pressure boilers. A buildup of black iron oxide is found beneath the deposit in the vicinity of caustic attack when exposed to the atmosphere, it turns into white substance of sodium carbonate due to conversion of sodium hydroxide with the reaction of atmospheric carbon dioxide. This phenomenon has been observed in 60 MW station where the heavy condenser leakage was responsible for caustic gouging. This phenomenon is also found in high heat transfer area where the poor circulation aggravate the condition.

Photograph No. 8: Presence of Caustic Gouging In Water Wall Tube, Unit-2, 60
MW, B

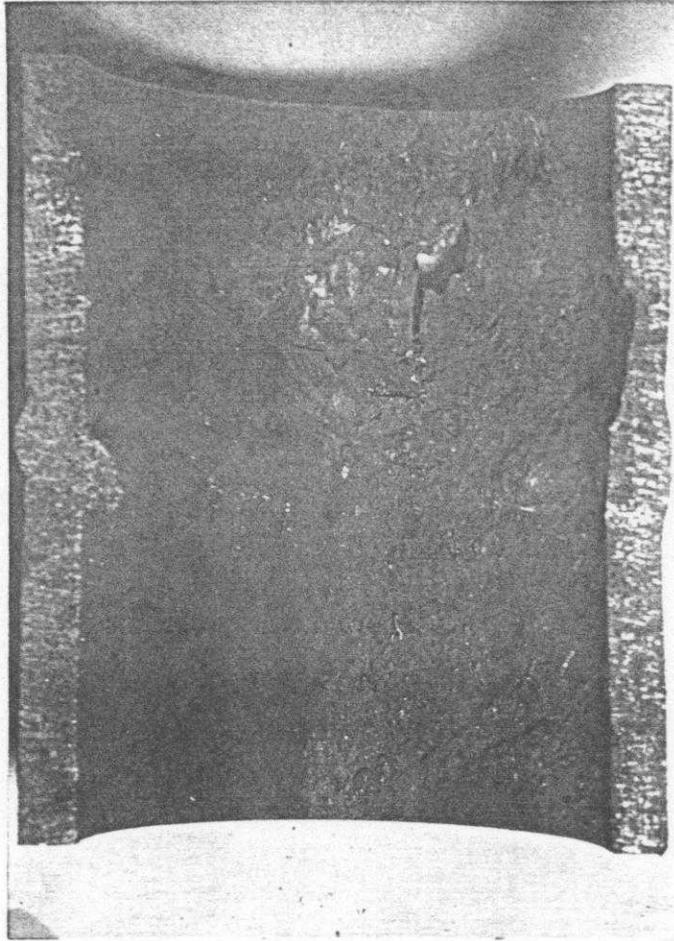
Photograph No. 9 : Gouging due to steam Blanketing Near the Welding Zone in Water Wall Tube, Unit-2, 60 MW.

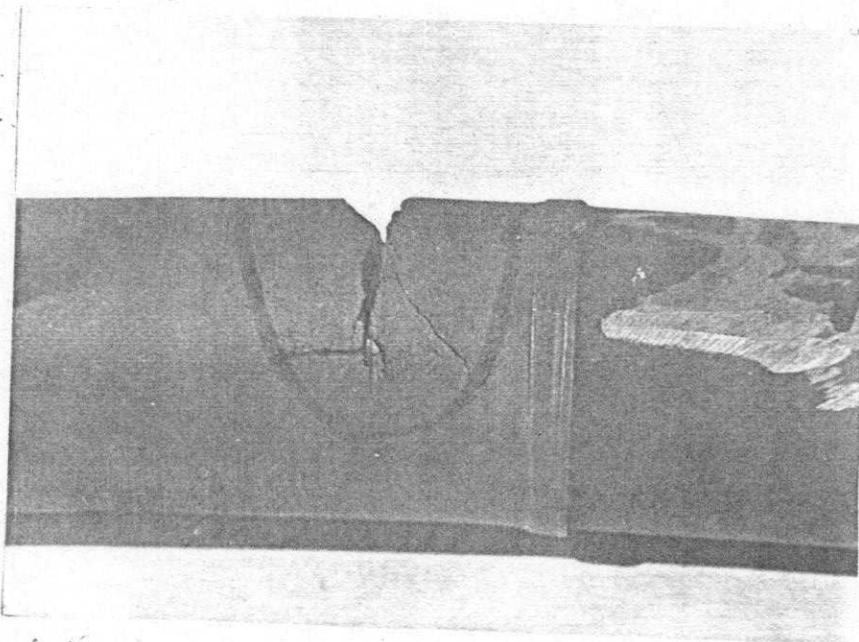
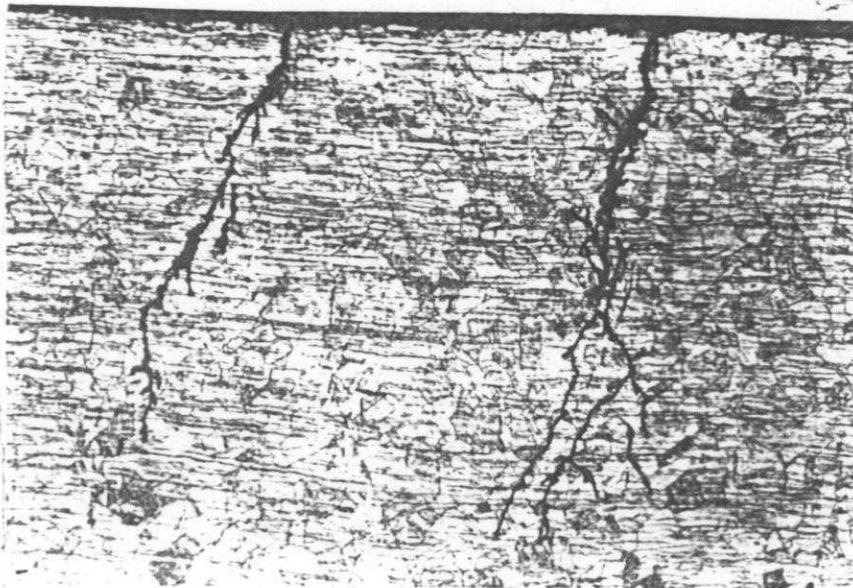
Transgranular & intragranular with bracking. These were caused by ingress of chloride & hardness in cooling water through condenser tube corrosion.

At one power station, several cases of transgranular SCC were found in a particular zone. Spool pieces of final superheater coils. That boiler gave problems just after commissioning of the unit. After detailed investigation it was established that tube was not cleaned before welding the spool pieces. Another source of chloride where failure occurred after several years of operation was condenser tube leakages.

Phot 10 (b) Transgranular Stress Corrosion Cracking of Stainless Steel Super Heater. 210 MW.

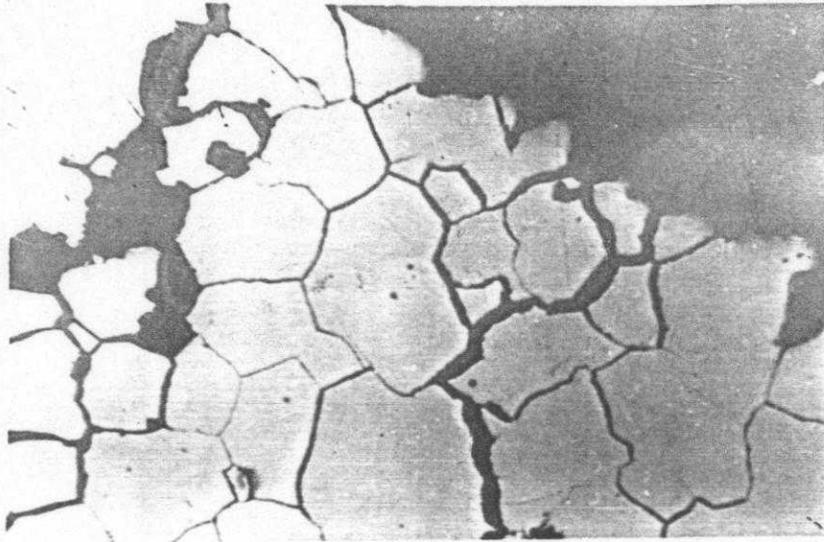
Several cases of superheater & reheater tube failures by caustic & chloride stress corrosion cracking (SCC) in 210 MW & 500 MW Unit boilers in NTPC Stations have been received. These tubes 304H & 347H grade austenitic stainless steels failed mainly at bends. The metallographic & SEM examinations revealed the characteristic features of SCC (Photograph No.11 &

Photo. ii. Intergranular Stress Corrosion Cracking of Reheater
Stainless Steel Tubes. 500 MW.

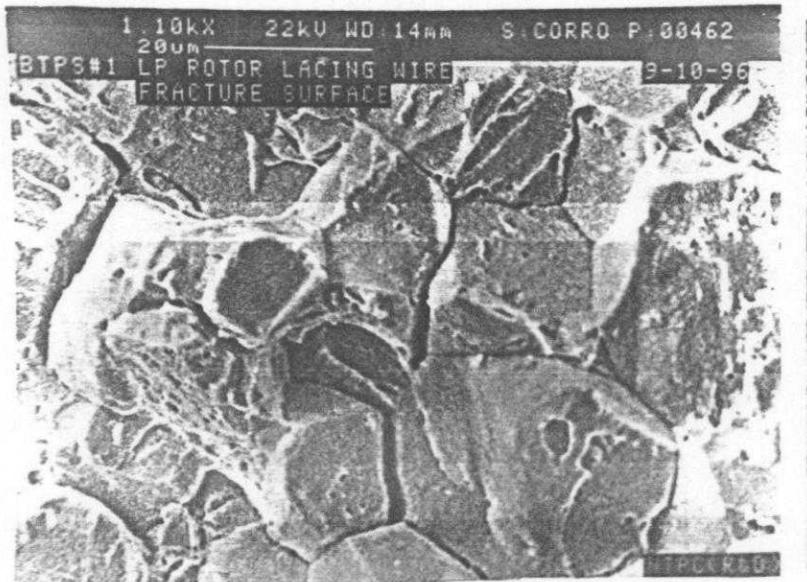
SCC of steam turbine blades in 110 MW & end retaining ring of 210 MW generator rotor were also investigated. Several cases of low pressure heater & condenser tubes have suffered due to SCC. (Photograph No. 12 & 13).

Photo. 12 Stress Corrosion Cracking (Intergranular SCEM)
of lacing wire L.P. turbine blades. 110 MW.

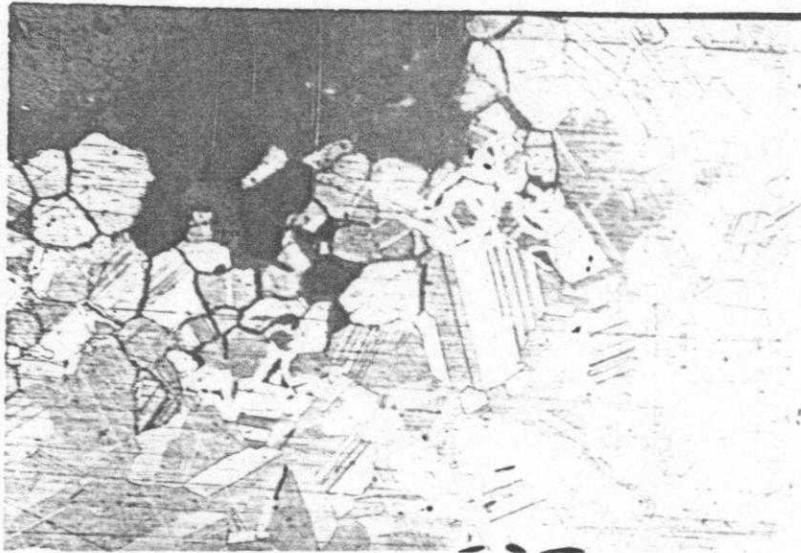
Photo.13 Intergranular Stress Corrosion cracking of brass condenser tubes. (210 MW)

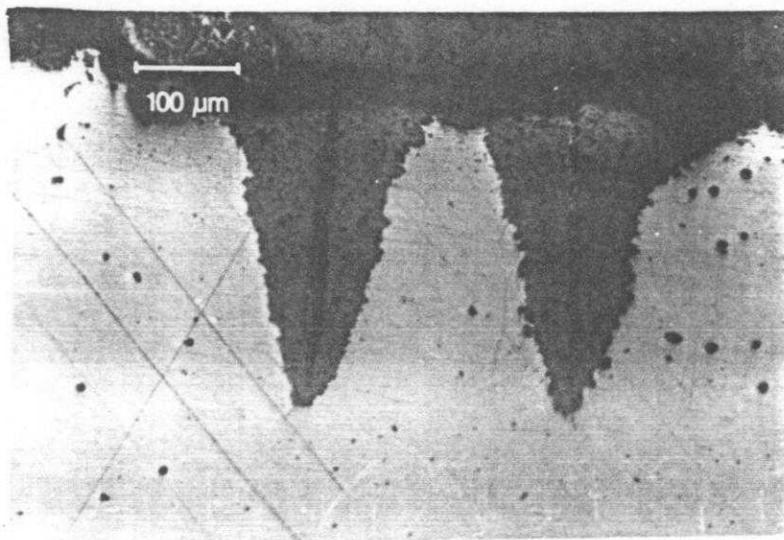
Metallographic examinations show the cracks to be transgranular, usually filled with oxide and relatively wide and blunt. They always initiate on the waterside surfaces and propagate outwards.

It is strongly influenced by number of Unit starts & operating hours & chemical cleanliness. Water chemistry and oxygen play a major factor: a two-orders-of-magnitude increase in dissolved oxygen, which is typical during boiler start-up, can lead to an order of magnitude reduction in the number of thermal (strain) cycles required to initiate corrosion fatigue cracks (Figure 7)

Photo.14. Corrosion fatigue of Water Wall tubes. 210 MW.
