# Service performance of refractories in connection with pusher reheating furnaces in Bhilai Steel Plant

Maheshwari Singh, R. S. Dahiya, Rajat Sen & A. K. Singh  
*Bhilai Steel Plant, Bhilai*

*Seven continuous pusher reheating furnaces are installed in 2.5 million tonne stage in the R & S. Mill, Merchant Mill and Wire & Rod Mill at Bhilai Steel Plant to cater the need of rolling of various finished products. In this paper, attempts have been made to brief out the service performance of refractories in various elements of the furnaces. The replacement of better refractory material and installation over original design in order to strengthen the weak link for continuous service ability of the furnace has also been discussed in brief.*

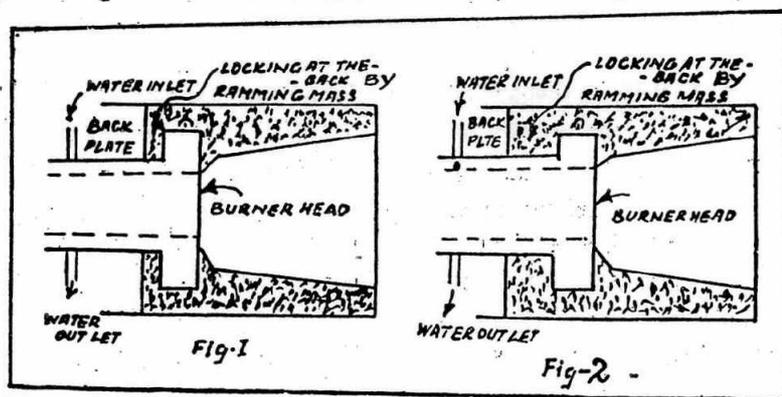
that air setting ramming masses of higher alumina content (60%  $\text{Al}_2\text{O}_3$ ) have taken up higher thermal load than hydraulic setting ramming masses whereas hydraulic setting ramming masses are easy to ram, have good green strength, provide a smooth profile of the burner. However, the shrinkage after firing of hydraulic setting masses is high. Some times this shrinkage causes such wide cleavages and burners ultimately collapse. The air setting masses have less shrinkage after firing but they have slightly less green strength and their surface profile is weak if ramming is not done very carefully. The life of rammed burner is about 18—20 months. The main reason of burner failure is due to the failure of burner heads. Generally there are two types of failures in burners. First one is flame shoot out at the back of the burner head, & the other one is failure of water cooled burner heads & subsequent water leakage on the ramming mass. As shown in figures before ramming, steel plates are welded at the back of burner for the ramming mass. If this steel plate provides sufficient room for ramming at the back of the

burner head, the ramming mass sort of locks the burner head from the back and this ultimately arrest any escape route of flame at the back of burner head (Fig. 2). When the steel plate is nearer to the burner head there is not much of space for the rammer to operate smoothly and ramming at the back is weak which is not strong enough to arrest shooting out of flames from the back side (Fig. 1).

Water leakages from water cooled burner heads on rammed burner and roof underneath to makes it wet which imparts severe thermal shock and ultimately burner or roof falls. In case of burner it may be due to pressure of steam which is developed by water leakage inside the ramming mass. Attempts were taken to cool the burner heads with chilled air, but it was also not very much successful as this process had its own limitation.

Burner blocks Fig. 1. Before modification and Fig. 2. After modification.

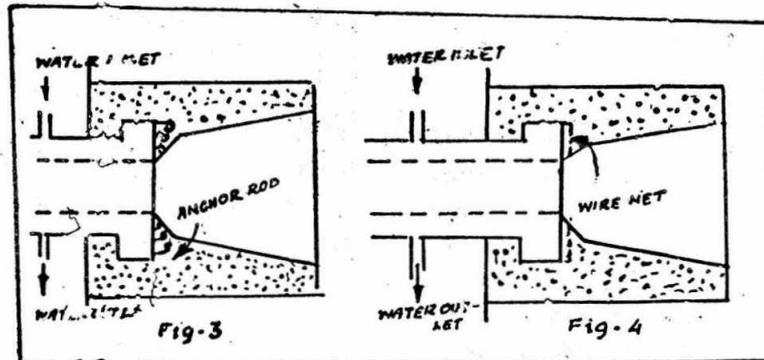
Burners are rammed in the same way as described previously in wire rod mill section of the article. Reasons of failure are same as discussed above. However, some modifications were done to hold the ramming mass together with water cooled burner heads by welding anchor rods or wire nets around the head as shown in the figures. But it was not very much successful as anchor rods (Fig. 3) were causing following inconveniences.

- i) They were an obstacle for smooth operation of rammer.
- ii) Their ends were very near to the surface of ramming mass. Hence during operation they were highly heated up or were directly exposed to the flame & ultimately their purpose were not solved. Further, wire net welded to burner head (Fig. 4) is not much effective in holding ramming mass at burner mouth.

Fig. 3 Ramming mass of burner with anchor rod. Fig. 4. Ramming mass of burner with wire net.

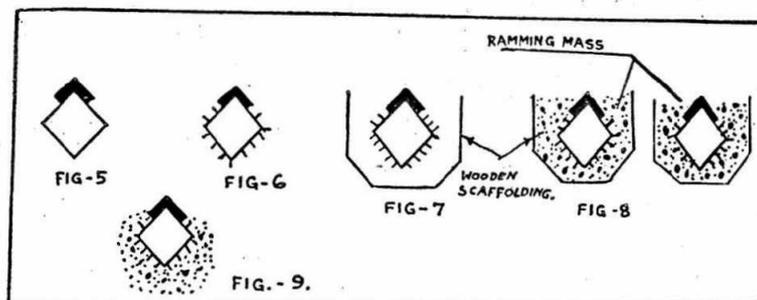
facturers. Old insulation sticking to the skids is removed and then small pins or studs are welded on three sides of the skids for anchoring the ramming mass. Wooden scaffoldings are fixed around the skids, part by part, and then thick slurry of ramming mass is poured in these scaffoldings. Scaffoldings are removed when the material sets perfectly as shown in Fig. 5 to 9.

Problems occur when the pins welded to the skid are not perfect in size and protrude out of the ramming mass after the skid insulation come in direct contact of the flame and fall very shortly and the hold on ramming mass after the skid insulation or pins are not firmly welded to the skid. Pins protruding out of the insulation come in

Fig. 5r—Fig. 9. Various modifications of insulating ramming mass for skid rails

direct contact of the flame and fail very shortly and the hold on ramming mass is very weak which slowly fails. Further, pin welding on old skids is not strong enough as the fused insulating material of last campaign adheres to the skid. This is not easy to remove completely and hence the welding is not proper. This ultimately causes failure of the insulation.

4. Monolithic refractories must be upgraded to suit the demand of at least 2 years from 18 months which is the present life.
5. To achieve economy by reducing heat loss in the skids, it is urgent to develop refractories and its application technique to match with the service condition. Instead of ramming, shaped bricks and insulating rings may be used to achieve life of atleast 1 year.

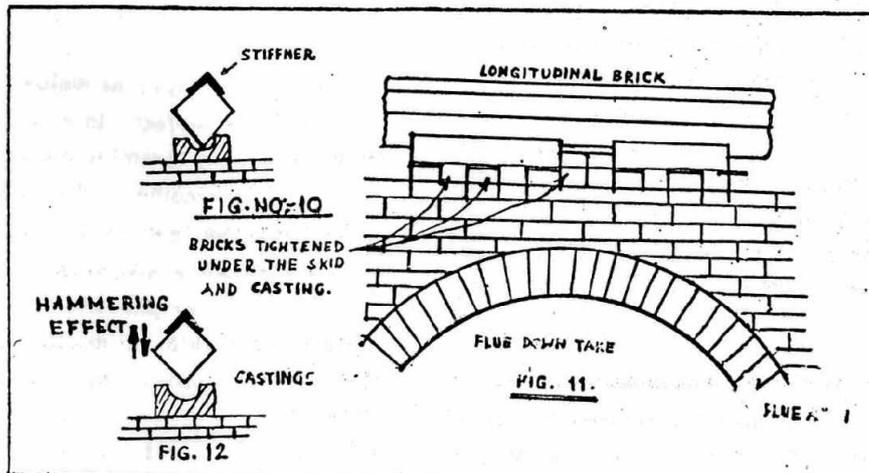
Water cooled skids rest on separation walls. They are aligned and supported from bottom by tightening grooved castings below them (Fig. 10 & 11.) Due to the service condition these skids are not in perfect straight line.

If the castings below the skids are not tightened perfectly or if the arches above the flue has sunk little bit, this causes tightened castings to become loose, then there is a gap between the skid and castings. The heavy stock which is travelling on these skids impart hammering effect on the loose castings or wall below it (Fig. 12) and wall collapses. This effect is more prominent if there is any variation in the distribution of load. This effect is less in the merchant mill reheating furnace, as stock travelling on the skids is lighter. As brick tightening below the castings was not giving good life, modification was done by using air setting ramming mass above the arches. This was favourable as ramming mass goes into every corner around & below the castings and provides better holding.

Fig. 10-12. Setting of skid and failure of the refractories.

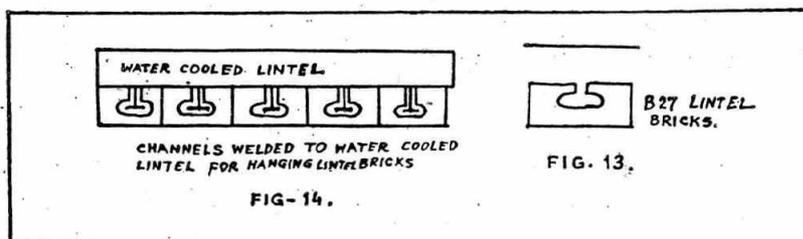
Charging and lintel has a life of 3—4 months. The shaped brick used here are of fireclay (Fig. 13). These bricks are hanged to water cooled lintel by means of channels welded to the lintel. Due to improper distribution or pushing of the stock going inside the furnace, stock overlap and hit the lintel brick-work and the lintel is damaged. As the temperature of this zone is not very high no serious damage is done to the furnace structure even after the failure of the lintel brick work. However, there should be some modification in brick shape or design to achieve more life.

Fig. 13. Fireclay shapes used for lintel Fig. 14. Fireclay shapes with welded channels

6. Curved roof should be designed/modified so that any emergency repair may be taken up from outside the furnace.
7. The shape of the lintel brick should be changed so that it is more stronger as desired by the service conditions.
