## INVESTIGATION OF CAVING-IN INCIDENT OF MIG 21 AIRCRAFT

**M. Ghosh, S. K. Das and S. R. Singh**

National Metallurgical Laboratory (CSIR), Jamshedpur-831007

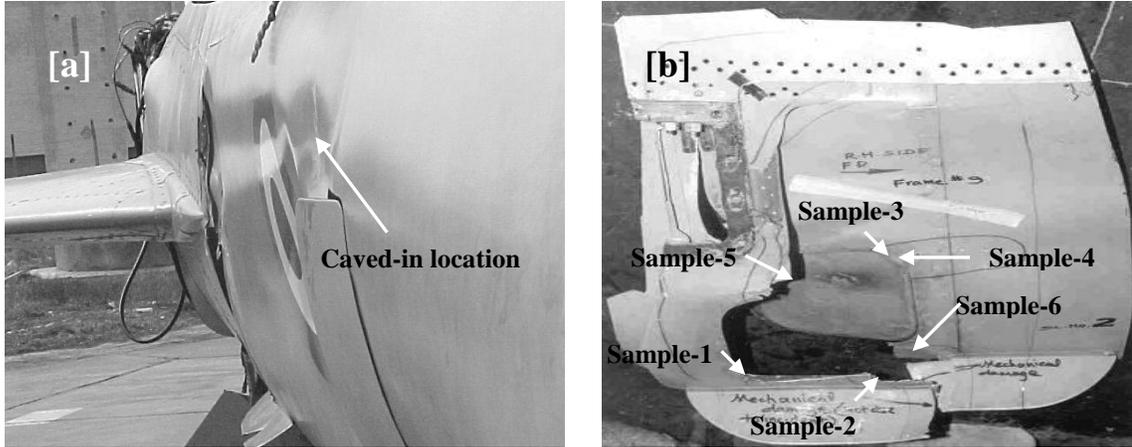
In an accident, the starboard (STBD) side of front fuselage was 'caved in' during ground run of the Mig-21. A post-incident inspection revealed vertical and horizontal cracking occurred at the edges of the additional air intake shutter (AAITS). The guard of the AAITS was sucked in causing extensive damage to the aeroengine. However, port side fuselage remained un-affected.

The affected regions of the 'caved-in' MIG-21 are shown in Fig.1a with the sampling locations in Fig.1b. The sample designation is given in Table-1.

Figs.1 (a & b): Photographs of ‘caved in’ MIG-21 aircraft [a] ‘caved in’ location at anti surge shutter, [b] multiple crack formation near additional air intake shutter and sampling location for fractography.

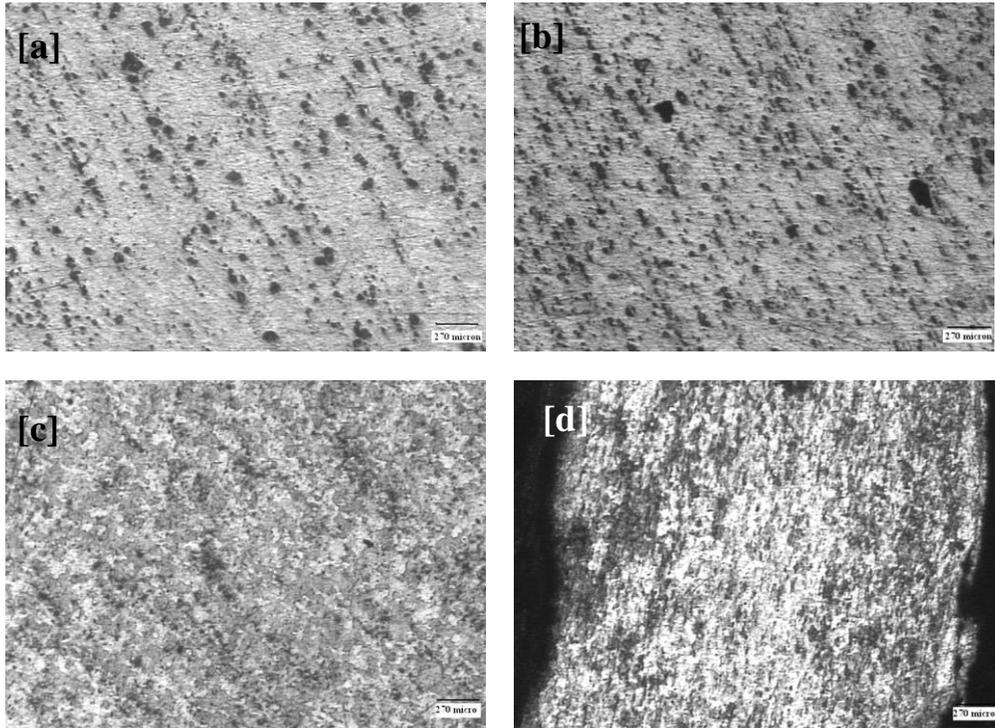
The optical (Fig.2a to d) and scanning electron micrographs (Fig.3a & b) of both the as received fresh sheet as well as service exposed sheets exhibit more or less same features.  $\alpha$ -Al matrix is decorated with the uniform distribution of second phase. The size of the second phase varies widely and they are preferably orientated along the rolling direction. Two types of precipitates are observed; the larger  $\sim$ 10-14 $\mu$ m and the smaller one  $<$  4 $\mu$ m. The pancake structure of grains due to rolling is evident in the transverse section (Fig.2b & d). The micro-analysis of the precipitates is furnished in Table-3. The precipitates are mainly consists of Al and Cu containing varying amount of Mn, Fe, Ni and Mg.

Fig.2 (a,b,c & d): Optical microstructure of specimens showing distribution of second phase in the matrix, [a] and [b] longitudinal and transverse section of sample-A, [c] and [d] longitudinal and transverse section of sample-D respectively.

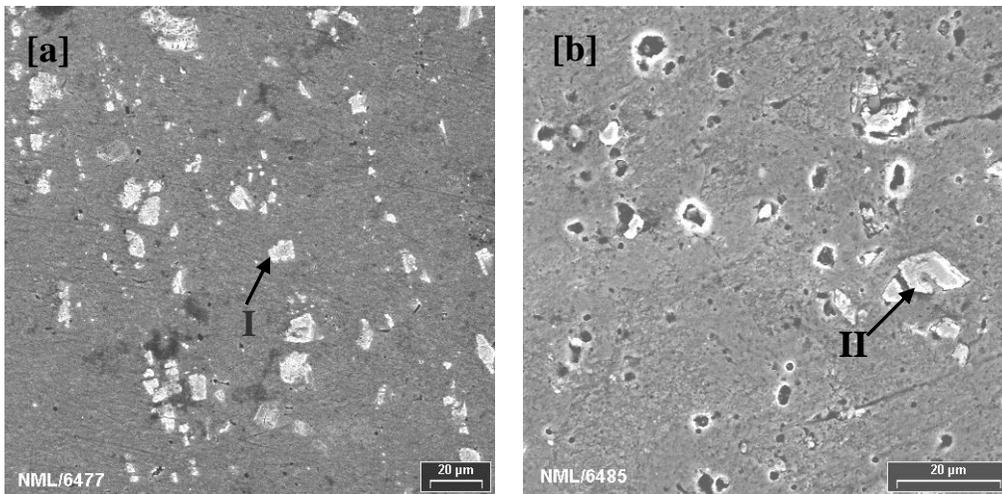
Fig.3 (a & b): SEM micrographs of specimens revealing different types of second phase in the matrix.

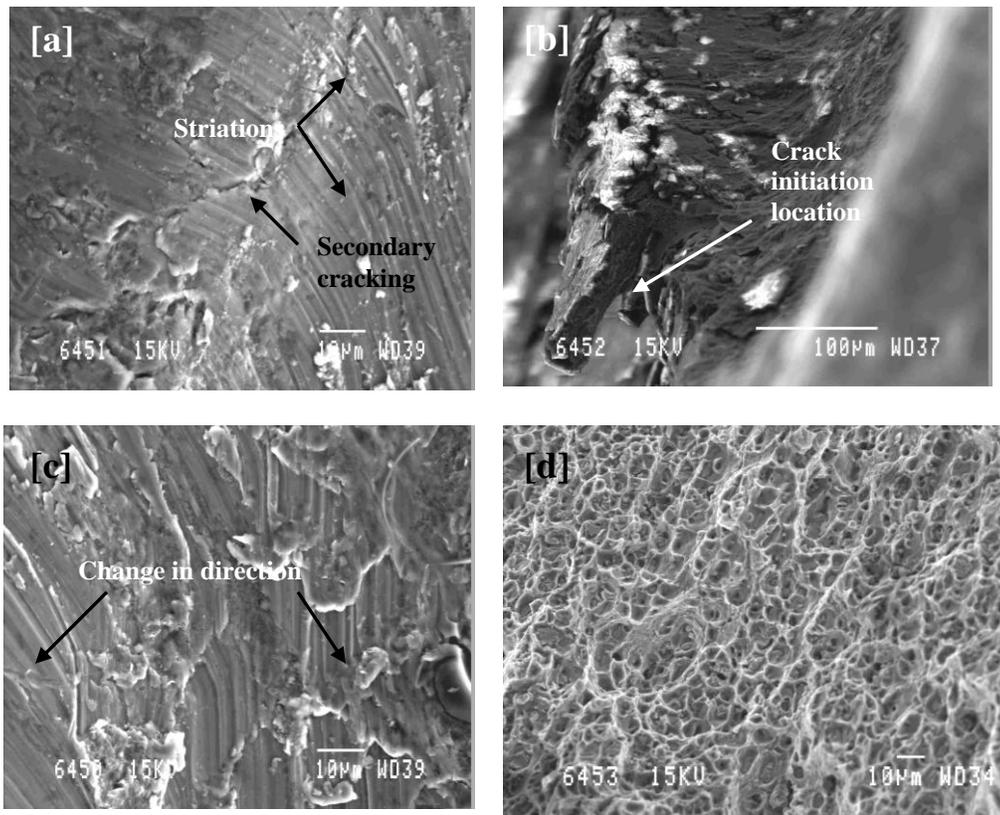
The SEM observations of the fracture surfaces of the six samples are shown in Figs. 4, 5, 6 and 7. The fracture region of sample-1 is transgranular cleavage in nature, imprinted with fatigue striations in localized region (Fig.4a). The fatigue crack is pre-existing in nature; however fracture initiated at surface (arrow in Fig.4b) and grows through the thickness direction as well as along the longitudinal direction (along the flight direction). As the curvature of the skin changes, the mixed direction of the crack propagation becomes prevalent in nature (Fig.4c); the right side curvature appears straight and the left side has got a radius. Fracture surface is covered with oxides at some locations. Adjacent to rivet joint, the fracture surface is shining in nature indicating fatigue failure, where as away from rivet it is dull in appearance indicating secondary dimple fracture owing to overload (Fig.4d). The length of the fatigue zone is ~3.5mm. Secondary cracking is also observed (arrow in Fig.4a).

Figs.4 (a,b,c & d): SEM micrographs of Sample-1 revealing fatigue fracture [a] fatigue striations and secondary cracking, [b] fatigue crack initiation location, [c] mixed direction of fatigue striation and [d] dimple fracture.

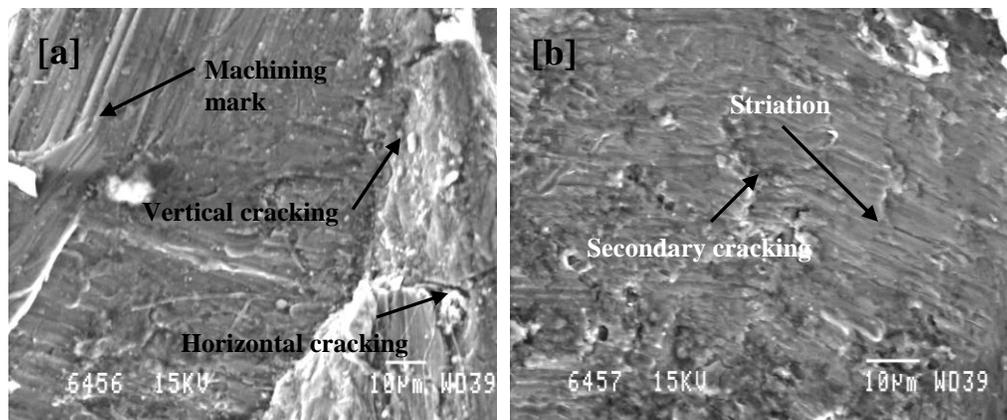
For sample-5, the fatigue failure initiated at the rivet hole (arrow in Fig.1b) having a length of ~3mm. Machining marks are found near the hole on the left side (Fig.5a). Two main cracks are found on the fracture surface (Fig.5a); one is horizontal (over the surface of the skin, moving towards the flight direction) and the other one i.e. the main crack moves vertically downward (along the thickness, perpendicular to the flight direction). Middle of the fracture surface is decorated with fatigue striations along with the existence of secondary cracking (Fig.5a and b).

Figs.5 (a & b) : Fractographs of sample-5 showing [a] two different cracks at right angle and [b]striations with secondary cracking.

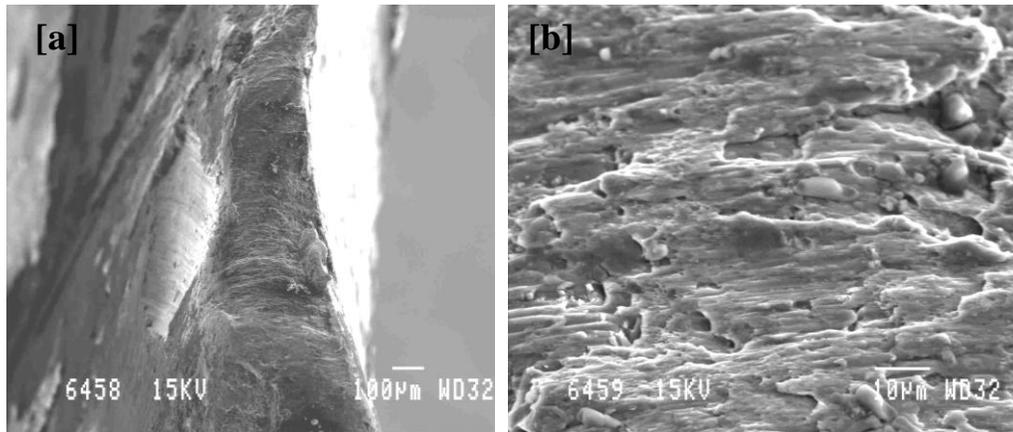
Fracture surface of sample-6 is the combination of dimples owing to secondary failure near the rivet hole (arrow in Fig.2b) and fatigue striations. However, in this case fatigue failure initiated from second phases embedded inside the sample i.e. somewhere across its thickness (Fig.6a). The length of the fatigue zone is ~800µm. The crack initially moves outward along the thickness direction (perpendicular to flight direction) and propagates along the periphery parallel to flight direction.

Fig.6 (a & b) : Fracture surface of Sample-6 illustrating [a] fatigue crack initiation location and [b] fatigue striations.

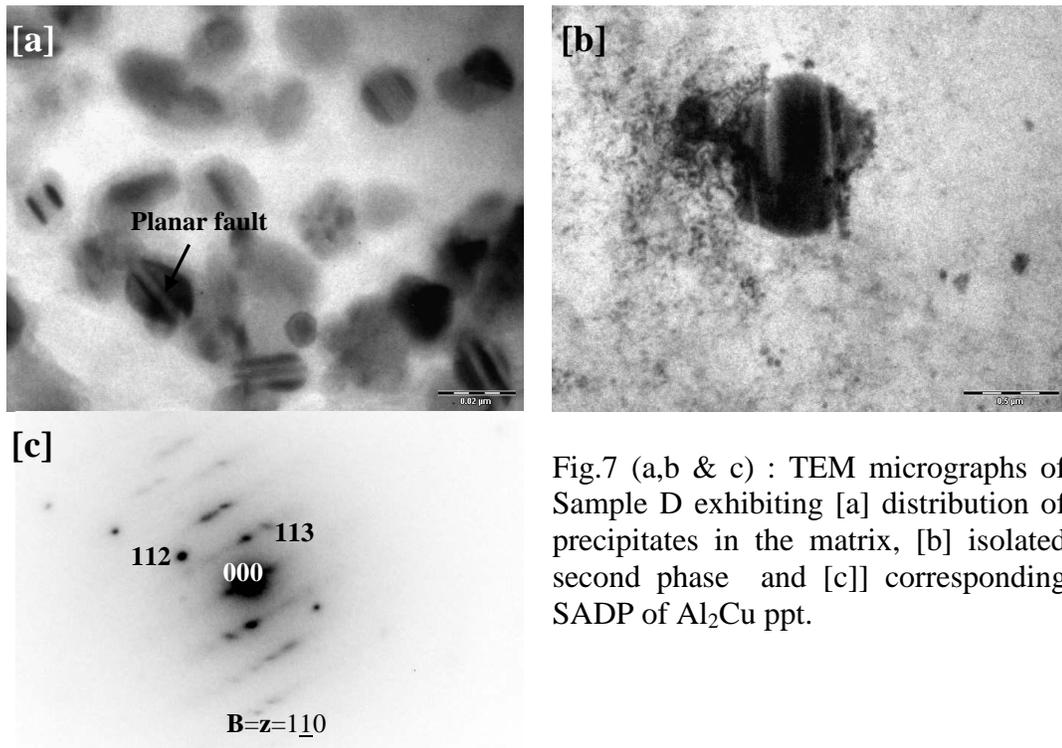
The TEM study reveals the sub-microscopic microstructural features present in the alloy. The fresh sheet as well as sample-D contains second phases of ~0.02 µm, well dispersed within α-Al matrix (Fig. 7a). Large second phases like ~0.5µm are also found (Fig.7.b). Planar defects are also observed in these precipitates (Figs.7a). The selected area electron diffraction pattern (SADP) shown in Fig. 7c spot pattern of aluminium matrix and Al<sub>2</sub>Cu precipitates. Shape of the precipitates also changes with the service exposure with respect to the fresh sheet as elongated precipitates are found along with the elliptical and spherical precipitates.

Fig.7 (a,b & c) : TEM micrographs of Sample D exhibiting [a] distribution of precipitates in the matrix, [b] isolated second phase and [c] corresponding SADP of  $Al_2Cu$  ppt.
