Application of metallography in failure investigations – some case studies

A. N. SINHA

National Metallurgical Laboratory, Jamshedpur - 831 007, India

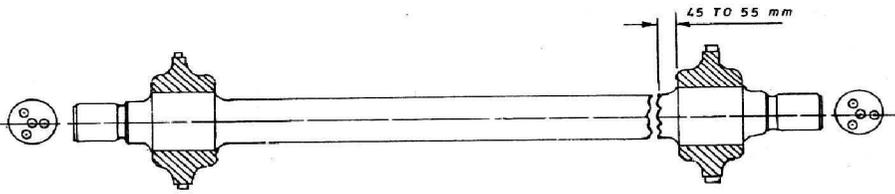
The axle failed after having been in use for only three months^[1,2,3]. The axle failed near the journal by fracturing transversely. The surface that failed was close to one of the wheels about 45 to 55 mm from the inner wheel seat collar (Fig. 1). The axle had been proof machined and assembled in the carriage after it had been

Fig. 1 : Sketch showing location of fracture of the rail axle

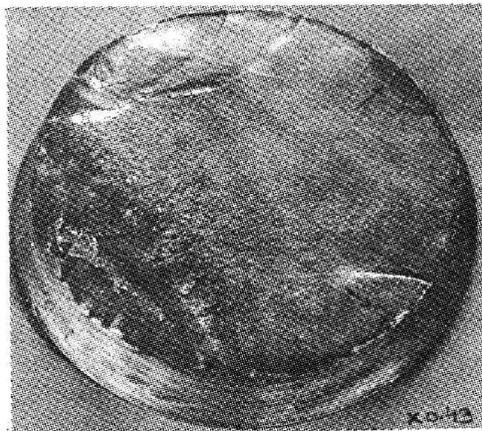
The failed ends of the axle were examined visually and the longer side was found to be badly mutilated. The other end which was shorter, showed signs of fatigue failure (Fig. 2). The macro investigation revealed that weld metal was deposited all around the circumference of the axle. This was apparently done to build up an undersize area, which is not a recommended practise. Further investigation

Fig. 2 : Macrograph view of failed axle showing signs of fatigue failure x 0.75

supported that contention and showed distinct wavy patterns of weld pool solidification, fatigue striations and hairline cracks around the circumference of the axle. The depth of the weld was found to vary from 5 to 9 mm. It was concluded that the failure was due to fatigue and cracks were initiated by welding discontinuities.

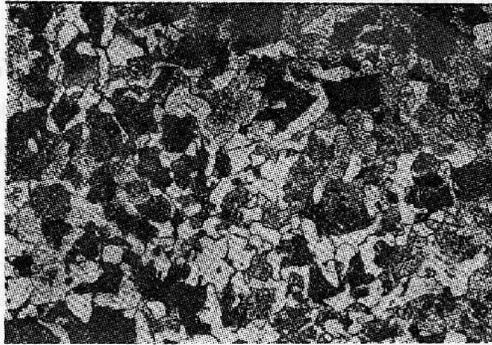
Fig. 3 : Microstructure of base metal of the axle away from failed parts showing normalised ferrite pearlite structure x 400

Microstructural study of the base metal and weld zone revealed (Fig. 3, 4, 5) initiation and propagation of the fine cracks at the edge of the surface. The base metal showed ferrite pearlite structure, whereas weld samples showed paths of fatigue cracking, Widmanstatten ferrite and accicular structures. These are typical cast structures with coarseness of the prior austenite grains. These structures are harmful and can generate stress that could initiate and propagate fatigue cracks. This stress was confirmed by X-ray measurement. Hydrogen content and mechanical properties support the above conclusion, which were evaluated and are shown in Table - 2.

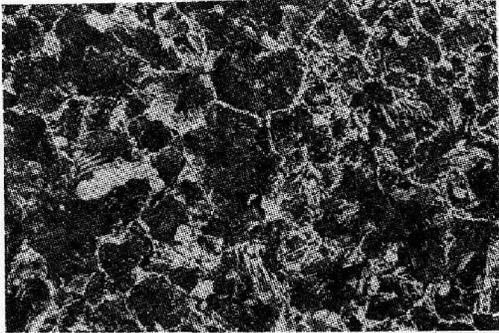
Fig. 4 : Widmanstatten ferrite structure in the welded zone x400

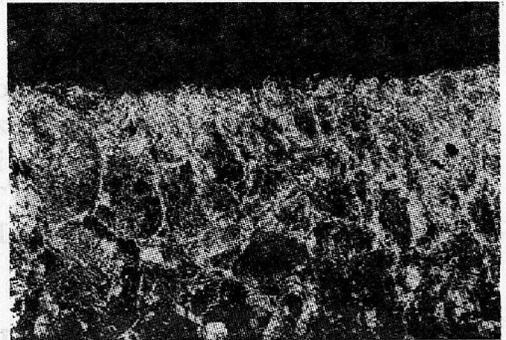
Fig. 5 : Presence of acicular structure close to the surface and weld deposit x 400

This brief metallographic investigation shows that the premature failure of the locomotive axle occurred because of the use of welding as a means of salvaging an undersized axle.

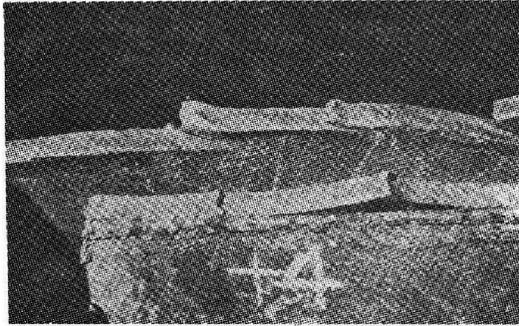
Macrostructural photographs showed brittle fracture (Fig. 6) which is possible in ductile material only when fluctuating pressure develops. Optical microstructures of the base material indicated ferrite pearlite and banded structure as is normally found in rolled products. However welded zone microstructures showed great variation and defects like fissures Widmanstatten.. structures and voids (Fing. 7). SEM study of weld pool and HAZ showed voids along the grain boundary and transgranular cracks. TEM photographs showed the presence of globular inclusions, which was not desirable.

Fig. 6 : Fractured surface of the roof dome joint showing brittle fracture x 0.3

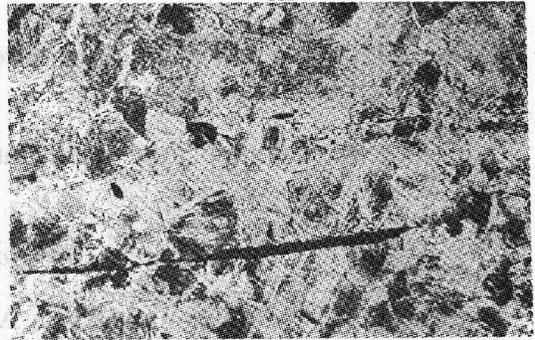
Fig. 7 : Microstructure of welded regions showing fissures x 160

The base material although appeared to be sound, while defects were introduced during welding, either because of shrinkage or because of higher hydrogen pickup [5,6,7]. The flux impurities, fissures, voids in HAZ and weld pool were identified by metallographic technique which justifies its importance in failure investigation

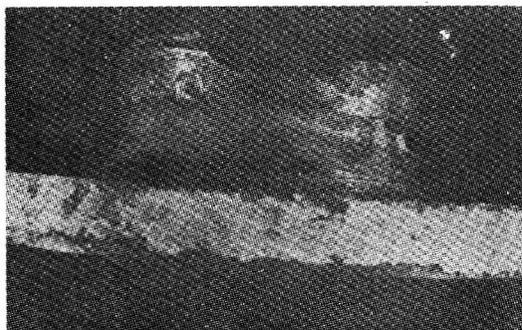
The visual examination showed machining defects near the bottom neck of the valve (Fig. 8), where failure took place with brittle fracture. The brittle fracture in a ductile material as concluded from the mechanical properties and chemical analysis indicated some fatigue failure. The ferrite pearlite structure of the valve material and tempered martensite of bolt material were as expected. The D_3 oxide type inclusion was slightly on the higher side for the valve material.

Fig. 8 : Upper portion of the valve showing machining defect x 0.65

of the material^[9]. Sulfides are known to inhibit cathodic reaction and thus its presence can cause a build up of absorbed hydrogen in to the metal, which may increase the tendency to cracking. A defect, like the machined notch acts like a crevice, where the volatile S ingress into the material, enhances the local stress intensity and thus initiate cracking. A combination of material defect (inclusion), machining defect (tool mark) and operating environment (volatile sulphur) each of which individually cannot cause a failure of this nature, occurring around the same region has led to the catastrophic failure of the isolation valve^[10,11].

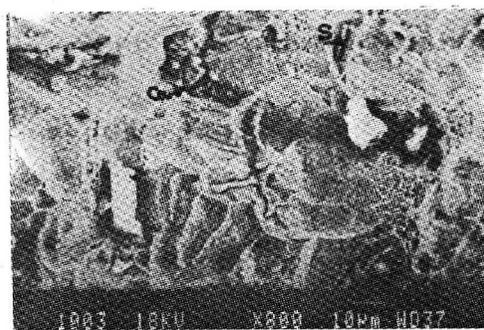
The SEM study of the fractured surface (Fig. 9) showed the presence of high S (0.11%) along with Ca, whereas the S content of the base material away from fracture was 0.02% only. This high S in the fracture was responsible for the brittleness.

Fig. 9 : SEM of valve material showing brittle fracture and presence of high 'S' & 'Ca'

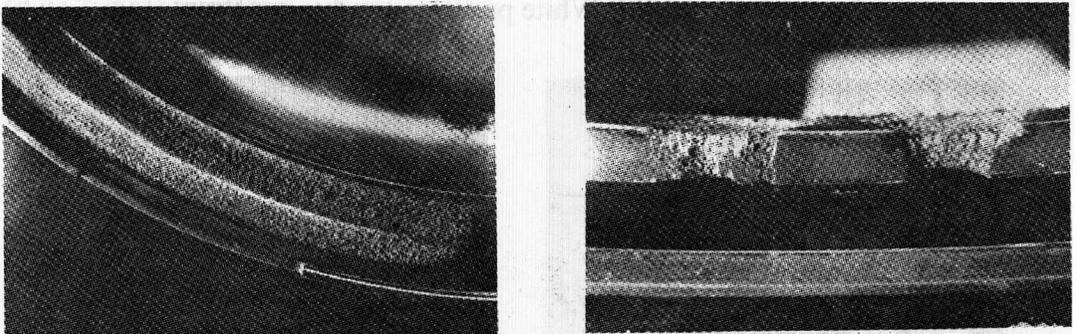
Fig. 10: (a) Corrosion/erosion of cover dome of the centrifuge, (b) corrosion/erosion of top frame $\times 0.50$

- i) Macro photographs are showing the badly corroded surface of the centrifuge (Fig. 10a,b), which indicated the intensity of corrosion.
- ii) Chemical analysis confirmed that the material was 304 AISI Stainless steel
- iii) Optical metallography : Optical microscopy showed thick grain boundaries and twinning indicating the austenitic structure with sensitisation. Some parts showed delta ferrite islands which can not exist in 304 S.S. (Fig. 11a,b,c).
- iv) SEM Study:- Cover dome of the centrifuge indicated intergranular corrosion and porosity in grains. White particles are dye penetrant (Fig. 12 a,b).

To avoid sensitization and α' martensite formation 316L S.S. has been recommended. Also welding has to be done with proper welding rod and post weld treatment was recommended.

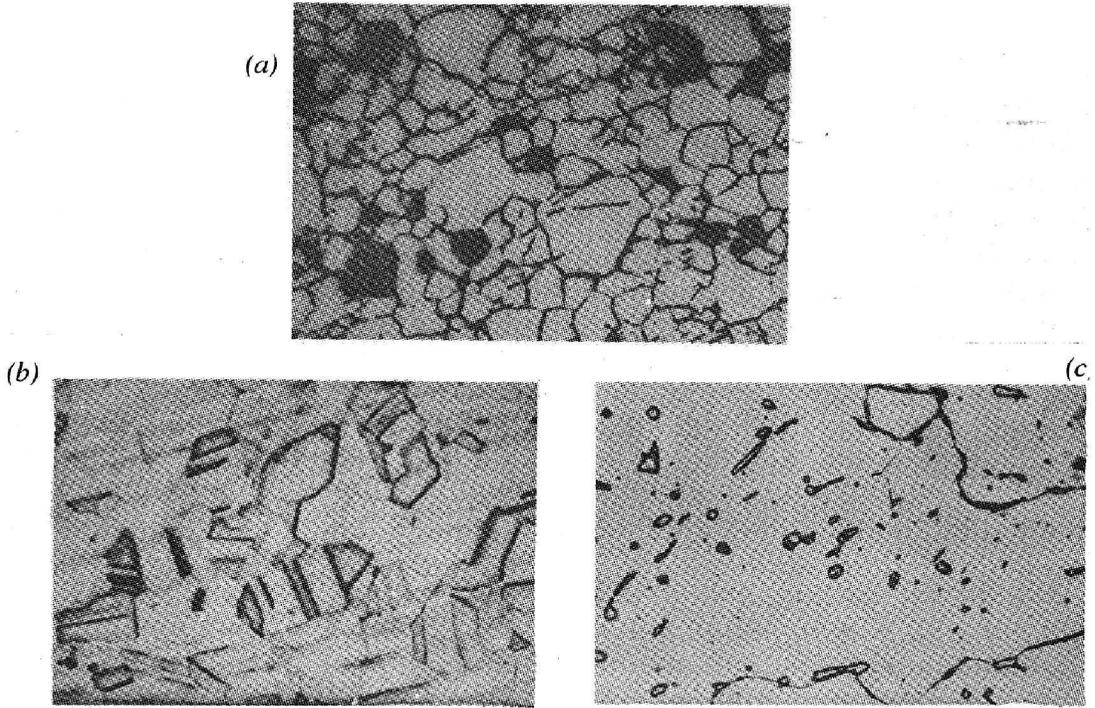
Fig. 11 : Optical metallographs showing (a) thick grain boundary x80
(b) twinning x160 and (c) delta ferrite x160

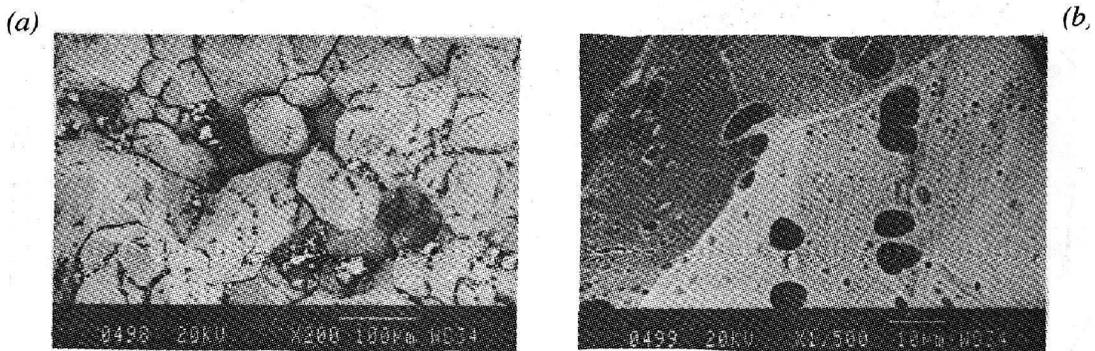
Fig. 12 : SEM photographs of cover dome showing
(a) intergranular corrosion and (b) porosity in grains

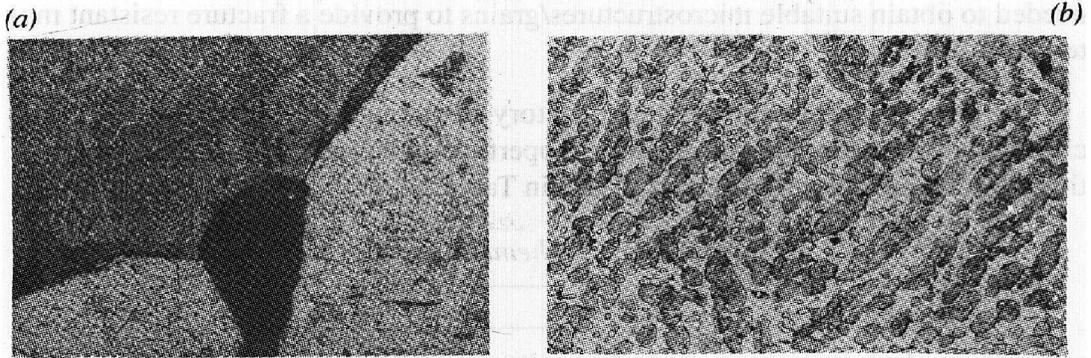
Fig. 13 : Welded part showing (a) pores $\times 40$ and (b) ferritic structures $\times 160$

- v) Metallography of Welded part : Weld zone parts showed pores and ferritic structure. This also was not desirable (Fig. 13 a,b).

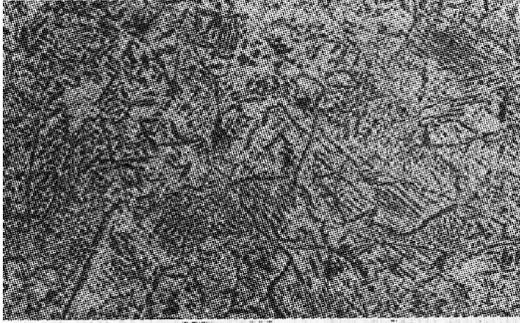
The microstructure of the failed sample, polished and nital etched shows tempered fine bainitic cast structures indicating that cast structure has not been fully removed and proper heat treatment was still needed to remove the cast structure (Fig. 15a,b).

Fig. 15 : Microstructure of failed sample showing tempered fine bainite and cast structures at (a) x200 and (b) x500

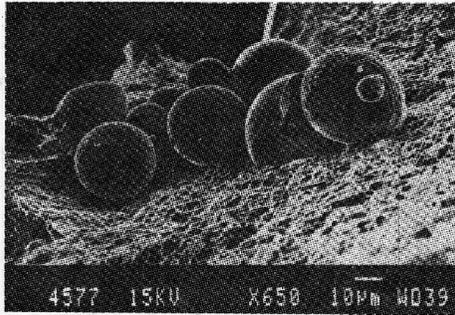
SEM study of fractograph of the sleeve showed that the material was not killed properly (Fig. 16). It shows the presence of coagulated iron oxide in the globular form indicating insufficient deoxidation which may also be responsible for poor resistance to fracture. EDAX was used to confirm that it was only iron oxide and no other inclusion existed.

Fig. 16 : SEM photo showing presence of coagulated iron oxide in the globular form
