Engineering Failure Analysis 10 (2003) 85–91

## Turbine blade failure in a thermal power plant

The failure of a LP (low pressure) turbine blade of a 220 MW thermal power plant is presented. The blade was made of martensitic stainless steel and the structure was tempered martensite. There was no evidence of degradation of blade material. The fracture took place at the aerofoil region, 113-mm from the root. Throughout the blade surface Si rich phases were detected. Several pits/grooves were found on the edges of the blades and chloride was detected in these pits. These were responsible for the crevice type corrosion. The probable carriers of  $\text{Cl}^-$  were Ca and K, which were found on the blade. The failure mode was intergranular type. Possibly the ultimate failure was due to corrosion-fatigue. © 2002 Elsevier Science Ltd. All rights reserved.

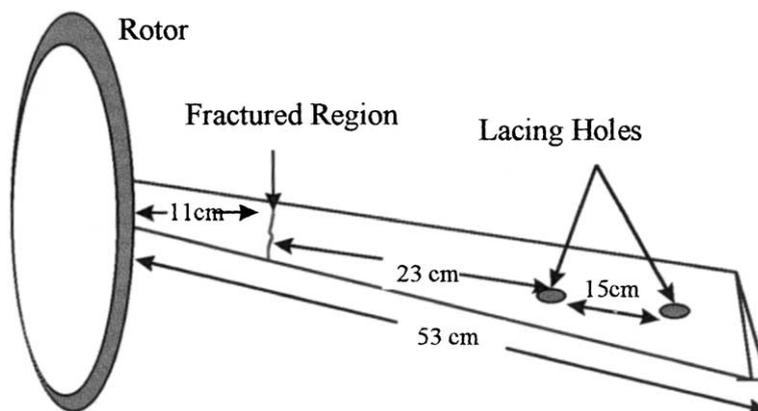
Chemical analysis of the blade material was carried out by a standard wet method. A portion of the failed blade with the fracture surface was cut for fractography study. A portion of the fractured blade (100 mm away from the fracture surface, as shown in Fig. 1) was cut for metallography. A few random pieces were also cut from the other two blades as already mentioned (i.e. 33,000 h service exposed and 100,000 h service exposed) for SEM and metallography. The metallography samples were prepared by using standard metallographic techniques and etched with Glycergia (a dilute solution of HCl, HNO<sub>3</sub> and glycerol). The microstructure of the blade material was analysed by optical microscope and a JEOL-840 scanning electron microscope (SEM) equipped with an energy dispersive X-ray (EDX) analysis facility. Hardness values were measured using a Vickers Hardness Testing machine under 10-kg load.

Fig. 1. Schematic of the turbine blade with the fractured region as shown.

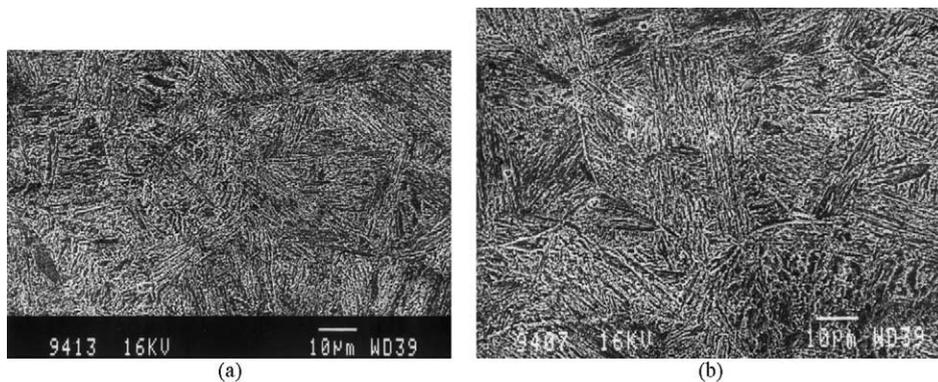
SEM micrography shows a tempered martensitic microstructure [Fig. 2(a)]. Micrographs of the other two blades also show a similar microstructure [Fig. 2(b)]. Similar features were observed in randomly selected specimens indicating homogeneity of microstructure. There was no evidence of microstructural degradation in the failed blade or in the one which did not fail. This is expected because the temperature that the blades were exposed to was low (of the order of 150 °C).

Fig. 2. SEM micrographs of (a) fractured blade and (b) nearby blade. Tempered martensite is clearly revealed from both the microstructures.

The material is as per the chemical composition and mechanical property values of martensitic stainless steel. There is neither inhomogeneity nor any microstructural degradation of the blade material. Therefore, the possibility of material failure due to material degradation is ruled out. This is of course, expected, since the material temperature was low.

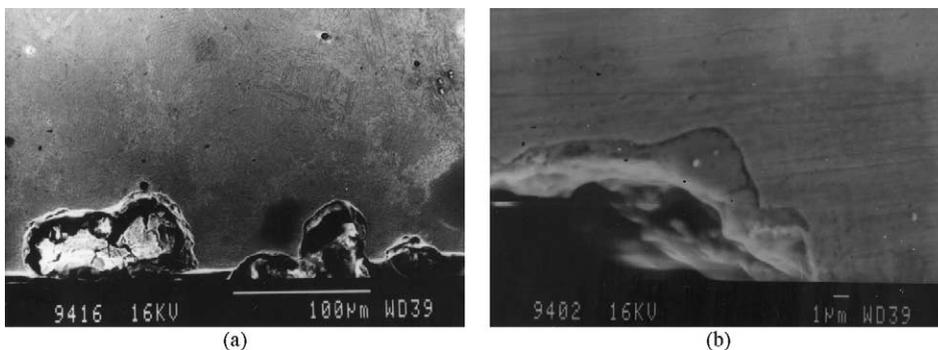
Several grooves were observed along the blade edges [Fig. 3(a)]. These grooves are parallel to the fracture surface and several such grooves were present throughout the blade edges. However, compared to the fractured blade, the density of the grooves was less in the other blade. EDX analysis revealed the presence of substantial amount of Si in the grooves [Fig. 3(b)].

Fig. 3. Fractographs of the fractured blade (a) showing several grooves along the blade edges and (b) indicating the presence of a substantial amount of Si in the grooves.

There were several grooves at the edges of the blade. These grooves, in a few cases were found to be enriched with a Si phase. XRD analysis of the scale adherent to the blade surface indicated that it was SiO<sub>2</sub>. Normally the source of SiO<sub>2</sub> is steam. During rotation of the blade under steam pressure, these SiO<sub>2</sub> particles impinge on the blade material and form grooves by repeated strikes (erosion corrosion) [5,6]. The process of erosion by SiO<sub>2</sub> particles is dependent on the particle size, morphology as well as its velocity with which it strikes the blade material. If we consider the SiO<sub>2</sub> particles as spherical balls then the area in the matrix after material loss would look like a cone. The space behind the particle would act as a crevice and lead to crevice corrosion.

If the blades are kept clean and free of deposits and debris, crevice corrosion and pitting can be prevented or minimised.

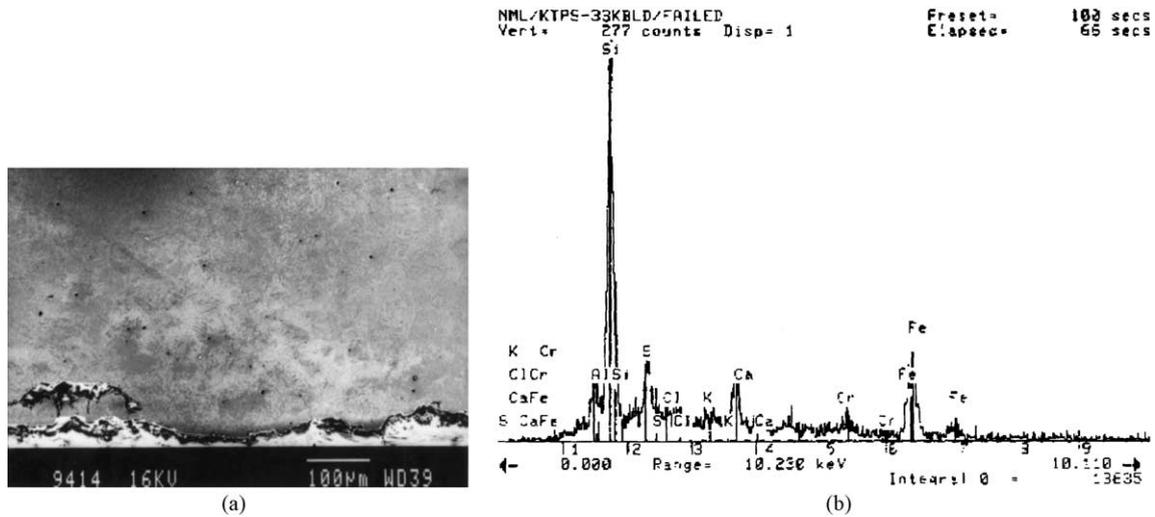
Observation of the blade edges (33,000 h service exposure) of the nearby failed blade showed a Si-rich phase within the material [Fig. 4(a)] which is confirmed from Fig. 4b. There were some fine cracks which had been exposed to the ambient temperature.

Fig. 4. (a) SEM micrograph showing Si rich phases in the grooves and (b) SEM-EDX confirming the presence of Si.

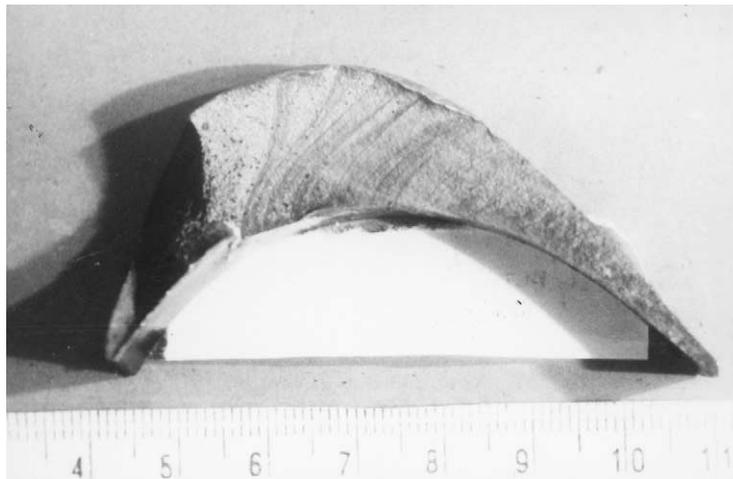
The fractured surface of the blade, which failed in the first place, revealed a smooth surface. Beach marks were observed and indicated that the crack might have originated from the thinner side of the blade. Some portion of the fractured surface appeared black which is indicative of the presence of Fe<sub>3</sub>O<sub>4</sub> (magnetic) scale. The blade revealed the presence of adherent scale of varying thickness.

The low magnification image of the fractured surface of the failed blade is shown in Fig. 5. Several beachmarks can be seen on the fracture surface. The curvature of the beachmarks indicates that the crack

Fig. 5. Micrograph of the fractured blade, showing several beachmarks and also the crack initiation point, which is towards the thinner side of the blade.

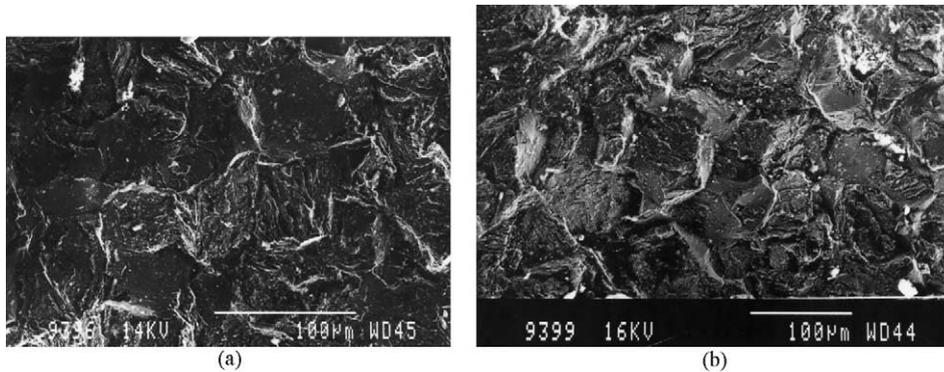
initiation point is towards the thinner side of the blade. The SEM fractography showed intergranular fracture mode at the starting point [Fig. 6(a)]. This morphology was observed till final fracture [Fig. 6(b)]. In a few areas, cleavage type fracture mode was also observed. The presence of beachmarks along with the intergranular morphology of the fracture surface indicates that corrosion fatigue could play a strong role in controlling the initiation as well as propagation of the crack. The possibility of corrosion due to steam is not ruled out. The fracture surface also showed pits of shallow depth, which might have been generated after the initiation of the crack (Fig. 7). The pits were observed very near to the blade edge. SEM-EDX indicates the presence of chloride ions inside the pits. These pits were oriented perpendicular to the fracture surface and did not have any role in the fracture process. However, their presence indicates that a corrosion environment was available which caused pitting.

Fig. 6. (a and b) Fractured surface showing an intergranular type of fracture with a cleavage type fracture in few areas.

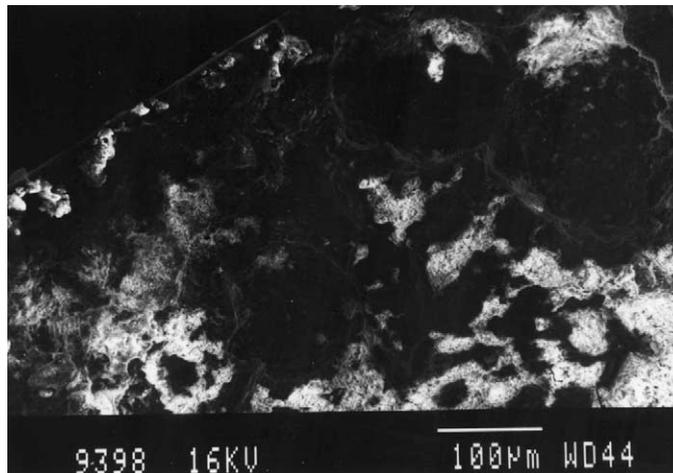
Fig. 7. SEM micrograph of the fractured surface showing several corrosion pits.

The pits observed on the fracture surface were found to contain chlorine, which facilitates initiation and propagation of crevice attack. The possible sources of Cl<sup>-</sup> are steam and feed water through a condenser tube due to leakage. The possible carriers of the chloride were Ca and K. They were found throughout the blade surface. From the beach marks on the fracture surface, it could be seen that the fracture initiation points lay at the aerofoil trail edge region, which has the thinnest cross-sectional area. Therefore, in this area a plane stress condition prevails. Under plain stress condition, fracture toughness is very much dependent on the specimen geometry. Therefore, formation of crevices below the SiO<sub>2</sub> particle on the blade surface would be the ideal position for crack initiation. Nevertheless, in a LP turbine, under the reduced load (in a load following plants) the so-called Wilson Line (point of initial condensation) shifts to a higher temperature point [7]. In cyclic operations the load fluctuates (i.e. decreases and increases) and so the blade surface is alternately getting wet and dry. As long as the steam is dry there is very little corrosion. But with little condensation the steam might contaminate with high concentration of chloride salt as steam condensate contains 10<sup>6</sup> times more salt than steam vapour [8,9]. Under reduced load this salt might deposit on the blade surface facilitating corrosion attack. Again, during shut down, O<sub>2</sub> and CO<sub>2</sub> might dissolve in the acidic salt (due to evaporation of NH<sub>3</sub>) and might aggravate the corrosive condition.
