A SUMMARY OF SOME TYPICAL STEEL FAILURES IN MACHINE PARTS AND STRUCTURAL SECTIONS

E.W. PIERCE,

CHIEF METALLURGIST SOUTH WORKS, U.S. STEEL COMPANY

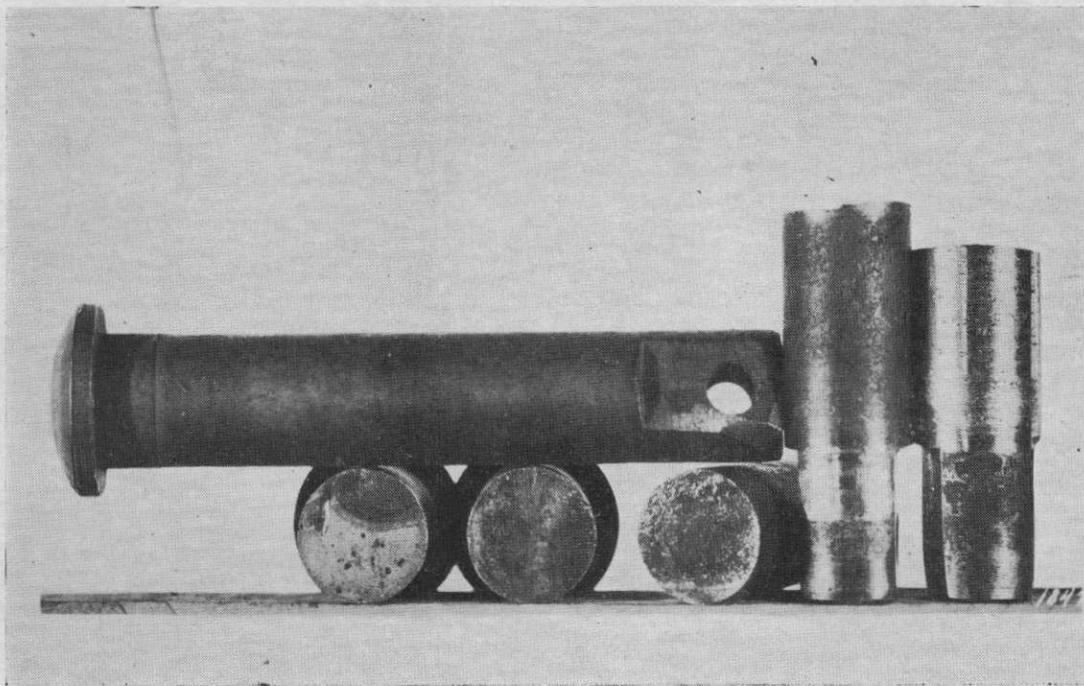
Plate—1

Photograph—New pin with some failed parts shown in Plate 1.

Failure occurred in some cases after only one day of service. Hardness was 52 Rockwell C across the section. The degree of hardness was considered excessive and recommendation was made to change the grade to AISI type 410, low carbon 12% Cr stainless steel, and to heat treat to about 38 Rockwell C for the application.

New pin #1 with parts of pins failed in service. Note fatigue type failure in sample #3 and areas of wear in samples #4 and #5. Magnification $3/4$ X

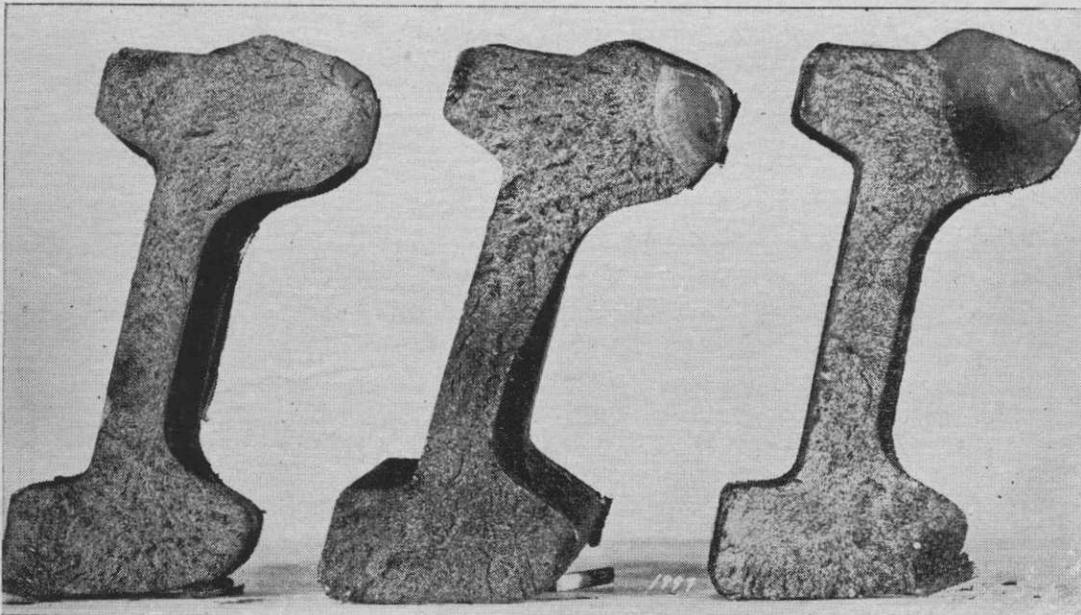
Plate—2

The eight failed joint bars were made during the years 1943-46 and the failures occurred during 1950. Visual examination of all eight bars showed that the failures started in the head zones by fatigue cracking followed by sudden rupturing through the remainder of the sections. This is illustrated in the photograph. Pickling in acid revealed secondary cracks on both head and toe adjacent to the fractures in all bars. This condition was apparently caused by the battering associated with the movement of the rail ends. The stressing effect of this movement was indicated by the metal which was upset into the space between the rail ends.

Photograph showing Various Degrees of Fatigue Penetration before Complete Failure of Rail Joint Bars.
Magnification X 9

It was recommended that a change in design should be considered in order to prevent the upsetting or pinching of metal between the rail ends.

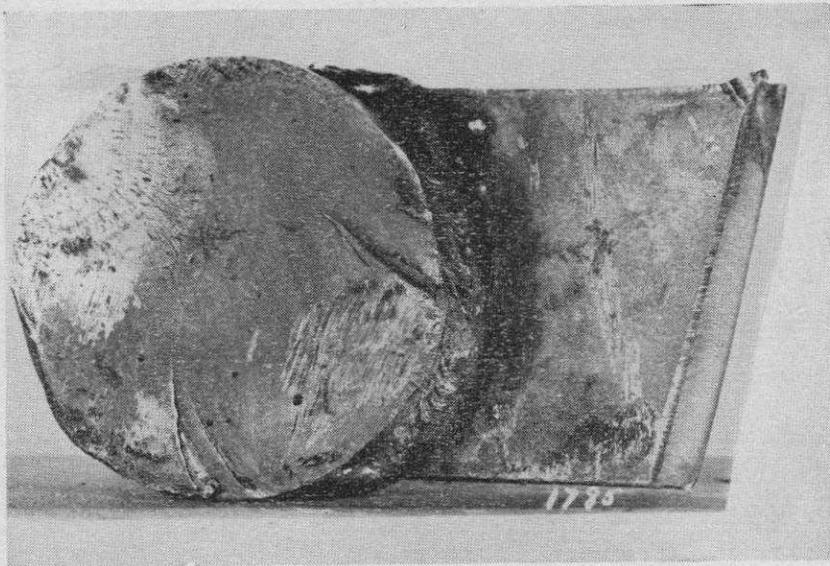
Plate-3a.

Grain coarsening is known to produce an adverse effect on the toughness of steel but no data are available to allow estimation of the loss caused by the extreme coarsening in the subject sample. However, it is evident from the photograph that the fracture failure was of the progressive or fatigue type.

The point of origin was in a coarsened zone as evident by comparison of Plate 3a.

Stirrer Shaft as Received Showing Progressive Nature of Failure.

The coarsening is believed to be associated with long welding time. It was noted in the section as polished for metallographic examination that there was a space between the stirrer blade and the shaft, and the weld depended entirely on the fill and fusion of the weld metal. A better fit at this point would facilitate the welding operation and improve the weld by allowing fusion of the blade with the shaft.

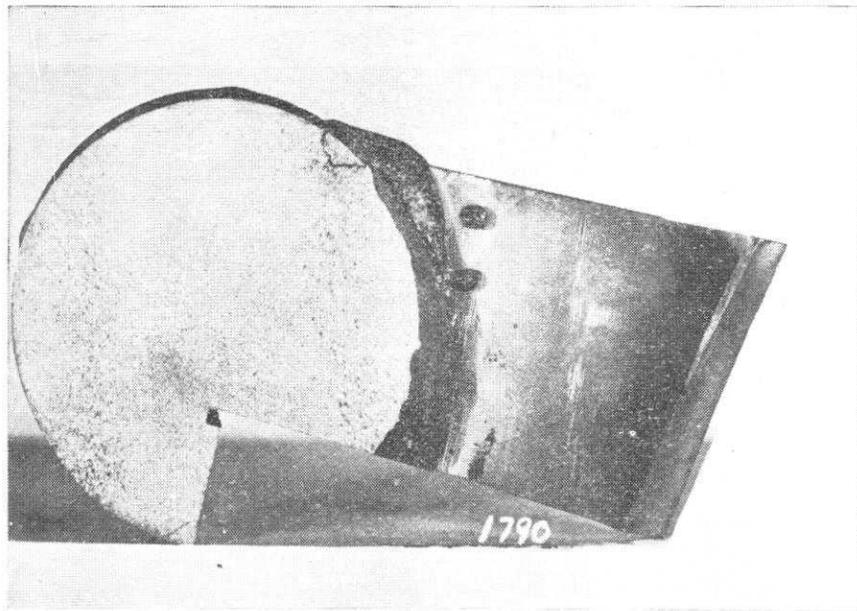
Plate—3b.
Macro-Etched Cross-Section Adjacent to Failure.

Microstructure Normal fine grain austenite structure was severely coarsened by welding operation resulting in grains as large as 0.16" actual maximum dimension.

The transverse macro-etch, Plate 3a, revealed areas which were coarsened apparently by the heat of welding. In the photograph this is evident for the zone on the right at a weld location. The zone on the left is believed to have been coarsened by a weld not included in the sample.

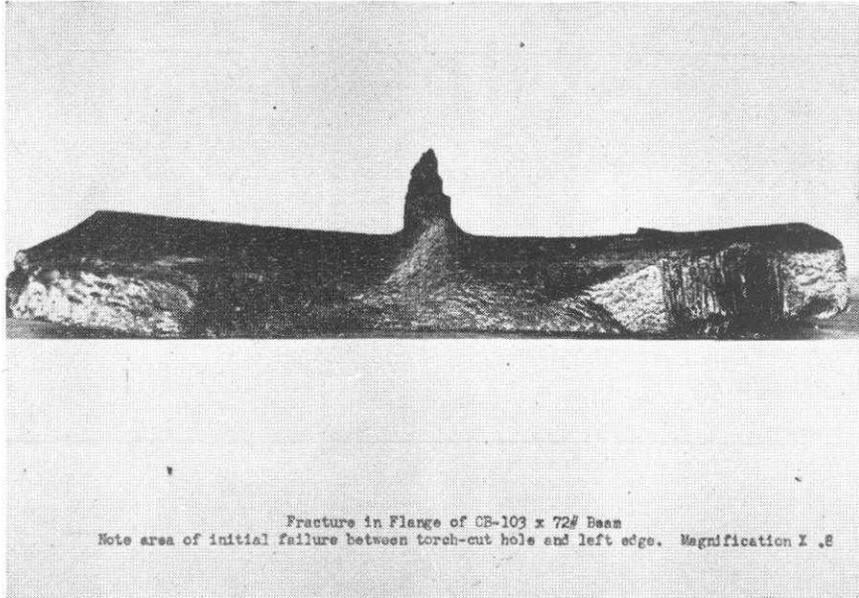
Plate-4

The failure occurred by sudden rupturing through most of the beam section during a severe storm. The sample for examination included the failure but had to be saw-cut to separate the parts and expose the fracture. Part of the fracture is shown in Plate 4 and it may be noted that the left zone, between the torch-cut hole and the edge of the flange, had been worn smooth. This indicates that failure had occurred through this zone at some time prior to the rest of the rupturing. Metallographic examinations along this first section of the failure showed the normal microstructure of ferrite and pearlite. A condition which may have acted unfavorably and initiated the failure, was noted in the rough irregular contour of the torch-cut holes. These irregularities would result in stress concentration which together with the increase in hardness noted above would favor the start of a crack at one of the holes. Although it is common practice to torch-cut holes as was done in this case, the harmful effects noted could be avoided by a smoother cut or by reaming.

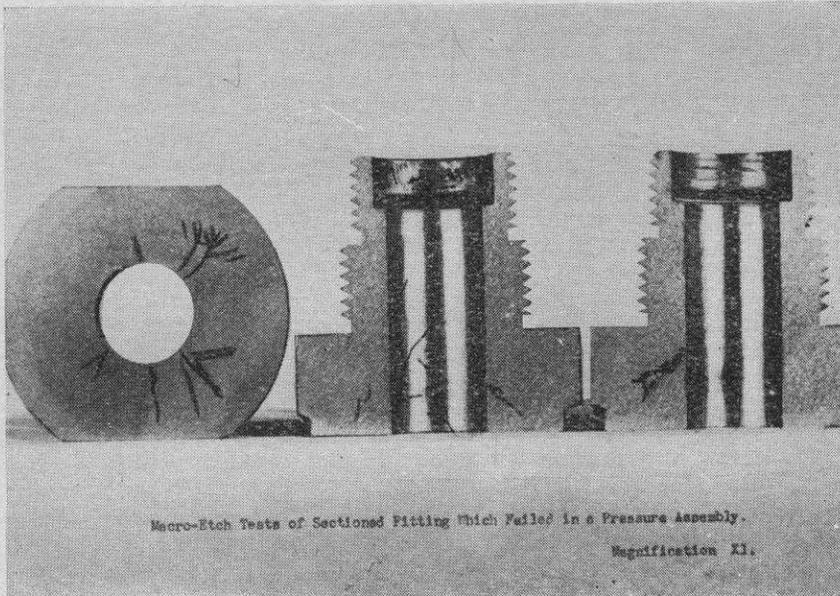
Plate-5

Photograph Part as sectioned for macro-etch testing is shown in Plate 5.

The macro-etch tests as shown in the photograph revealed radial internal cracks. Two of the branch-like cracks penetrated the surface of the shaft at the junction with the threaded section but this is not visible in the photograph. The leakage probably occurred at these two points of failure.

The cause of failure was not definitely established but the presence of chlorides, heat and pressure are known to be unfavourable factors in resistance to stress corrosion. On the basis of the metallographic examination and the conditions known to exist during operation, it is believed that the failure was the result of stress corrosion.

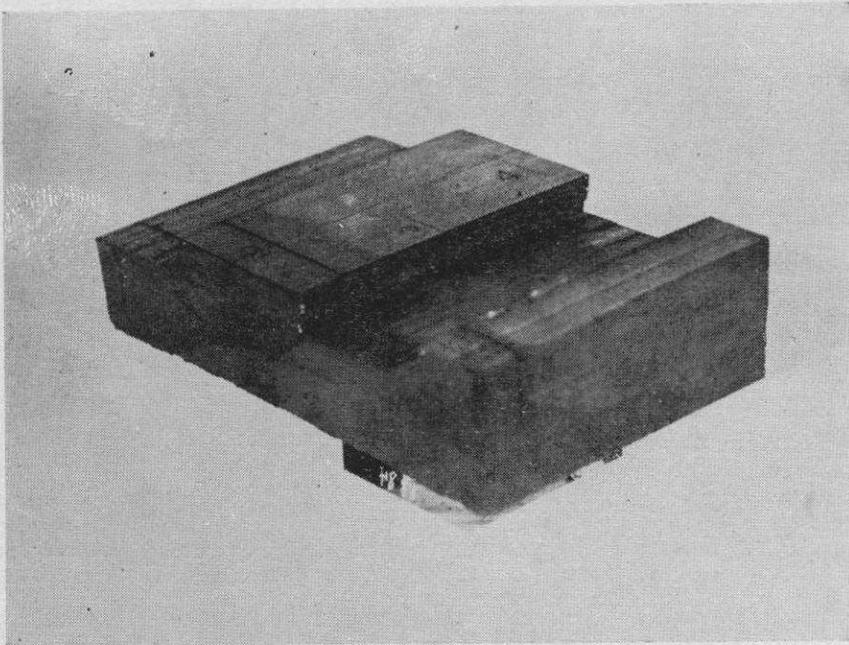
Plate—6

Magnaflux testing revealed the radial discontinuity running longitudinally as shown on the transverse face of the sample. In addition, hairline-indications parallel with the originally noted cracks, 2, 3 and 4 were observed in one keyway, but are only slightly apparent in the photograph.

The cause of failure was not definitely determined because of lack of information regarding such variables as operating temperatures, stresses in the turbine ring and water source supplied to the turbine. However, the type of failure was characteristic of stress corrosion.

Water Turbine Ring Sample as Magnafuxed to Show Cracks.
Magnification X 8

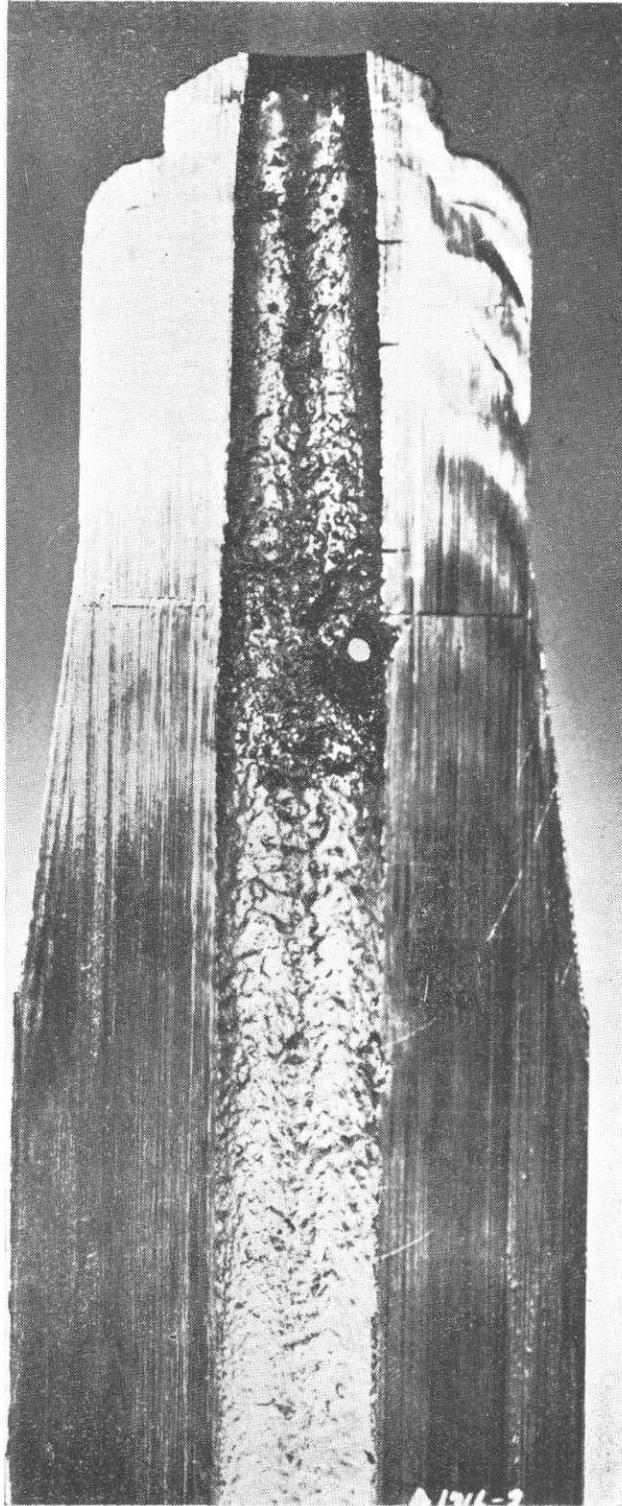
Plate—7

One nozzle failed very rapidly after only six extrusions because of penetration of the wall thickness by the molten zinc. The other, which was secured for comparison, had been in service for approximately six months without failure.

Half Section of Stainless Nozzle Showing Point of Penetration
by Molten Zinc in Extrusion Process.

In metallographic examinations the zinc penetration was found to be progressive along the inner wall. It appeared that penetration occurred by formation of a zinc-iron alloy. In the failed nozzle the layer of zinc plus zinc-iron alloy measured about .027" deep while in the satisfactory nozzle a maximum of .010" depth was found with some portions free of penetration. Both nozzles had microstructures consisting essentially of austenite but the failed nozzle had excessive carbide precipitation compared to practically none in the satisfactory nozzle. This was a good indication that the failed nozzle had been heated to a considerably higher temperature than the other.

It is reported in the literature that the attack of iron by zinc begins at about 420°C. (788°F.) and increases rapidly with rise of temperature. The zinc was extruded through the subject nozzles supposedly maintained at a temperature of 720° to 760°F. by means of heating with gas flames directed on the tapered OD of the nozzles. Since other characteristics such as chemistry and soundness were very similar, it appears probable that excessive operating temperatures accounted for an accelerated rate of zinc-iron alloy formation in the failed nozzle. The rapid penetration of the zinc-iron alloy formation to the surface was probably related to the temperature gradient existing between the nozzle bore and the heated surface. A point of higher temperature along the bore probably was the location of an accelerated attack which progressed along the temperature gradient at increasing rate as the point of heating was approached.

Because of the critical temperature conditions existing in the service of the nozzles and because of the mutual solubility of zinc and iron, the application of stainless steel for this purpose cannot be guaranteed. For possible successful operation it appears essential to control temperature precisely at the minimum required for the die-casting operation and also to heat the nozzle as uniformly as possible.
