CRACKING OF BUCKET LUGS IN PELTON TURBINES A CORROSION FATIGUE PHENOMENON

A.B. Winterbottom, Norges Tekniske Högskole
(Norways Institute of Technology).

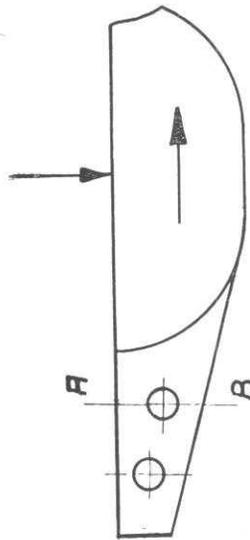
The designers estimate the maximum stresses in the lugs due to centrifugal force and to assumed steady jet force, as follows, in kg/cm^2 + being tensile—pressure.

Jet on Bucket	Jet off bucket
Position A	+450	+ 30
„ B	- 70	+430

These stresses are found in an elementary way, neglecting stress concentration, and the actual maximum stresses must therefore be assumed to be considerably higher.

Fig. 1. Pelton Wheel bucket (diagrammatic) showing approximate relative positions of resultant jet and centrifugal forces as well as fixing bolts.

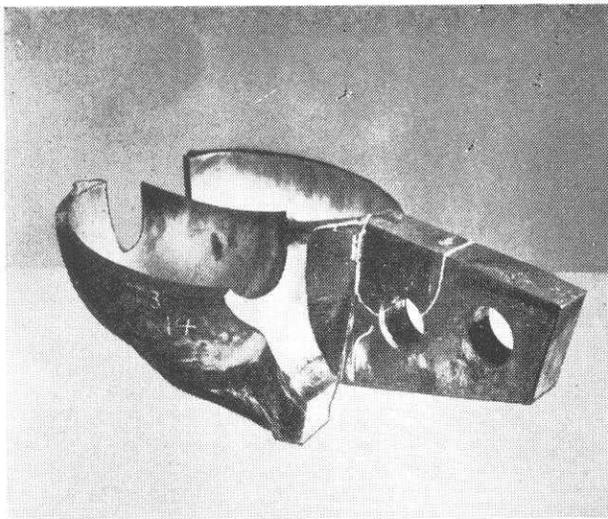
The cracks seemed to occur preferentially in position B and have the typical appearance of fatigue cracks as can be seen in Fig. 2,3 and 5.

The unavoidable conclusion seems therefore to be that alternating stresses on the lugs arising from bucket vibrations have led to corrosion fatigue. It has not been possible to find corrosion fatigue data for this type of steel under test conditions strictly comparable with service conditions, viz. soft mountain water at temperatures from 0°—10°C. However, McAdam* has found corrosion fatigue tests on similar steel compositions in salt spray and fresh water spray not greatly different, while Gough and Sopwith† reported the results

Fig. 2. Bucket fracture discovered January 1952. The turbine was stopped on hearing a knocking noise and the bucket was literally hanging by a thread on the right hand lug while the left hand lug was completely broken.

As a new turbine was to be ordered for the plant where the failures cited had occurred it was decided to order the wheels cast in one piece both for the new and existing units and for two new units at another plant. The present wheel with bolted on buckets will serve as a reserve for the existing turbine, while reserve wheels cast in one piece are on order for the new units. This policy was considered safest until the stressing conditions have been experimentally investigated and the various remedial measures studied with fatigue testing machines, as this work will take some time. Even though the production of such large complex castings in high chrome steel must be regarded as difficult, it is considered that the avoidance of the delicate bolt connections and the weakening of the highly stressed root sections represent substantial advantages. Turbine manufacturers in Switzerland, France and Italy have gone over to wheels cast in one piece and it is understood that German manufacturers are following suit.

- 1) the use of inhibiting paint e.g. chromate pigment or alternatively zinc rich paint or even zinc coating
- 2) the use of shot peening or surface rolling to induce superficial compressive stresses
- 3) the use of nitrided steel which on nitriding develop superficial compressive stresses.

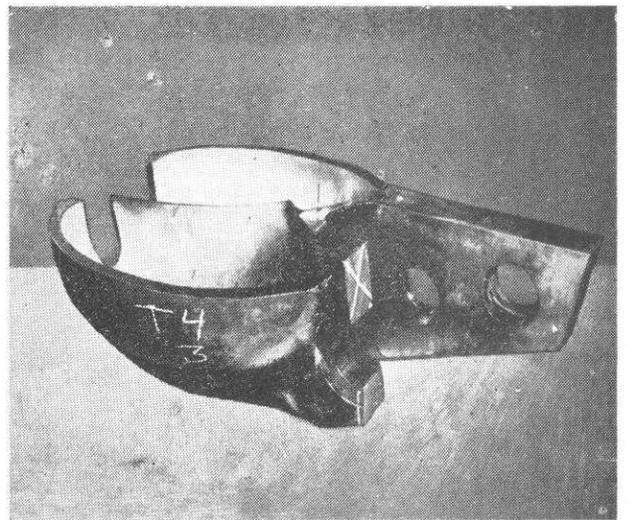
Fig. 3. Bucket fracture found under inspection. Left hand lug cracked in position B to bolt hole (see fig. 1) and sawed off on other side (marked with cross.)

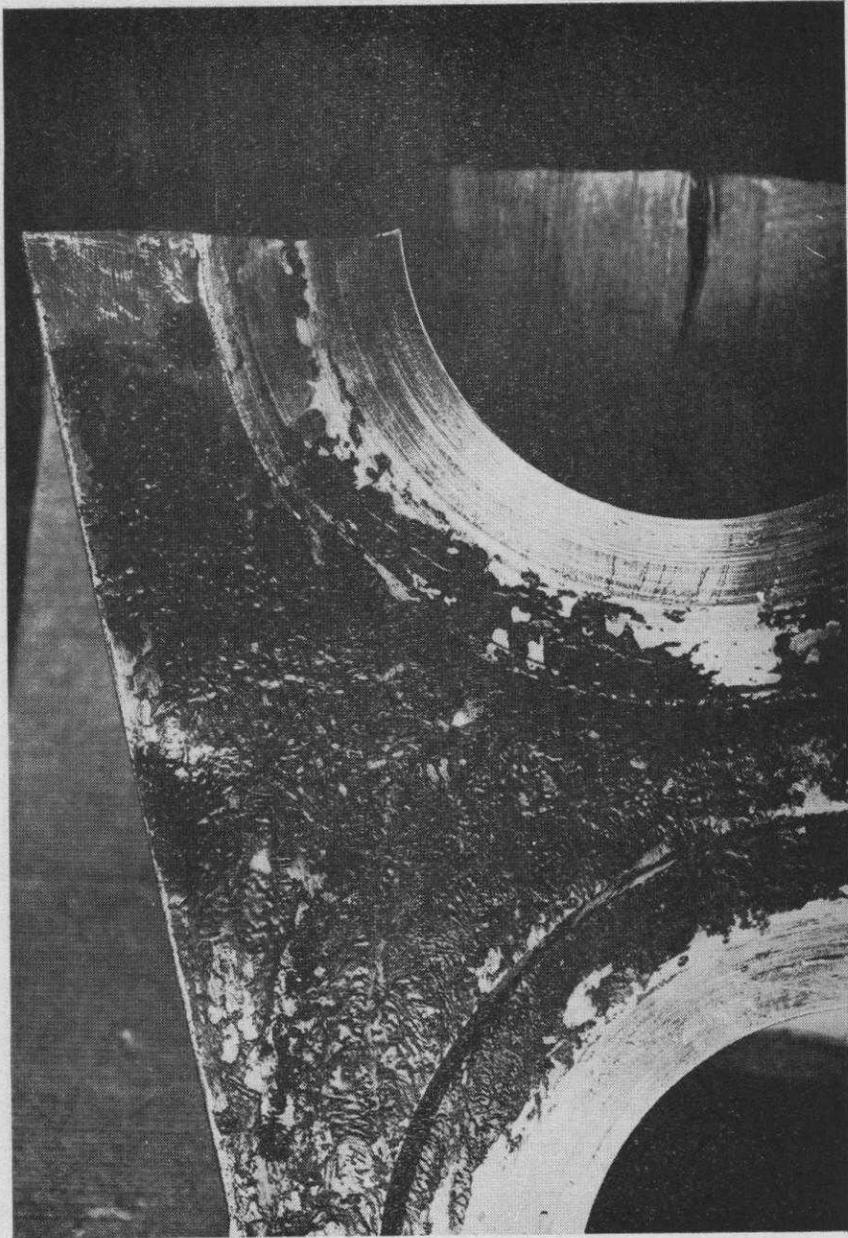
Fig. 4. Pelton bucket lug with fatigue fracture on left hand side to bolt hole (natural size). This type of bucket weighs about 190 kg.

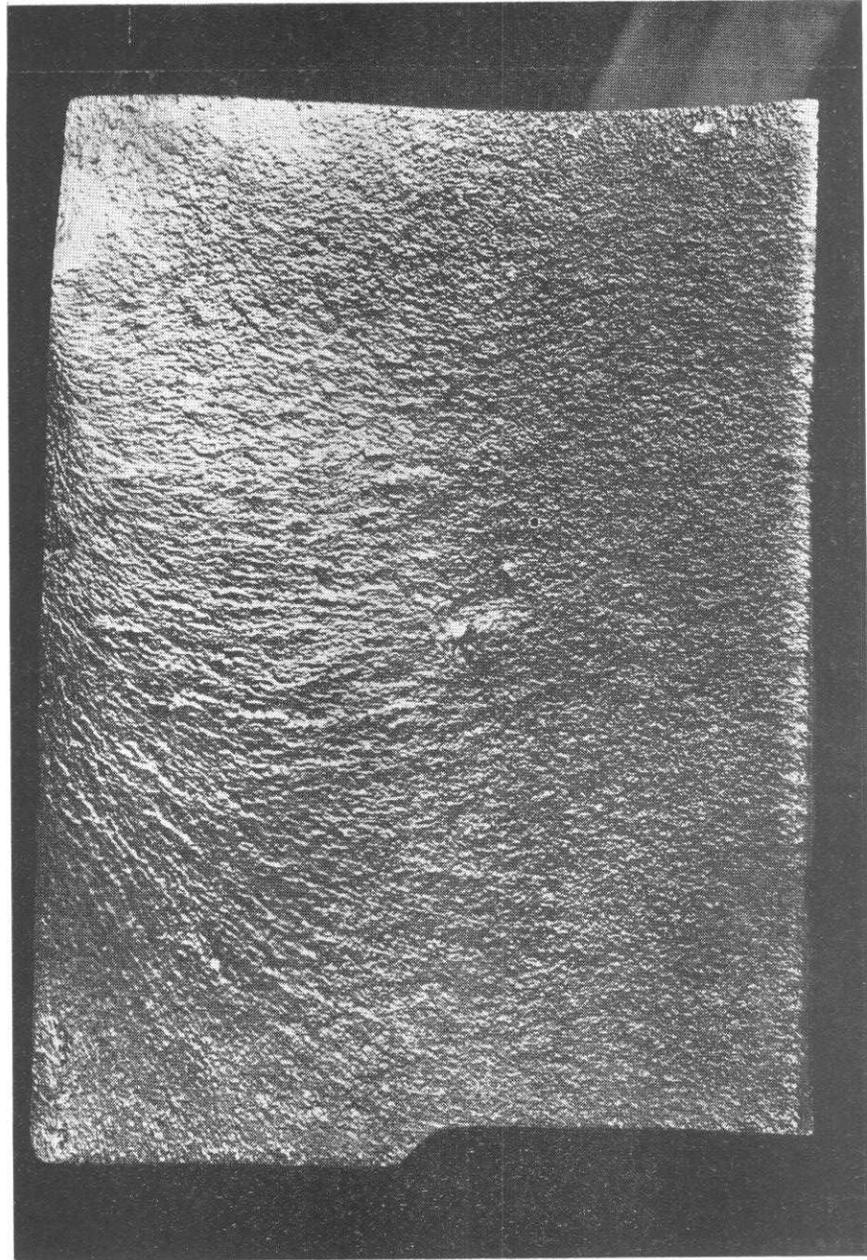
FIG. 5. Face view of same fracture shown in Fig. 2. (Natural size) Bolt hole is on left hand boundary on photograph.

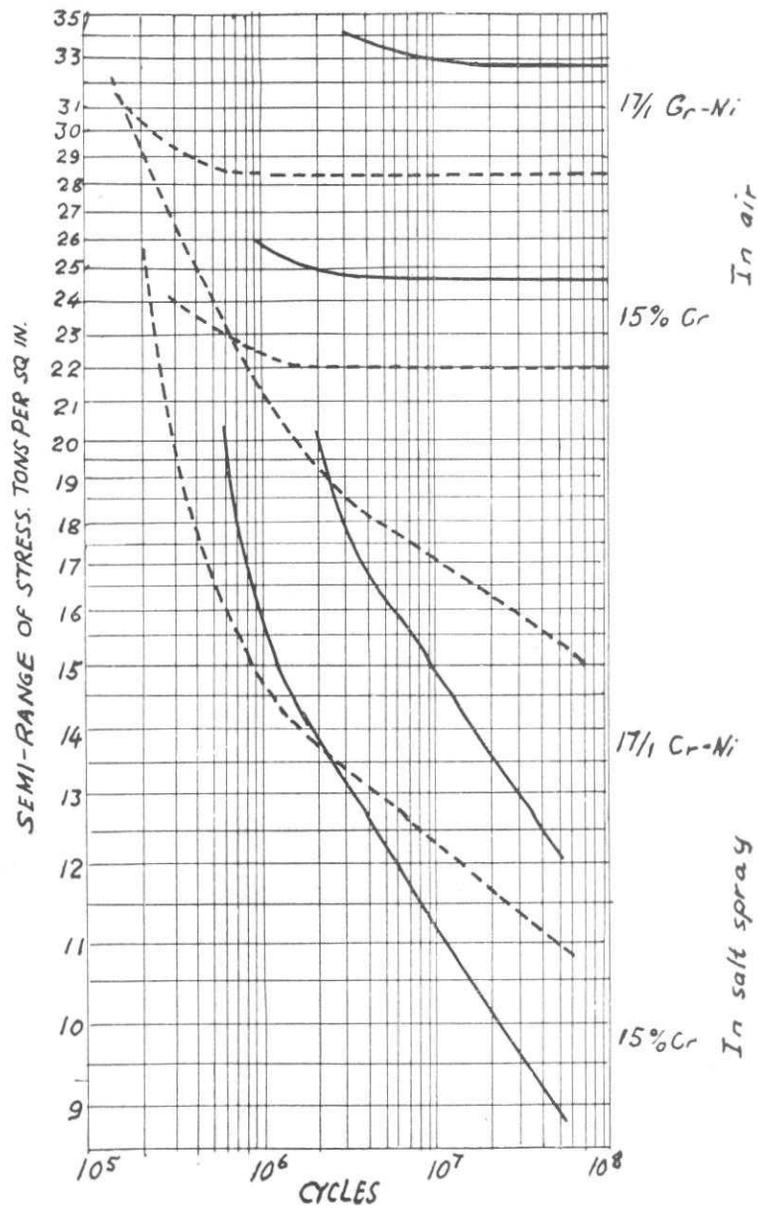
reproduced in fig. 6 for chromium steels in salt spray. Here it will be seen that by extrapolation the alternating stress corresponding to a life of 10^9 cycles/sec. is of the order of $+ 1,200$ kg/cm or roughly 3 times the estimated nominal maximum stress. However, it is appreciated that stresses arising from vibrations have not been taken into account, and it is hoped that it will be possible to make some direct determinations of stresses on turbines in operation by means of strain gauges.

Fig. 6. Fatigue tests in air and salt spray on 15% Cr. steel and 17/1 Cr/Ni steel. Full lines: rotating bending tests; dashed lines: push-pull tests: (after Gough & Sopwith: "Comparative Corrosion Fatigue Tests employing two types of stressing action". J. Iron & Steel Inst. Vol. 127 (1933) pp 301-322).
