SOME INTERESTING ENGINEERING FAILURES ENCOUNTERED IN AUSTRALIA

G. G. McDonald M.Sc.*

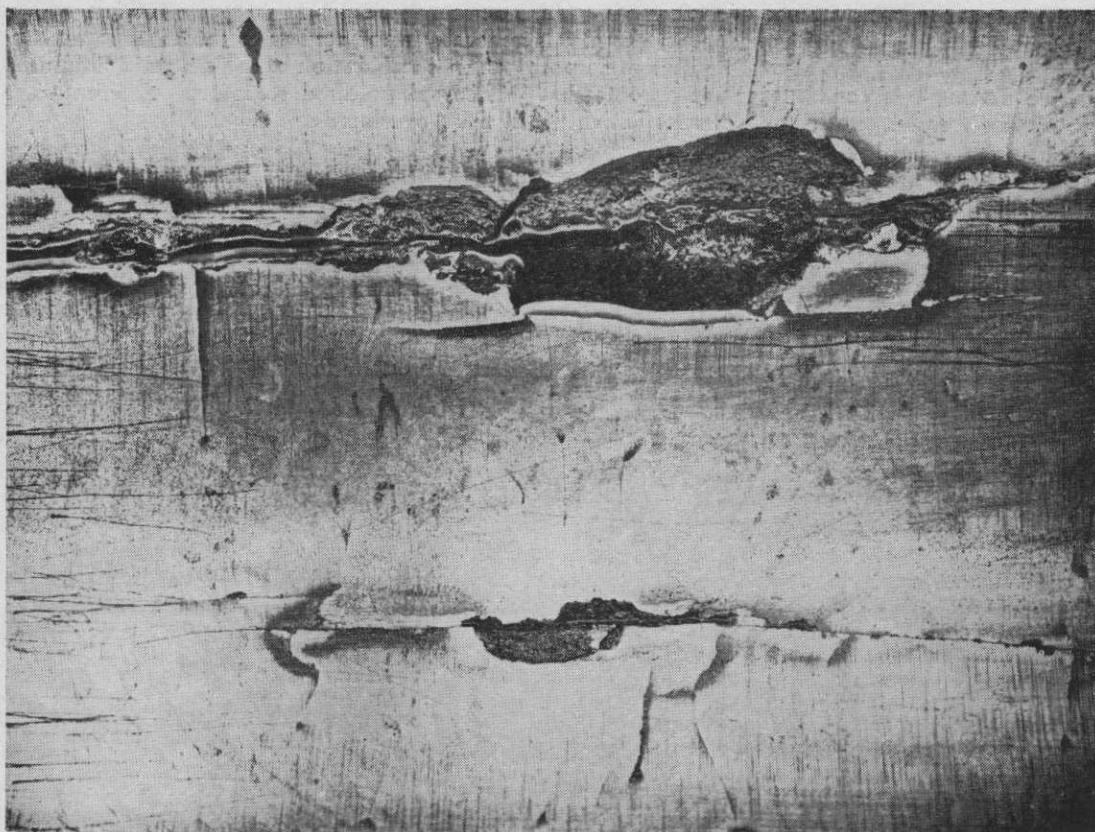
The bore surface of the cylinder was found to be very extensively damaged, two wide longitudinal cracks 14 and 10 inch long respectively and lying about 2 inch apart being present in the upper half of Figure 1. Very extensive spalling of the steel adjacent to the cracks had occurred while, in addition, the bore surface showed a second system of cracks running circumferentially. Typical damage at the bore surface is shown in Fig. 1. Subsequent examination of sections from the cylinder showed the primary longitudinal cracks to extend radially to depths of $1\frac{1}{4}$ to $1\frac{1}{2}$ inch, while a third system of cracks, branching from the primary cracks and running parallel to the bore, was also seen. It was clear, then that spalling at the bore had occurred at intersections of the three crack systems. Microscopic examination of metallographic sections showed all the cracks to be intercrystalline in nature and to be lead filled along their entire lengths—a typical grain boundary network of lead is shown in Fig. 2.

It was thus established that extensive intergranular penetration of lead into the steel had taken place, a phenomenon which, so far as was known, had not been reported previously. It was necessary then to establish the mechanism by which lead had been enabled to "wet" the steel surface and to penetrate along intergranular paths. Two deep scores on the upper half of the bore, each corresponding with one of the deep longitudinal cracks, provided the answer to this question. The scores had been caused by contact of the leading edge of the ram with the cylinder bore during the first part of the ram travel. In normal press operation this should not occur because of the 0.010 inch clearance maintained between ram and cylinder; in the present instance, however, trouble had been experienced with the press foundation at new installation and this had caused slight misalignment between ram and cylinder during the first half of the extrusion cycle. This allowed metal to metal contact which broke down the oxide film and allowed lead to wet the steel surface under local conditions of high pressure and temperature due to friction. It was clear from the metallographic evidence that lead penetration then occurred along grain boundaries, first along roughly radial paths and then at two directions normal to this primary direction to form secondary and tertiary crack systems. Subsequent extensive development of each system and eventual intersection of the systems had caused spalling of the bore surface and failure of the cylinder.

Fig. 1. Typical damage at bore surface, showing chipping around longitudinal cracks; note also the large number of crack running circumferentially. Mag. 1X

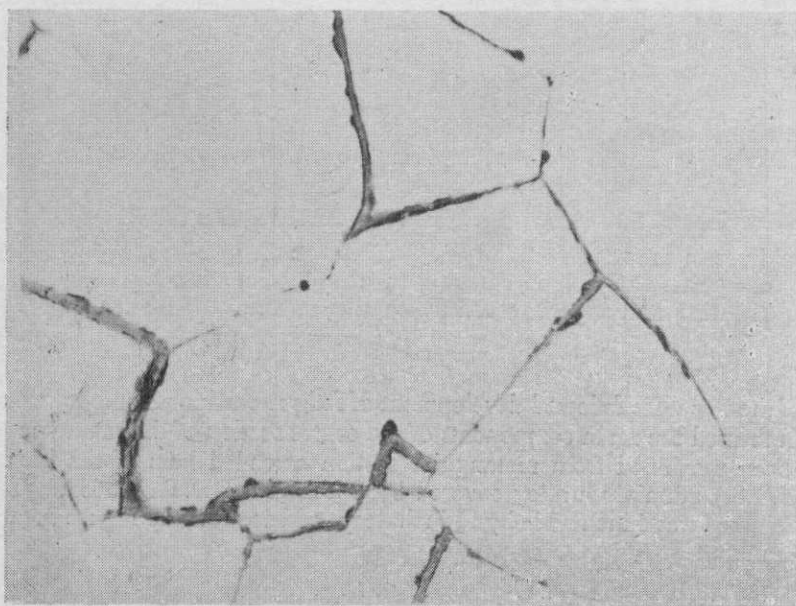
Fig. 2. Microsection from steel cylinder, unetched, showing intercrystalline network of lead. Mag- 750X

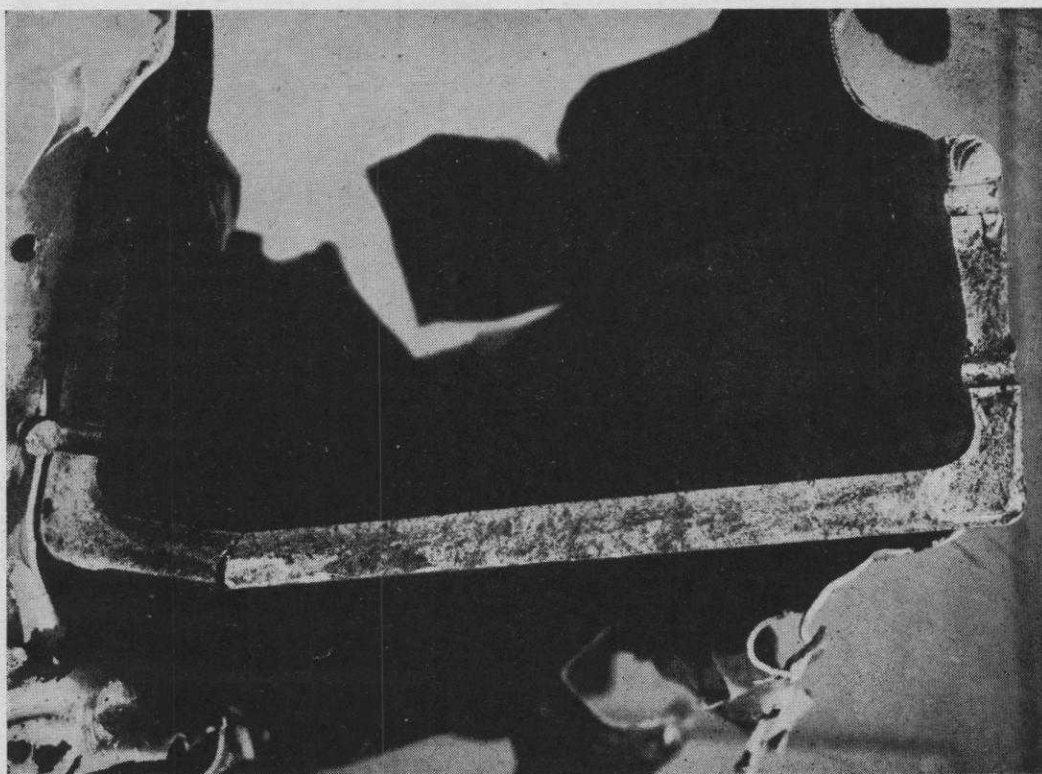
Failure of the structure followed development of fatigue cracking in the lower of two channel members which formed the main components of the centre section of the main spar boom. Both channels had been machined from rectangular section extruded bars of the high strength (38 tons/sq. inch U.T.S.) aluminium alloy covered by Specification D.T.D. 363A. The channel in which failure occurred was 4 inch wide by $1\frac{3}{4}$ inch deep, and as shown in Figure 3, fatigue cracking had developed in one rib.

Fig. 3. Fracture in aluminium alloy channel section, showing fatigue cracking in right hand rib.

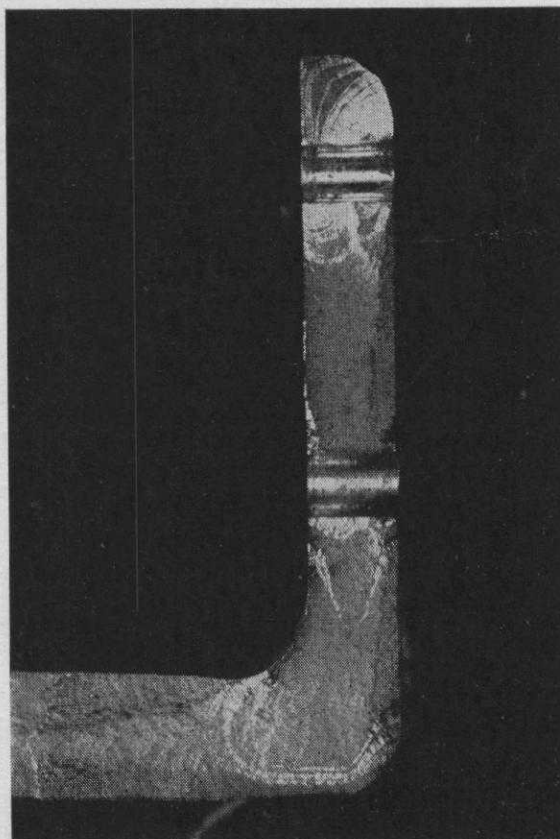
Figure 4 shows in greater detail the zone in which fatigue cracking developed and progressed before final failure of the structure. Cracking originated at the outer corner of the upper rivet

Fig. 4. Area affected by fatigue cracking in channel section, showing zones of alternate fatigue and rapid crack propagation.

hole and progressed through the section between this hole and the edge of the channel in a series of alternate stages of true fatigue progression and "rapid" jumps. These latter jumps are to be seen in Figure 4 as dark, curved bands of varying widths: in covering this portion of the section, some fifteen or sixteen stages of alternate fatigue and rapid crack propagation had been involved. Similarly two fatigue cracks originated at the bottom of the upper rivet hole, both developing again by a number of alternate steps of slow and rapid progression until the two systems amalgamated. A sudden heavy load application then caused a major "rapid" jump which covered the major portion of the section between the two rivet holes. Further fatigue cracking then commenced at the lower surface of the bottom rivet hole and again alternate slow and rapid crack propagation occurred until cracking had extended around the corner of the channel and about 5/8 inch along the base. Final rapid failure of the entire structure then occurred as a consequence of the next heavy load application.

The sequence of slow (fatigue) crack propagation alternating with rapid jumps can be readily followed by reference to Figure 4. The failure is of particular interest to the engineer in that it illustrates failure in a structural member of a design just below the safety borderline for normal service alternating stresses, and also shows the effect of intermittent heavy loading superimposed on normal vibration stresses by factors such as air-pockets. The mechanism of failure is also of interest to the metallurgist, for it provides information on the sensitivity of a high strength aluminium alloy to notches of extreme sharpness. It is clear in this instance that the alloy showed low notch sensitivity in an application where rapid failure could have been expected at a considerably earlier stage than actually occurred.
