National Workshop on Boiler Corrosion, 11-12th April, 1995, NML Jamshedpur, INDIA

SOME CASE HISTORIES OF FAILURE OF REHEATER TUBES

RAGHUBIR SINGH Materials Evaluation Division National Metallurgical Laboratory, Jamshedpur 831 007

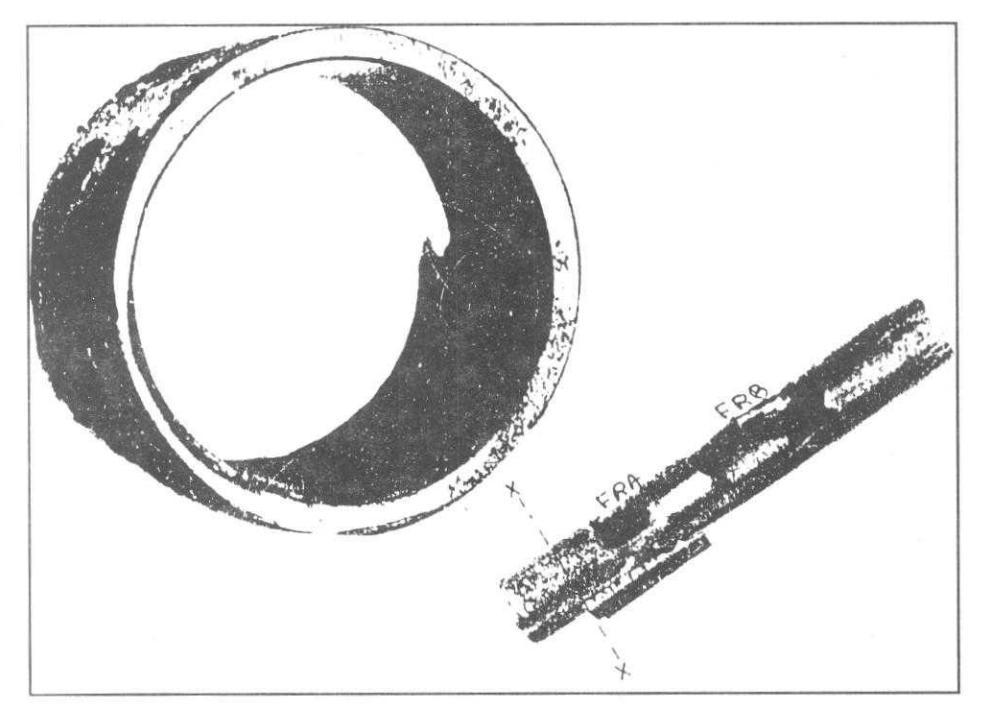
Figure 3 shows another failure of a reheater tube. Here the failure had taken place from the welded cleats. Figure 4a schematically shows the cleats and pin arrangements and Figure 4b the failed pin/cleat. FRA and FRB as marked on Figure 3 are position where the cleats were welded. Figure 3 also shows the cross section of the failed tube. It may be seen that the tube had suffered external wastage of metal from one side (see the right hand side of the cross section).

- Tube material specification : 2.25Cr-1Mo; cleat/pin material specification not available. However cleat was ferro-magnetic and the pin nonmagnetic;
- o steam parameter : 535°C/35 cm².

Fig. 3 : Photograph of the failed reheater tube. The bottom photograph shows cross section at X-Y

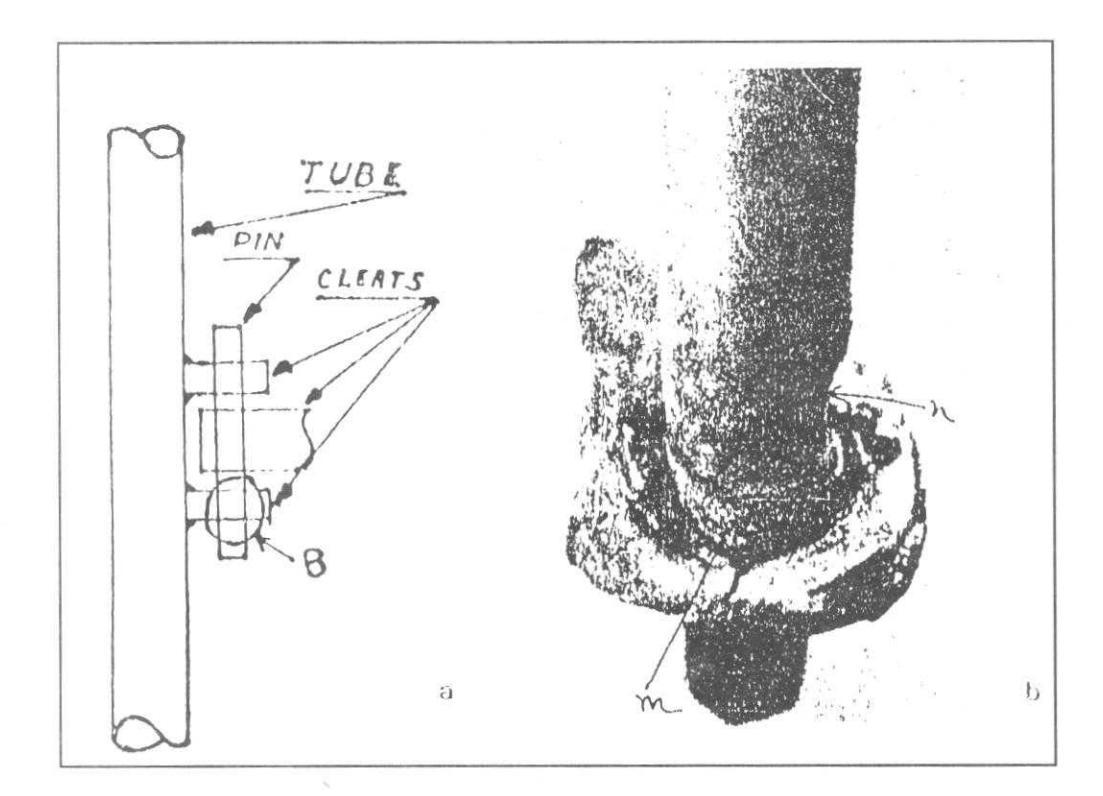
From the Figure 4 showing the failed pin, it is evident that some low fusion temperature ashes had accumulated upon the cleats and pin

Fig. 4(a-b) : a : Schematic view of the reheater tube with cleats, and b : Photograph of the pin with cleat in region marked B in 'a' above severe oxidation attack at 'm' and 'n' may be noted.

joints and eaten into them. As far as cleat and pin temperature is concerned, they certainly experience very high temperature because they are not cooled directly by the steam. Usually they operate at a temperature approaching that of flue gas which may lead to severe loss of creep strength and corrosion and, in worst case, melting. Failure of these support leads to misalignment of tube which may increase their exposure to the aggressive flue gases.

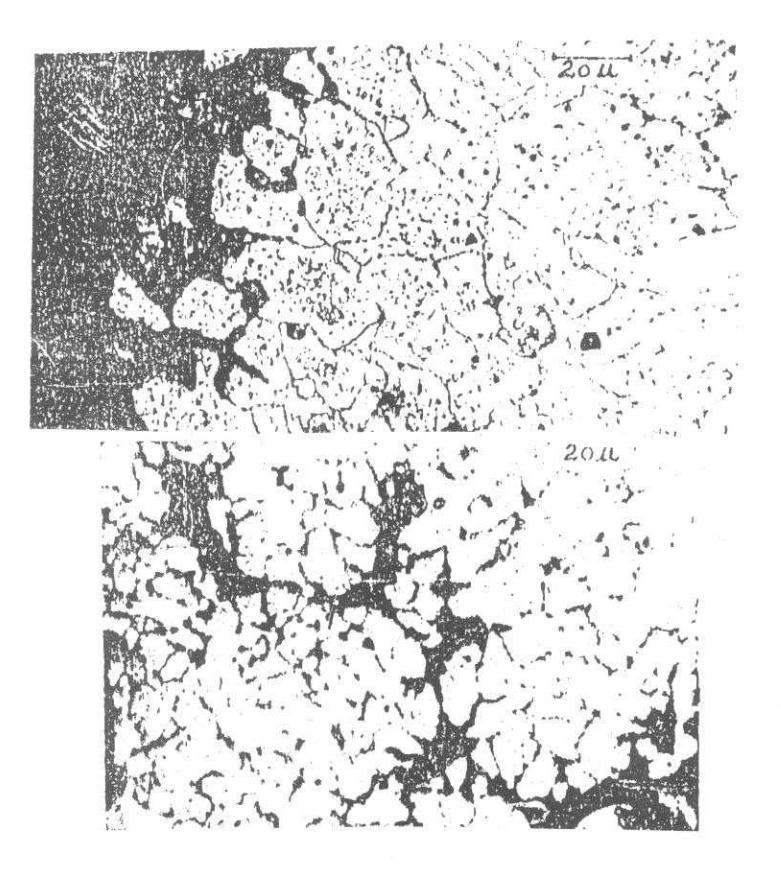
The investigation showed that the failure was essentially on account of high temperature environmental attack. This was borne out by the microstrucures of the failed tube and the cleat given Figure 5. The Intergranular attack in case of both the tube and the cleat is obvious. This type of attack could be possible only if low fusion point ash formed as discussed in case of the previous failure.

Fig. 5 : Microstructures showing integranular attack a(top): Fire side of the reheater tube in the zone of failure b(bottom) : Outer surface of the failed cleat

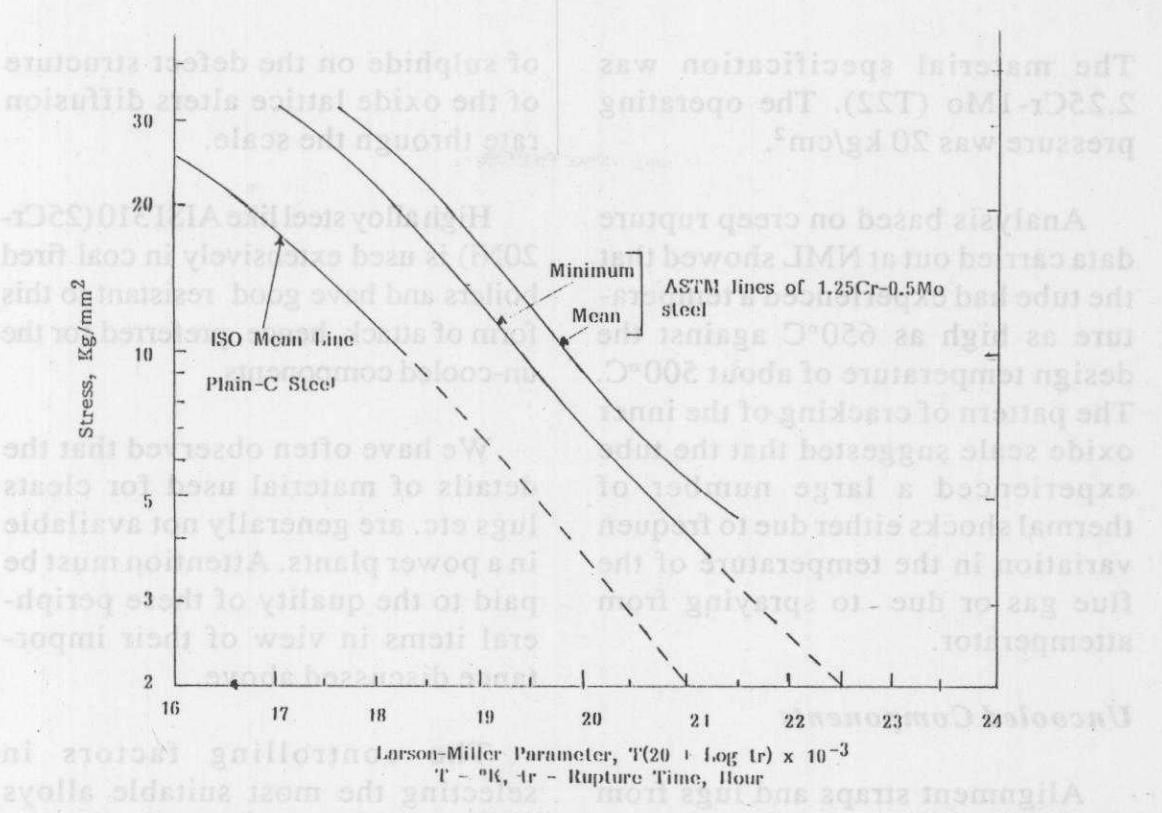
This failure was also analysed using Larson and Miller Parameter (LMP) plot given in Fig. 7. The value of LMP was calculated using the following equations:

In this case t_r was 24,000 hour and LMP corresponding to a stress level of 2 kg/mm² = 21. Using these data, operating temperature was found to be 588°C which is close to the service temperature which was measured and found to be 610°C. Hence, the failure was mainly on account of creep.

Fig. 7 : Stress versus Larson Miller Parameter plot for 1.25Cr-0.5Mo steel (ASTM-T11 Grade) and plain carbon steel (ISO data), dotted linc line represents extrapolation of the data to low stress levesls.

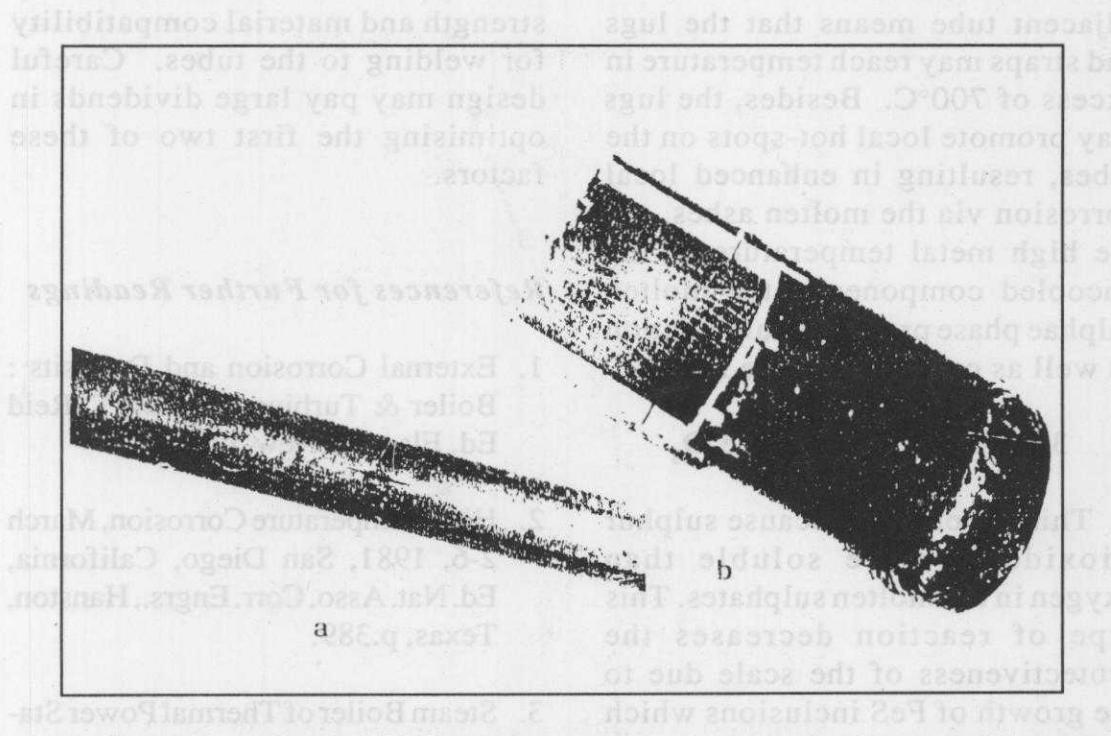
Figure 6 shows yet another example of failure of reheater tubes. Here a longitudinal crack of about 35 mm length and a transverse opening of about 2 mm had occurred. The tube also showed some circumferential bulging near the rupture -170 against 157 mm original circumference. Thick, hard, black and redish oxide layer was present on the outer surface. About 500 mm length of oxide layer in the rupture zone had completely peeled off from the outer surface. Adherent black oxide was present on inner surface which had cracked in both longitudinal and circumferential direction as a result the surface bore the appearance of a mesh (Fig. 8b). The failure had occured after about 50,000 hour of service life.

Fig. 8 : As-received failed tube, a narrow longitudinal crack (a) and oxide cracking on inner surface (b) may be noted.

The material specification was 2.25Cr-1Mo (T22). The operating pressure was 20 kg/cm².

Analysis based on creep rupture data carried out at NML showed that the tube had experienced a temperature as high as 650°C against the design temperature of about 500°C. The pattern of cracking of the inner oxide scale suggested that the tube experienced a large number of thermal shocks either due to frequen variation in the temperature of the flue gas or due to spraying from attemperator.
