Engineering Failure Analysis 6 (1999) 267-276

Failure analysis of counter shafts of a centrifugal pump

G. Das*, A.N. Sinha, S.K. Mishra (Pathak), D.K. Bhattacharya

National Metallurgical Laboratory, Jamshedpur 831 007, India

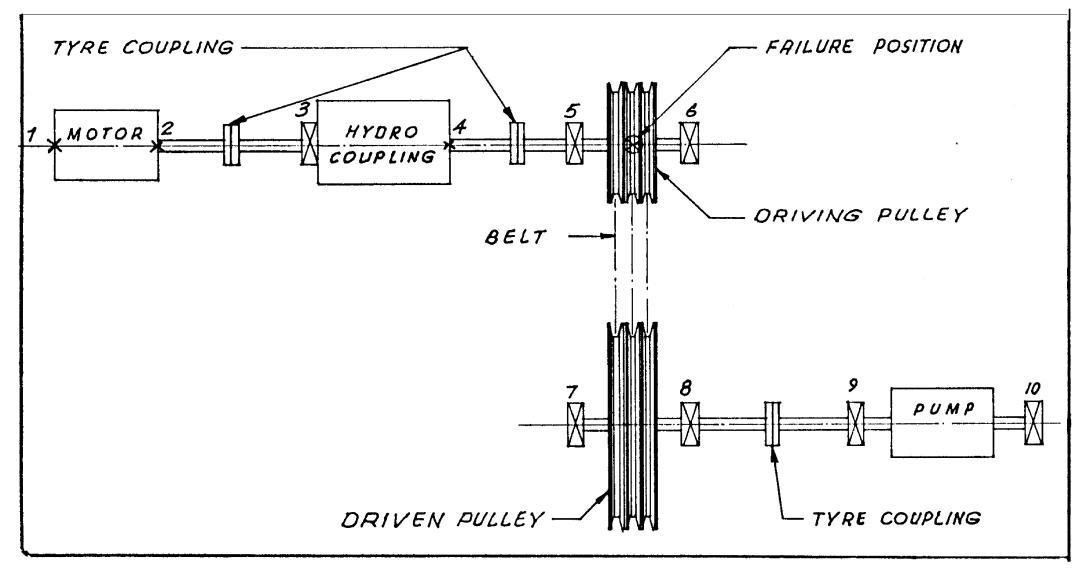
Fig. 1. Schematic diagram of the failed centrifugal pump.

Visual examination of the failed end gave the appearance that both the shafts failed by fatigue. A macroscopic view of the failed region of shaft B is shown in Fig. 2. Signs of smearing and distortion at the key edge were observed. Both the shafts failed at the end where the pulley is fitted as shown by the arrow mark in Fig. 1.

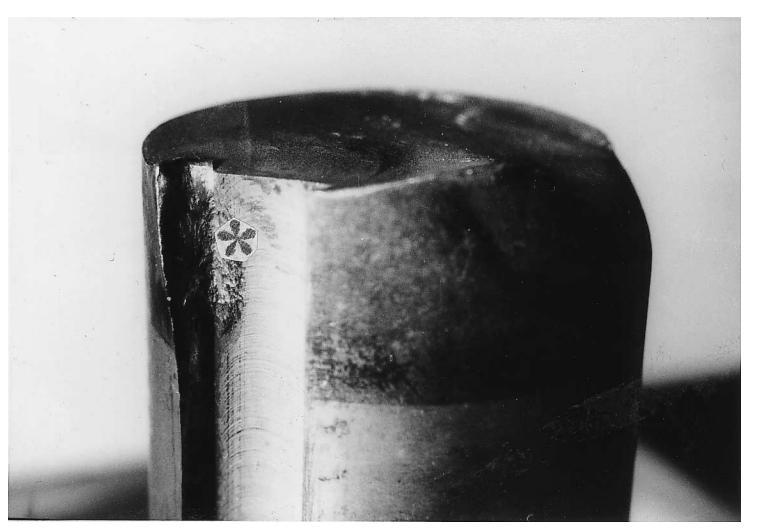
Fig. 2. Macroscopic view of failed end of shaft B.

Again, one of the keyways near the fracture surface was heavily deformed. Visual as well as microscopic analysis of the fracture shaft disclosed that the crack had initiated from the distorted region, shown in Fig. 1. Analysis of SEM fractographs confirmed the above. The microstructure of the plastically deformed region shows (Fig. 6) that the crack originated from the deformed region and propagated radially towards the centre. Here pulleys were assembled on the shaft by

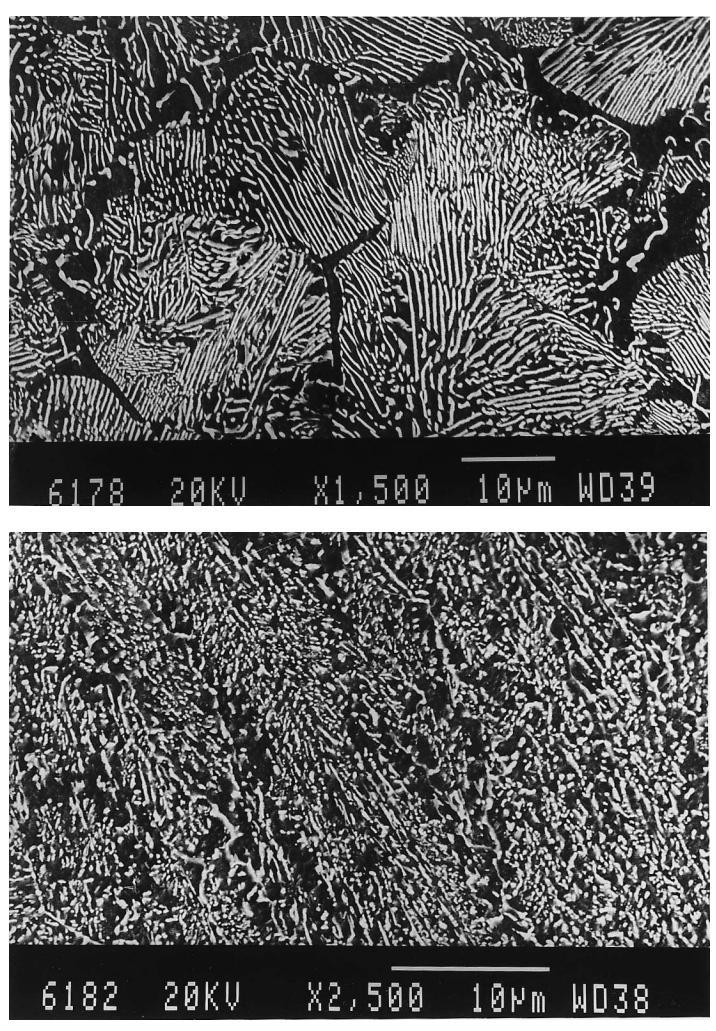
Fig. 3. SEM micrograph of (a) shaft A, showing ferritic-pearlitic microstructure and (b) shaft B, showing tempered bainitic microstructure.

observed as ferrite-pearlite for shaft A (Fig. 3(a)). Black patches indicate ferrite in the microstructure. A tempered bainitic microstructure was observed for shaft B, shown in Fig. 3(b). No significant inclusions or segregations were found; only a few pores were observed on the polished surface. The presence of pores are below the level of concern. The material used for the machining of the shafts was almost clean, only a few oxide inclusions of D4 fine ratings were observed.

Chemical analysis showed that the shaft was made of EN24 steel which is a recommended material for such applications. The shaft was of a ferritic–pearlite nature, whereas for this type of shaft the final microstructure should be tempered martensite [5]. Proper tempering should be done after solution followed by oil quenching and rough machining. The impact energy obtained was far lower than the specified level. The hardness value was found to be 170 HV, which is also lower than the recommended value for such applications. According to specification, the hardness value should be 340–400 HV [4, 5]. Visual examination and fractographic study of the failed shaft

Shaft B was also made of EN24 steel, confirmed by chemical analysis. The microstructure was predominantly tempered bainite. The hardness value was found to be 240 HV, still below the recommended level, while the impact energy was as per recommendation (51 J) [4, 5]. Though the

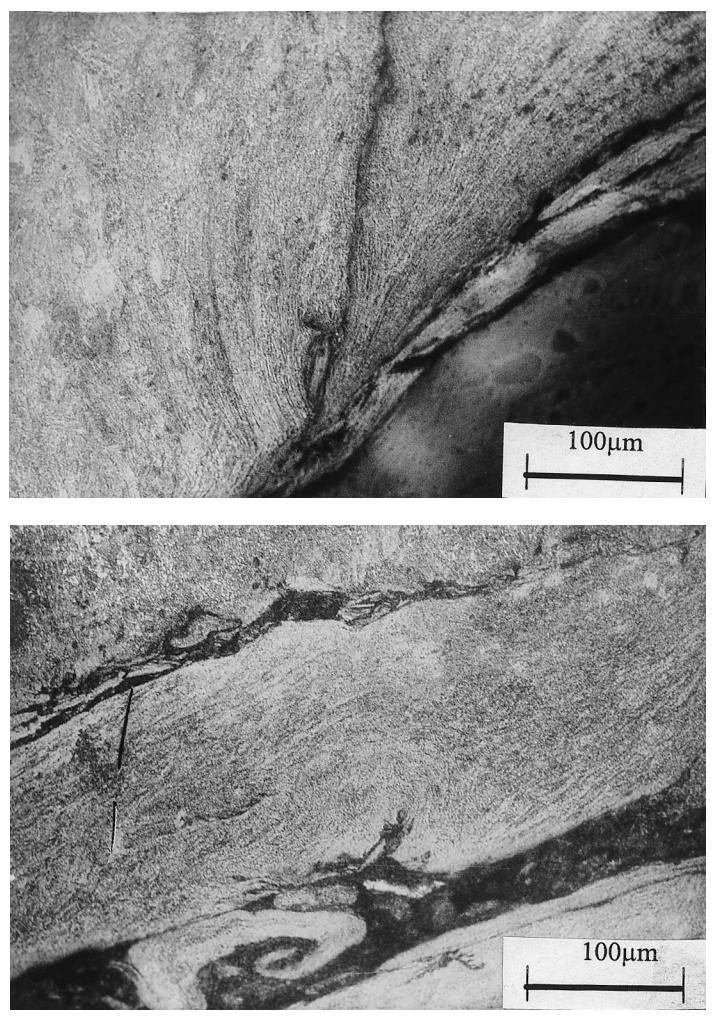
Figure 4 shows the microstructure of the distorted region along the axis and along the transverse direction at the key region (indicated by * in Fig. 2) of shaft B. Lapping of thin layers and some smearing of metal was found near the key region (Fig. 4(a)). Microstructural analysis of Fig. 4(b) indicated the presence of plastic flow lines. It is also observed that the cracks had initiated from the smeared region (Fig. 4(b)).

Fig. 4. Optical micrographs for shaft B at key region (marked by * in Fig. 2) (a) along the axis and (b) along the transverse direction.

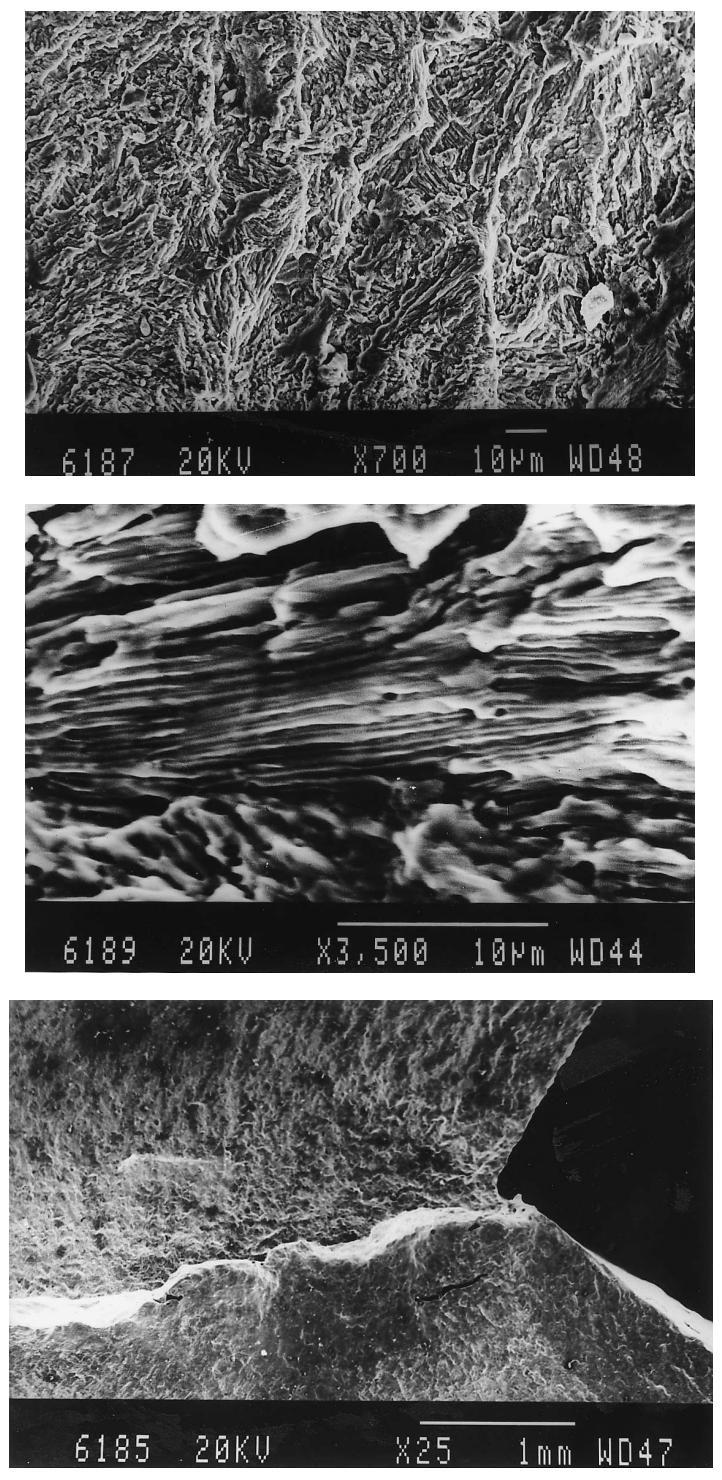
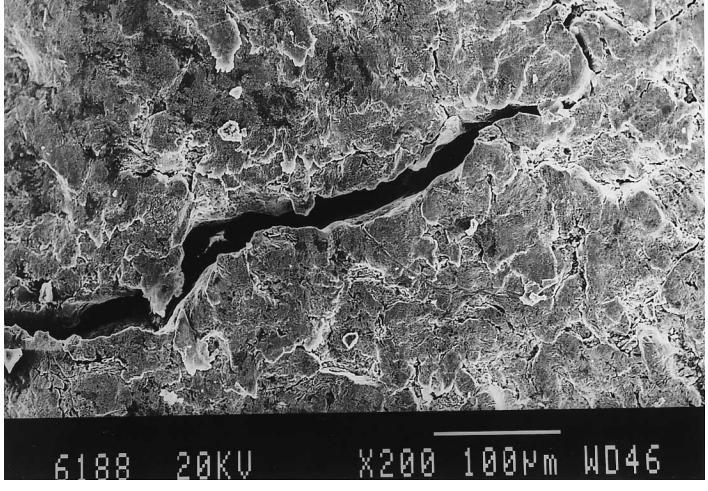
An SEM fractograph for shaft A is shown in Fig. 5. The fracture surface of the broken shaft showed that the fracture was by fatigue (Fig. 5(a)) and the cracks initiated from the locking key sites. The apparent striations observed in Fig. 5(b) are actually likely to be fractured pearlite. Figure 5(c) shows that the cracks had initiated from the keyway region. Propagation of secondary cracks was also observed, as shown in Fig. 5(d). A cavity of size approximately 300–400 μ m was observed in the fracture surface.

Fig. 5. SEM fractograph for shaft A showing (a) fatigue failure, (b) apparent striations, (c) crack initiation region and (d) secondary cracks.

disclosed that cracks had propagated from one of the keyways and failure was by fatigue. From the above discussions, it is clear that the heat treatment of the shaft was not properly done.

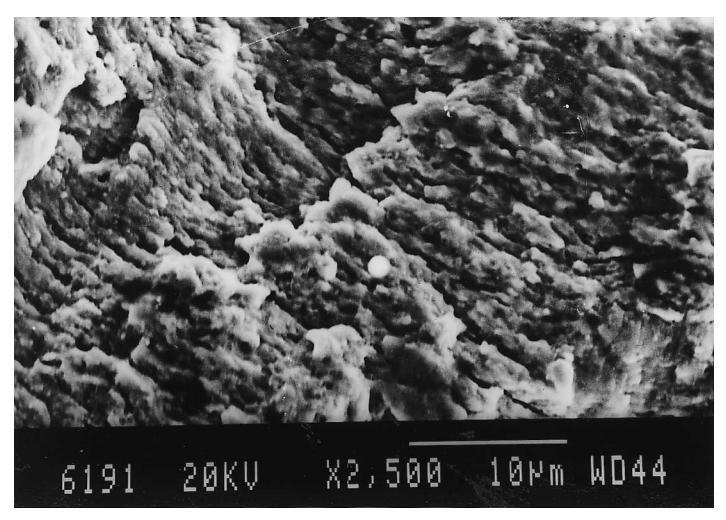
Similarly shaft B also failed by fatigue. The presence of striations in Fig. 6 supports the view of fatigue failure. Here also, the crack had initiated from the distorted key region where some plastic flow of metal was observed.

Fig. 6. SEM fractograph for shaft B showing fatigue striations.

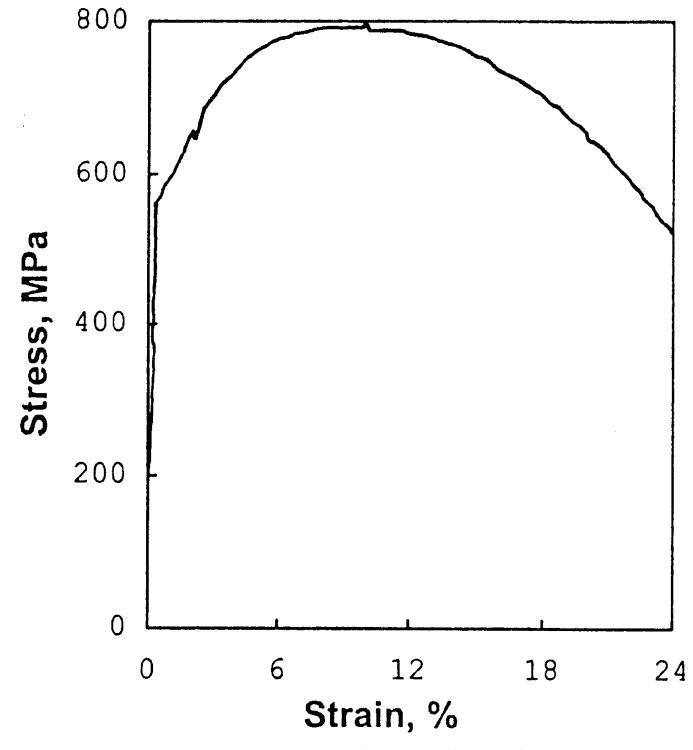
Cylindrical specimens for tensile tests were prepared from shaft B along the longitudinal direction. The test was performed with a strain rate of 10^{-3} /s. The stress–strain diagram is shown in Fig. 7. The yield strength, UTS and % elongation were found to be 530, 750 MPa and 22.55 respectively. The YS and UTS values were below the recommended level whereas % elongation satisfied the requirement.

Fig. 7. Stress-strain diagram for shaft B.
