Tin plated contacts: Problems due to Fretting corrosion and whisker growth

T.S.N. Sankara Narayanan

Part 1 – Fretting corrosion

Part 2 – Whisker growth

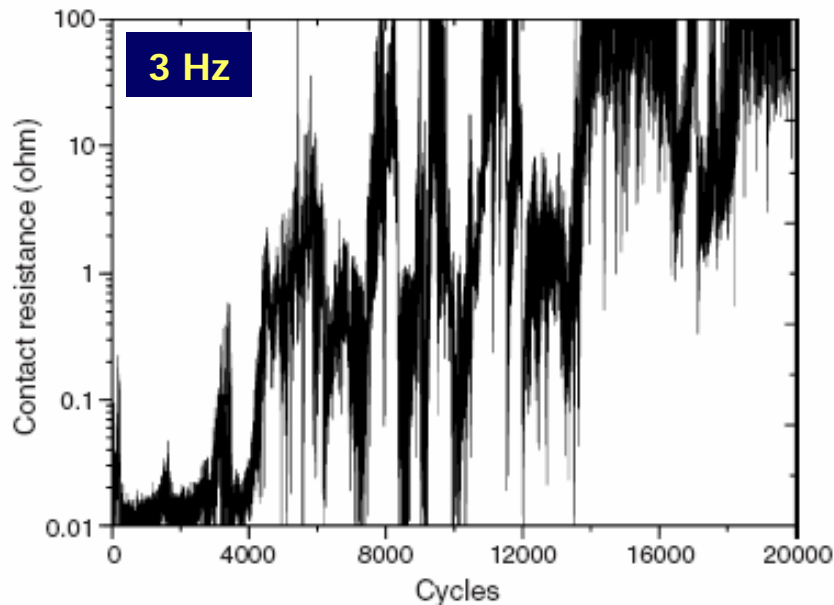
Influence of frequency

At 20 Hz - the rate of wear of tin coating is high

At 3 Hz - the contact zone gets more time for oxidation

The threshold value of CR (100 mΩ) is reached early at 20 Hz – due to the faster removal of tin coating that results in the formation of higher quantities of wear debris and oxidation products

At 20 Hz – the contact zone gets relatively lesser time for oxidation

Increase in wear rate leads to an increase in the extent of accumulation of wear debris and oxidation products at the contact zone, which causes a rapid increase in contact resistance

Amplitude: $\pm 25 \mu\text{m}$; **Temperature:** 22°C ;
Humidity: 55% RH; **Normal load:** 0.5 N;
Current load: 0.1 A

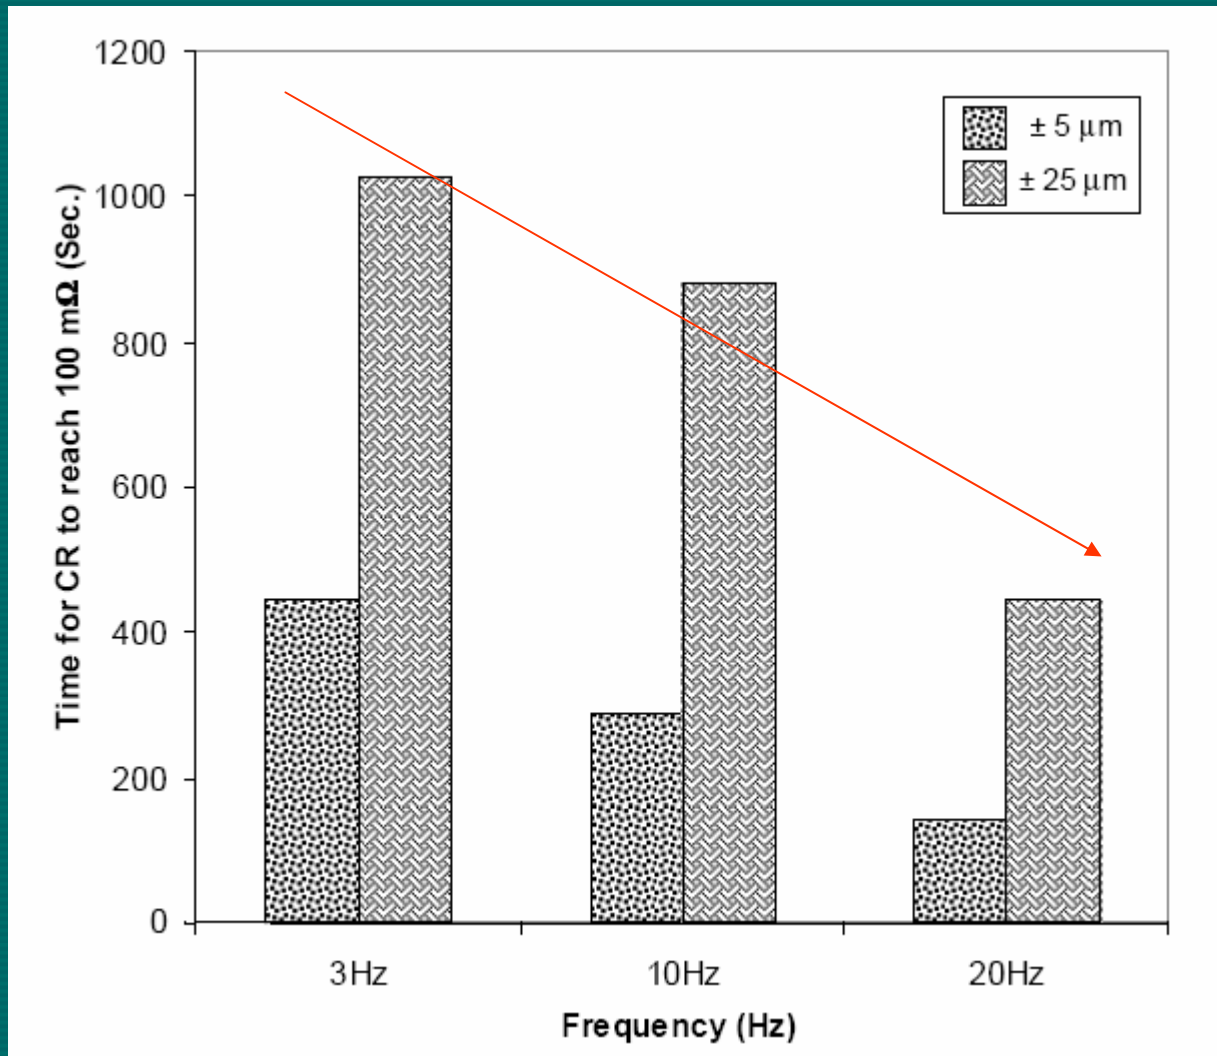
Plot of the time required for the contact resistance to reach a threshold value of 100 mΩ for the track lengths of $\pm 5 \mu\text{m}$ and $\pm 25 \mu\text{m}$ at three different fretting frequencies of 3, 10 and 20 Hz

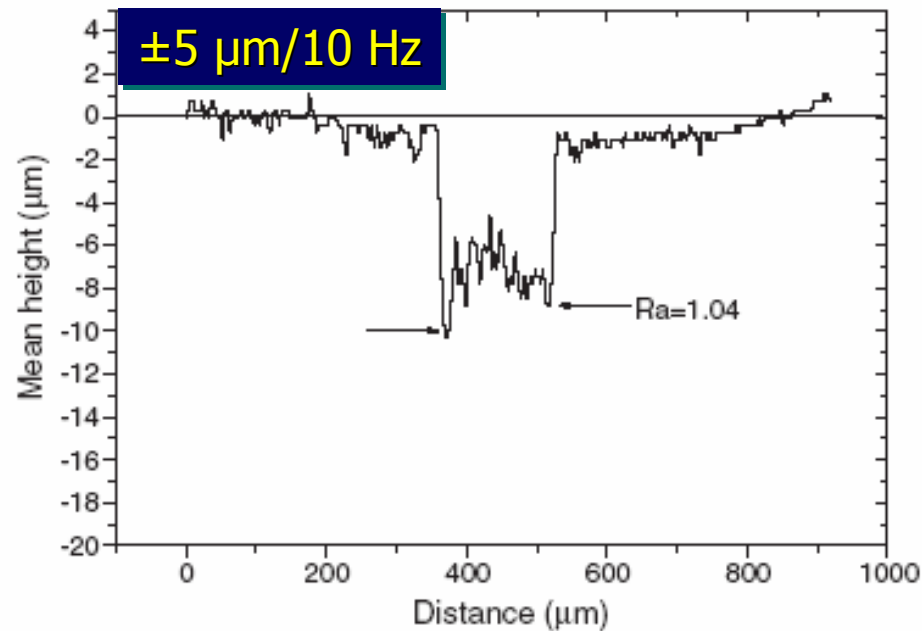
Surface profile across the fretted zone of the tin plated contacts after 20,000 cycles

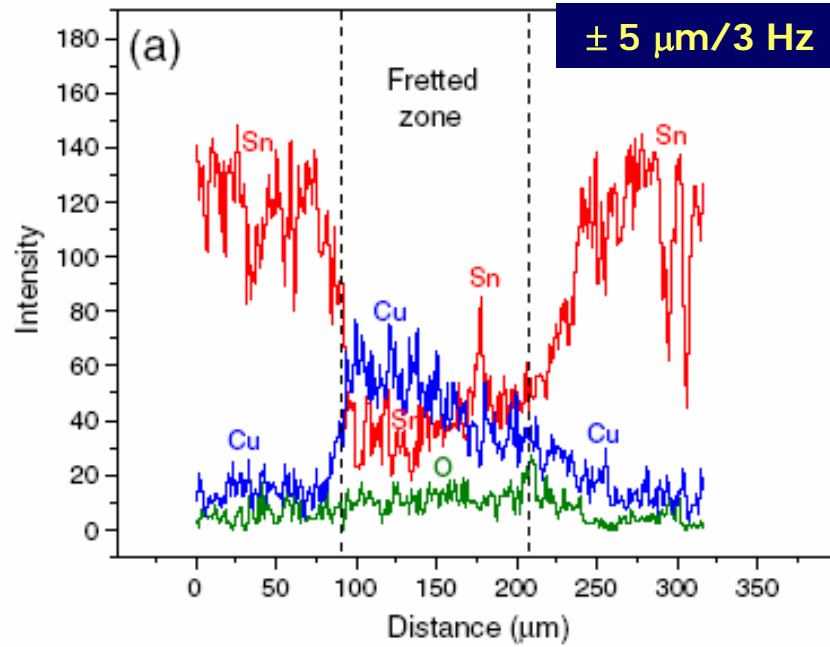
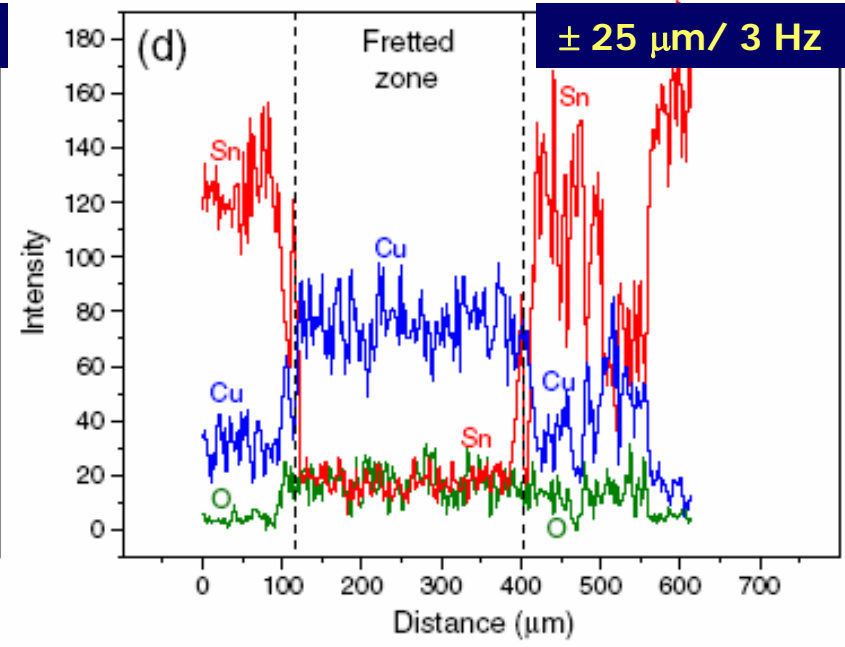
EDX line scan performed across the fretted zone after 20,000 fretting cycles

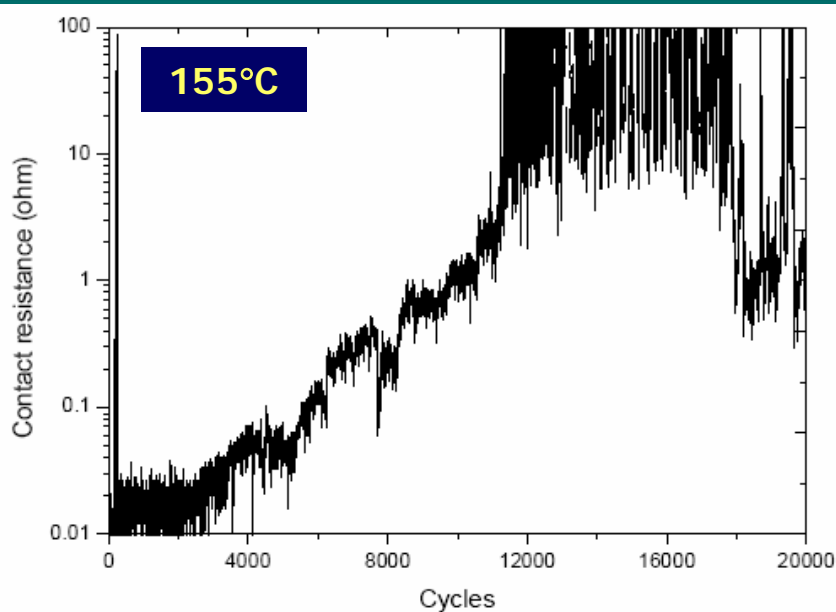
The extent of oxidation increases with increase in temperature

The softening of tin around 85°C enables a low CR for longer cycles

Beyond 125°C, the contact resistance increases rapidly

**Amplitude: $\pm 90 \mu\text{m}$; Frequency: 10 Hz;
Humidity: 55% RH; Normal load: 0.5 N;
Current load: 0.5 A**

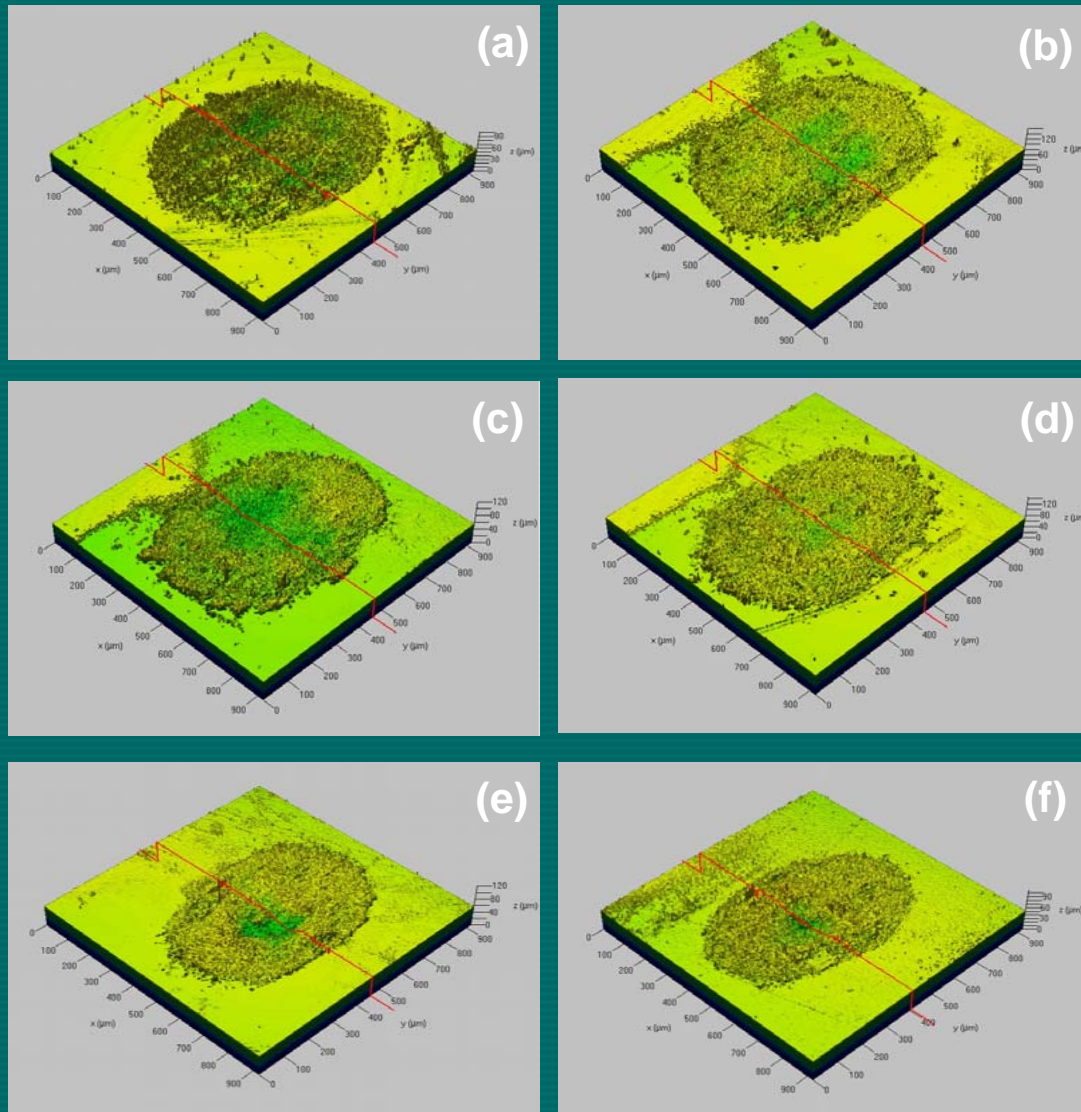
3-Dimensional view of the surface profile of the fretted zone of tin plated contacts subjected to fretting at various temperatures for 20000 cycles
(a) 25°C; (b) 85°C; (c) 105°C (d) 125°C (e) 155°C; and (f) 185°C

Roughness parameters calculated using the surface profiles of
the fretted zone of tin plated contacts subjected to fretting
for 20000 cycles at various temperatures

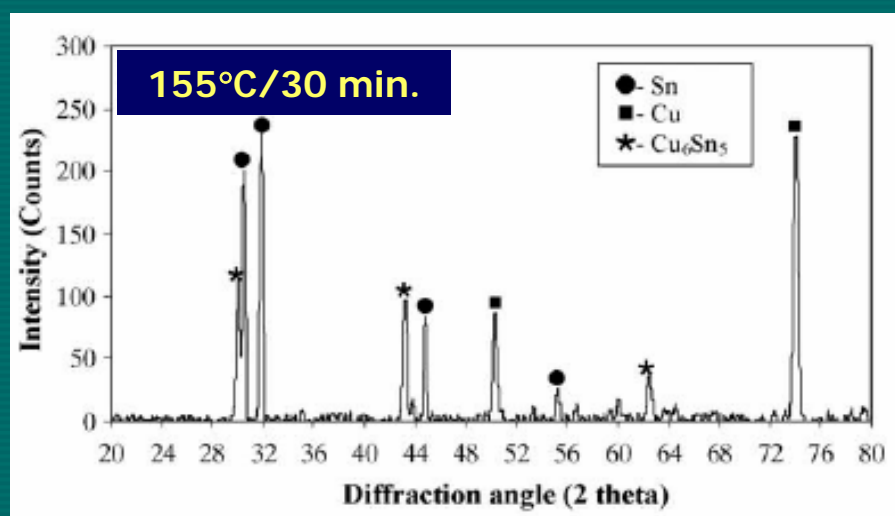
XRD pattern of tin plated copper alloy contacts in as-received and annealed conditions

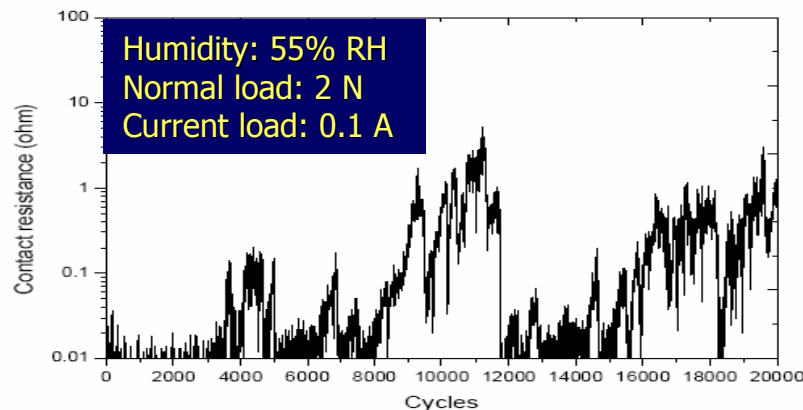
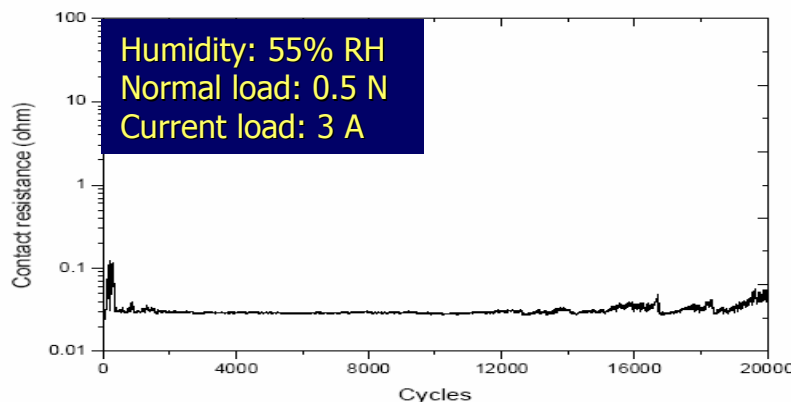
Frequency: 10 Hz; Amplitude: $\pm 90 \mu\text{m}$;
Temperature: 27°C; Current load: 0.1 A

At >85% RH – better performance - condensation of water vapour provides lubrication at the contact interface and enables a low and stable CR for longer fretting cycles

High loads -2 N - rate of wear of tin coating is higher

Higher load of 1 or 2 N helps to establish a better electrical contact and provides a stable contact resistance for longer cycles

The time to reach a CR of 100 mΩ is very low at 0.1 N - performance of the tin plated contacts is very poor at low load

At current load of > 1 A – better performance as this current load enables to break the oxide film and provides a stable and low CR

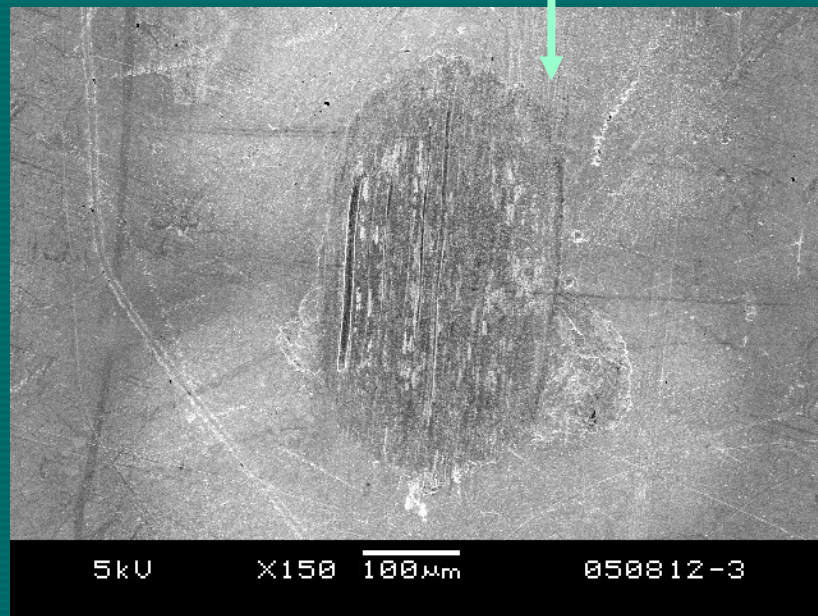
Influence of lubrication

Lubrication - A 50-50 mixture of petroleum oil and zinc diamyldithiocarbamate with a surface coverage of $6.76 \pm 1 \text{ mg/cm}^2$

Easily establishes metallic asperity contact between the mated tin plated contacts

CR of lubricated tin plated contacts remains stable for several thousand fretting cycles

100 mΩ threshold – around 100000 cycles

Extent of mechanical wear of the tin coating is significantly reduced

The contact zone experiences a lesser wear damage and exhibit a smoother profile.

The formation of tin oxide is not appreciable

No oxide accumulation at the contact zone

Lubrication is very effective in delaying the fretting wear during the initial stages and in preventing the oxidation and, accumulation of wear debris and oxidation products at the contact zone in the later stages

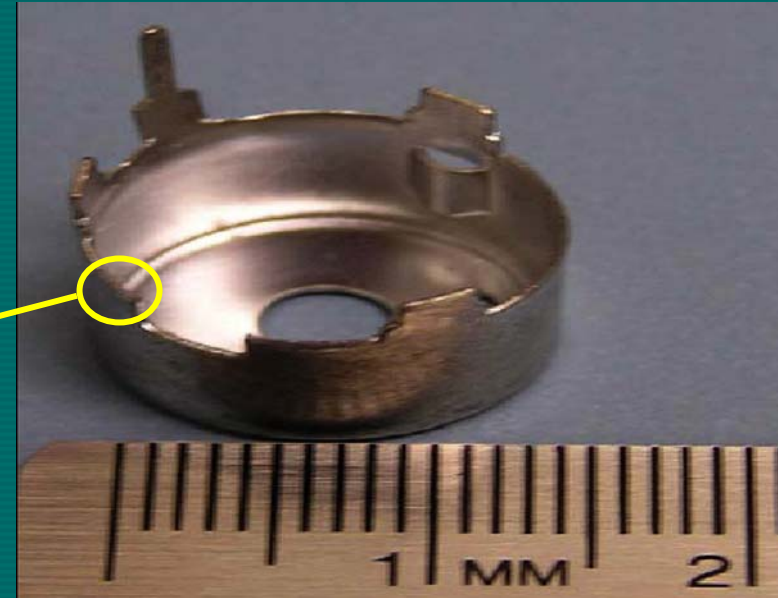
Tin-Plated Transformer Can

Tin whiskers observed in as-received cans Coincidental
with Mfr Switch from Tin-Lead to Pure Tin Finish

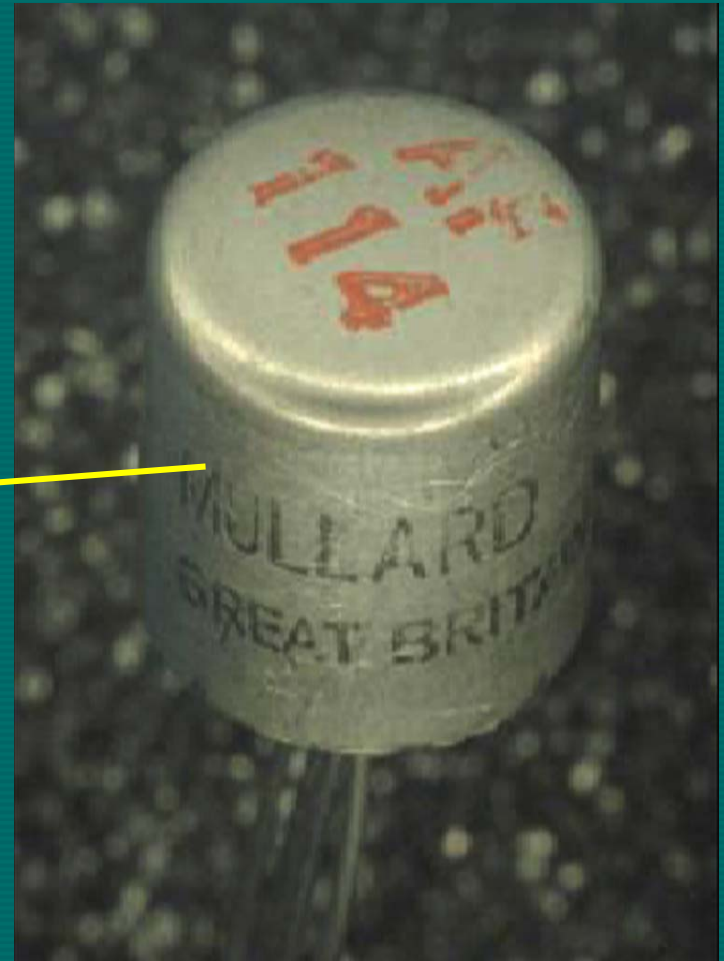
Tin plated transistor - Many radio malfunctions have been attributed to whiskers shorting case to terminals

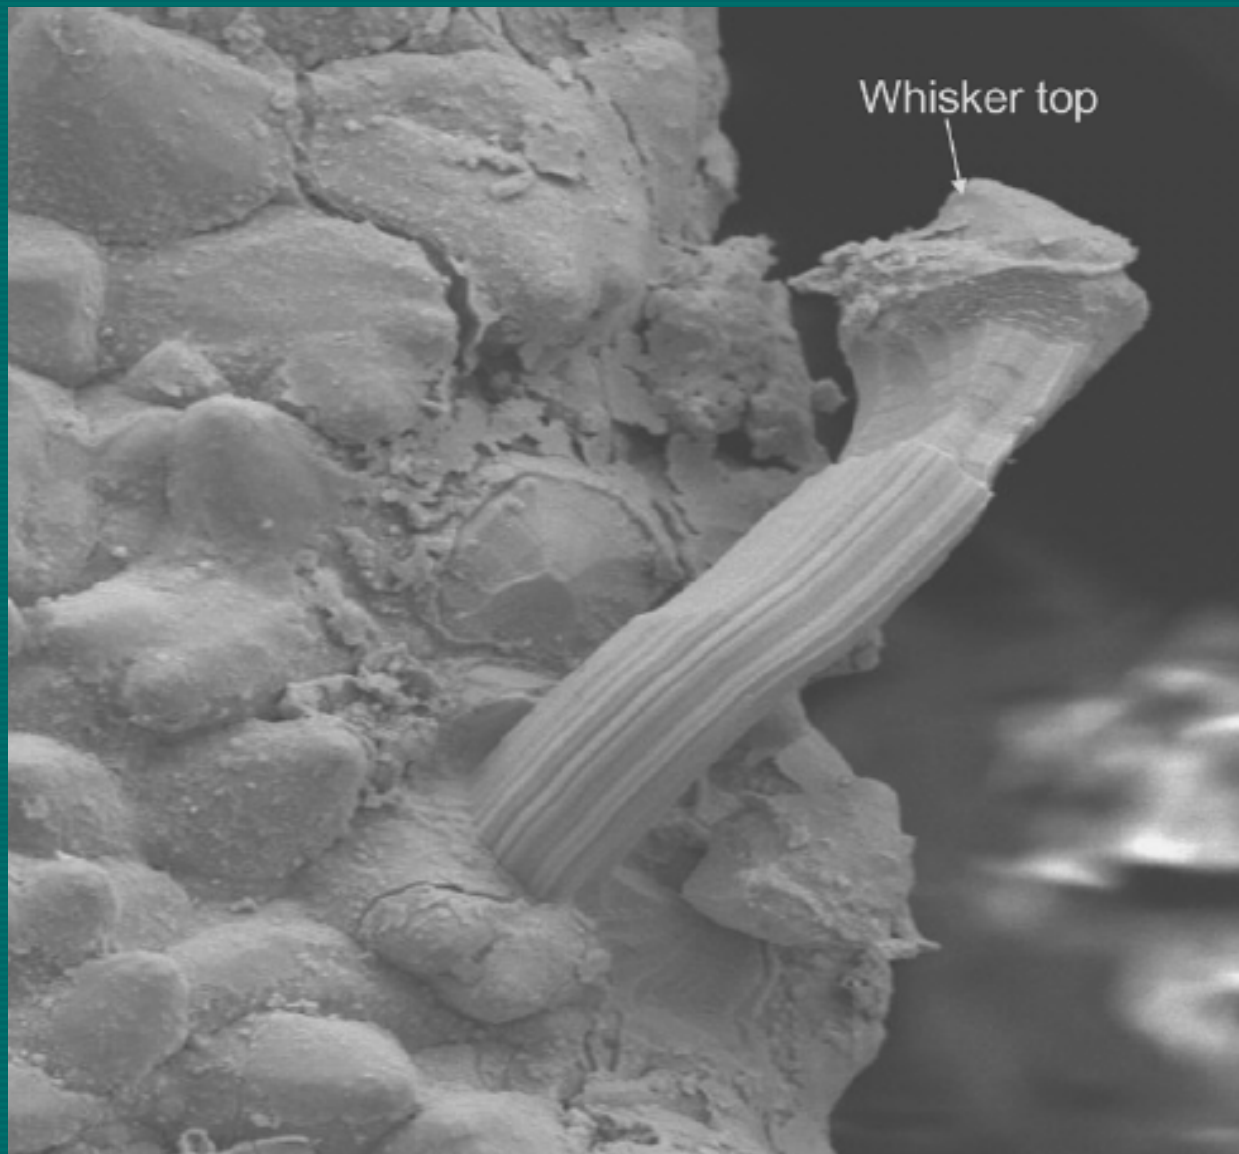
Tin whisker found after 26 weeks of aging at 60 °C/93%RH on a 15 μm -thick Sn on Cu plus post-plate 150 °C/1-h anneal

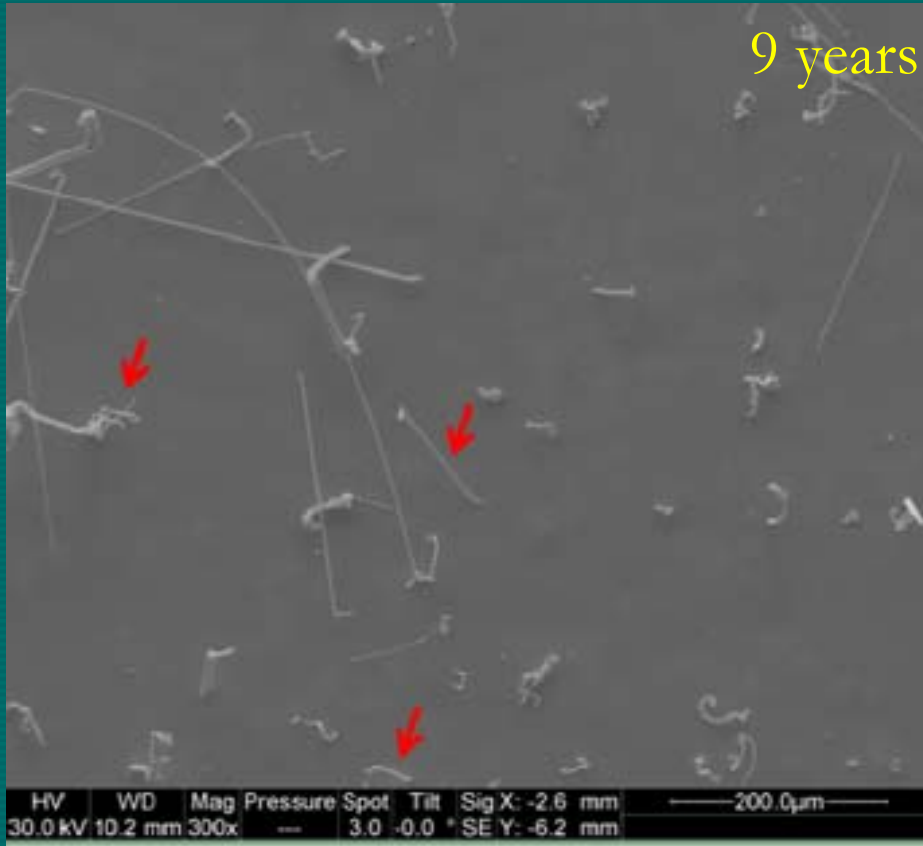
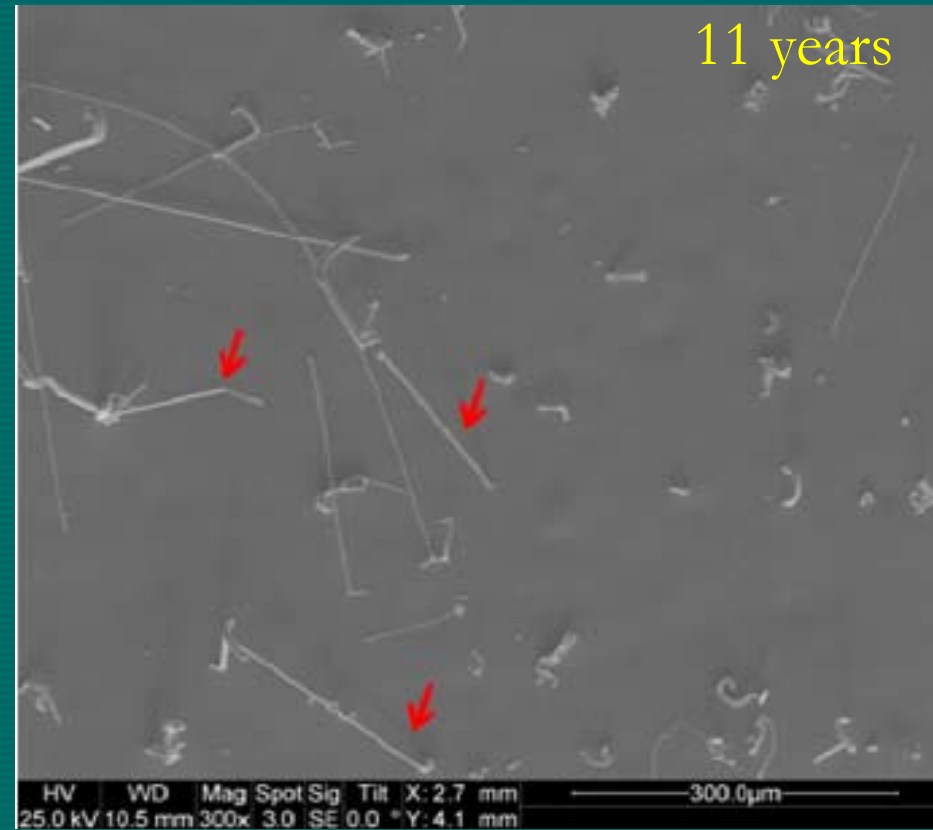
Whisker growth continues even a decade after initiation

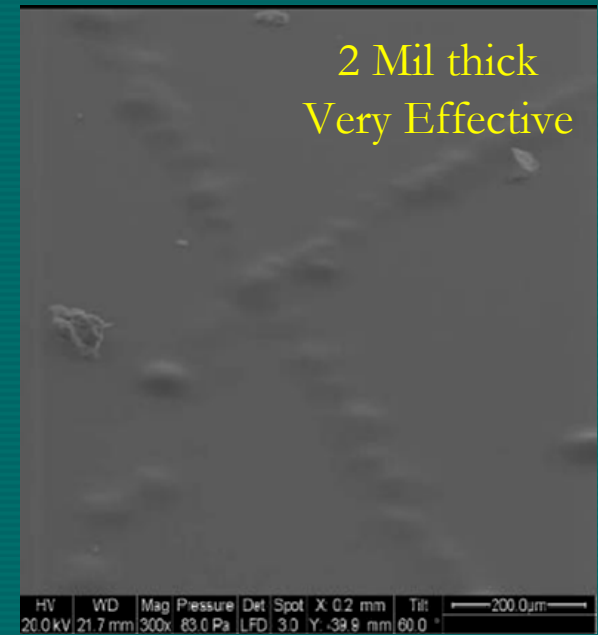
Whiskers are completely
entrapped under the
coating

Performance of the Uralane 5750 Polyurethane Conformal Coating after 9-Years of storage at ambient conditions
