## SERVICE FAILURES OF ENGINEERING METAL COMPONENTS

*B.R. Nijhawan, Ph. D. (Sheffield), B. Sc., (Met.), F.I.M. (Lond).*

### ABSTRACT

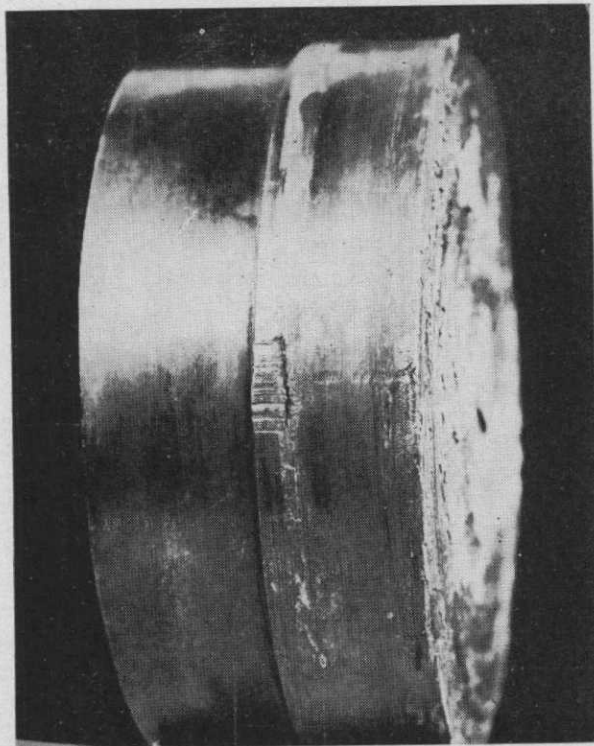
An examination of the broken face showed a clear cut fracture as shown by the complementary fracture faces (Figures 1 and 2). It would be observed from Fig. 3 that the surface of the steel shaft adjacent to the fracture was badly machined and poorly finished. The fracture took place along the line AB as shown in the attached drawing Fig. 4 Although a fillet of 1.8" radius was shown in the drawing along AB, this was not actually provided in the shaft. Instead, there was a very sharp corner from which the shoulder part ran sharply out.

A high degree of stress concentration would be caused under service conditions at this sharp corner, from which progressive cracking took place all round the circumference and developed gradually inwards toward the centre of the steel shaft. Rough surface finish of the stressed sharp corner would contribute to such cracking. A generous radius provided at the corner along with proper surface finish would avoid possibilities of such a failure.

FIG. 3. Same as Fig. 2 taken from a side, showing Sharp Corner and poor surface finish

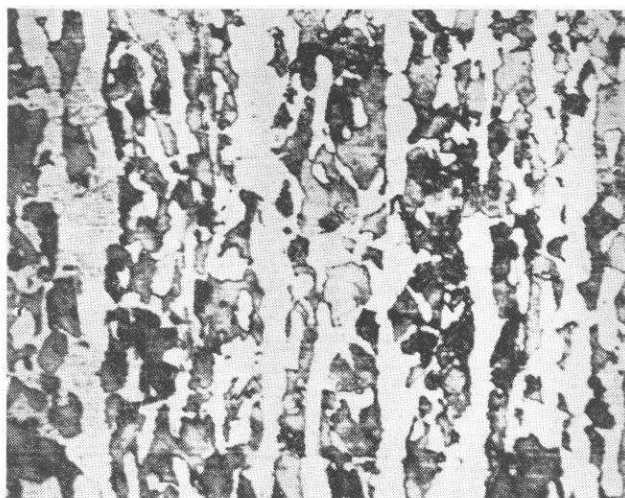
Micro-examination of the two steels was conducted at length. Steel I showed a highly banded structure as depicted in Fig. 5 whereas Steel II exhibited a very satisfactory micro-structure as shown in Fig. 6. The presence of 'banding' in the structure of Steel No. 1 is a detrimental feature.

FIG. 5. Pronounced Banded structure of Steel I. Etched in Nital x-250.

From the chemical composition of the two steels it was clear that steel No. I had been heavily deoxidized as shown by its higher silicon and aluminium (in solution) contents. This steel also depicts a highly banded micro-structure (Fig. 5). Both these features lead to the pointer that excessive oxidation of the steel bath had taken place during steel-making which necessitated an excessive use of deoxidants like silicon and aluminium. In technical language it may be said, that this steel had been doped with aluminium at later stages to rectify an excessively oxidized bath—a condition which should not have been allowed to develop in the first place. Highly banded structure of this steel indicated unsuitable steel-making and teeming conditions and is often attributed to various metallurgical factors such as excessive inter-dendritic segregation of elements like carbon and phosphorus, resisting subsequent homogenisation. Banded structures also cause poor machinability and should be avoided.

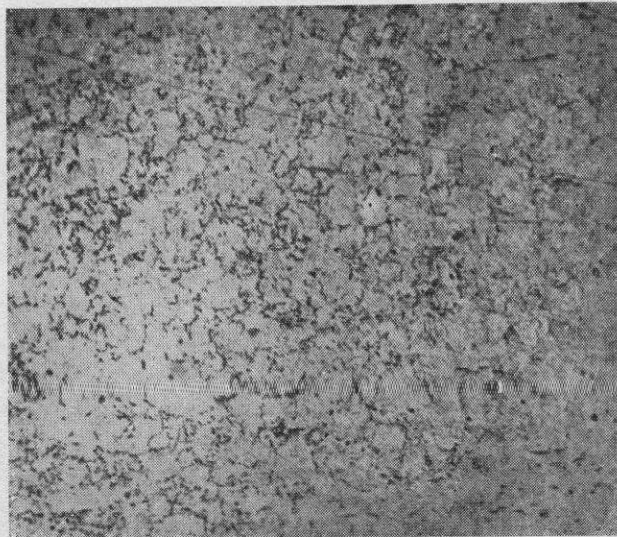
FIG. 7 McQuaid Ehn Grain-size No. 7-8 of Steel I. Etched in Sodium Picrate x-100.

The 'Killing' of Steel No. I with silicon and aluminium etc. conferred on it an inherently fine-grained structure as shown in Fig. 7—a highly desirable feature for a set of physical properties and number of applications but least desired for parts such as under investigation, of free-machining high sulphur types requiring high machinability and hardenability.

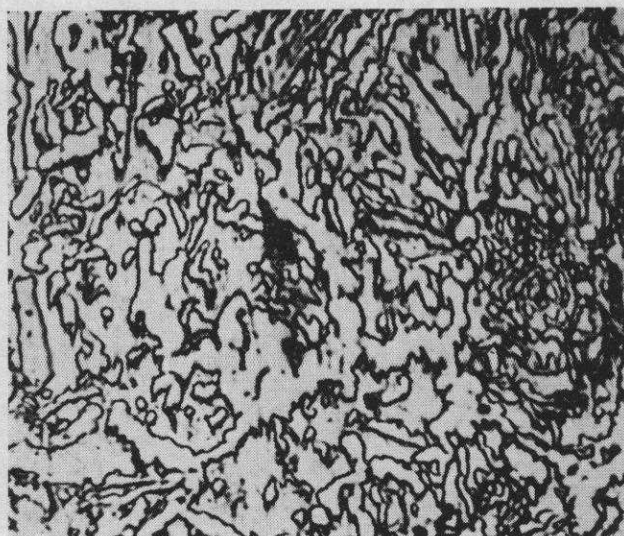
It was further observed that Steel No. 1 developed after pack-carburizing as required in the Grain-size test what is known as an 'Abnormal' structure. Abnormal structure does not lend itself to satisfactory hardening following carburisation. This abnormal structure of steel No. 1 is shown in Fig. 9.

Steel No. I which is inherently fine-grained, on carburisation developed an 'Abnormal' structure caused by the divorcement of Pearlite and subsequent coalescence of cementite into white ridges. Such a structure cannot be uniformly or fully hardened following carburisation. Besides, inherently fine-grained steels are shallow hardening and are unsuitable for parts requiring deep hardenability.

FIG. 9. Highly Abnormal Structure of Steel I on pack carburisation. Etched in Nital x-1200.

In view of above considerations, it is recommended that steel-making practice should be so controlled as to avoid excessively oxidized bath conditions. The use of highly oxidized steel scrap should also be avoided. For high sulphur, free-machining types of steels excessive use of deoxidizers like silicon, and aluminium should be restricted so as to ensure an inherently coarse-grained steel. Coarse-grained structures should improve the steel's machinability besides preventing the formation of an 'Abnormal' structure during carburisation, which would on subsequent hardening, cause 'soft spots', shallow and non-uniform hardenability.
