## SOME CHARACTERISTIC SERVICE FAILURES OF RAILS.

S.C. De, B. Met. (Sheffield)

T.V.N. Kida, B.Sc., (Met), A.I.M.

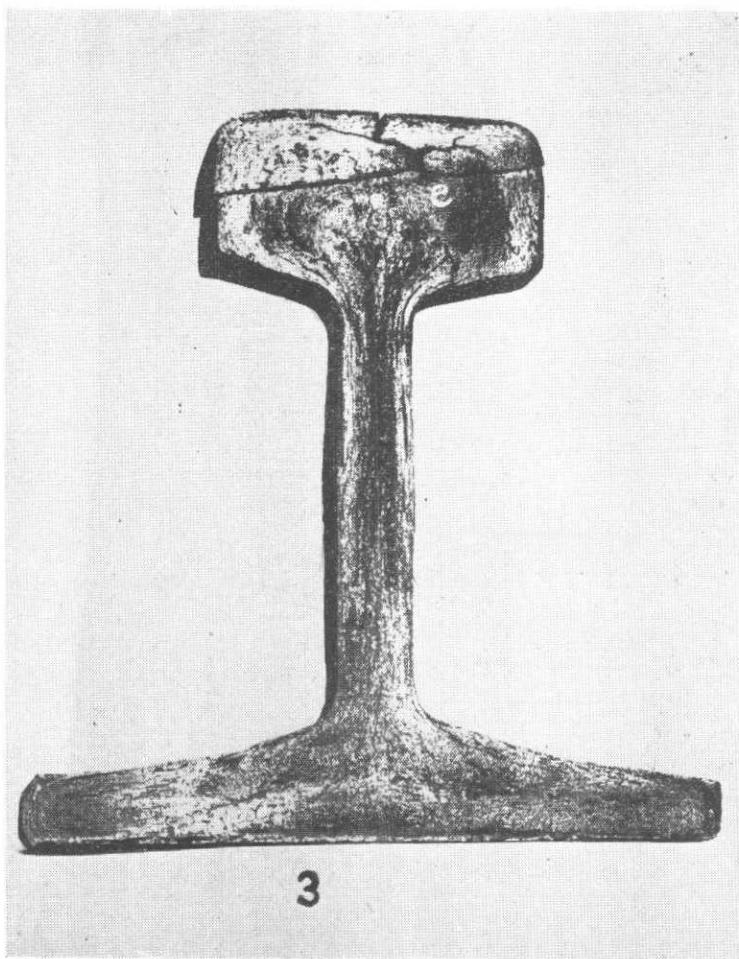
Like other metals steel crystallizes during freezing and, in so doing, crystallizes selectively. Segregation is a phenomenon of crystallization depending upon many of factors of which rate of cooling is one of importance. Injurious effects of segregation can be minimised by teeming the metal at proper temperature, and by cropping the top portion of the bloom adequately before rolling into finished product. Fig. 1 illustrates a type of failure due to segregation in 90 lbs. flat foot rails. Two of them marked A and B have vertical split and the other marked C has a horizontal one. The cause of splitting is due to the combined effect of heavy segregation of sulphur and phosphorus, and remnant of pipe in the rail. Chemical composition and the

FIG. 1 Failure of three 90 lbs, F. F. rails due to segregation.

hardness values of the rails shown in Fig. 1 are given below:—

Identification No. (Fig 1)	C.	Si.	Mn.	S.	P.	Hard- ness on standard position* V.P.H.
	Percent					
Rail—1.	0·31	0·036	0·62	0·124	0·178	178
Rail—2.	0·41	0·031	0·73	0·094	0·145	174
Rail—3.	0·32	0·072	0·70	0·10	0·044	156

270 V.P. H. was recorded on rail table surface near the split.
