# Fretting corrosion of tin-plated contacts: Evaluation of surface characteristics

Young Woo Park, T.S.N. Sankara Narayanan<sup>1</sup>, Kang Yong Lee\*

## Abstract

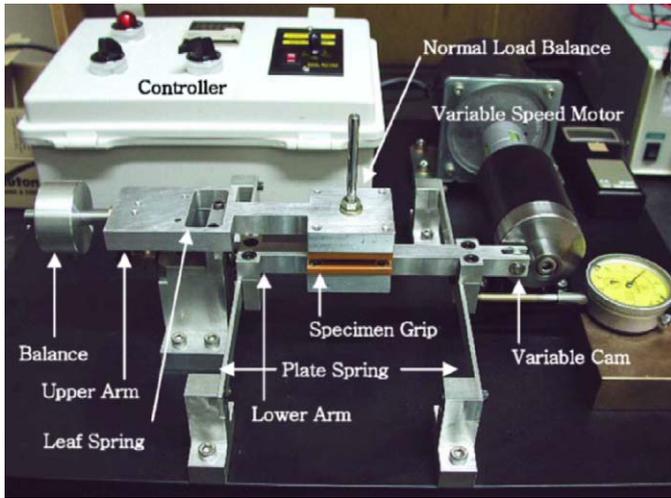
Fig. 1. The fretting apparatus used in the present study.

The fretting corrosion studies of tin-plated copper alloy contacts were conducted using the fretting apparatus shown in Fig. 1. The relative motion between the contacts was provided by a variable speed motor/precision stage assembly. The normal contact force was supplied by the weights placed on the balance arm. The contacts were flat versus 1.5 mm radius hemispherical rider (Fig. 2), both of them were made of copper alloy (Ni: 1.82%, Si: 0.75%; Zn: 0.01%; Sn: 0.37% and Cu: balance) and tin plated to a thickness of 3  $\mu\text{m}$ , supplied by Korea Electric Terminal Company Ltd., Korea. The rider and flat specimens were degreased using acetone in an ultrasonic cleaner, dried and carefully mounted in the fretting test assembly.

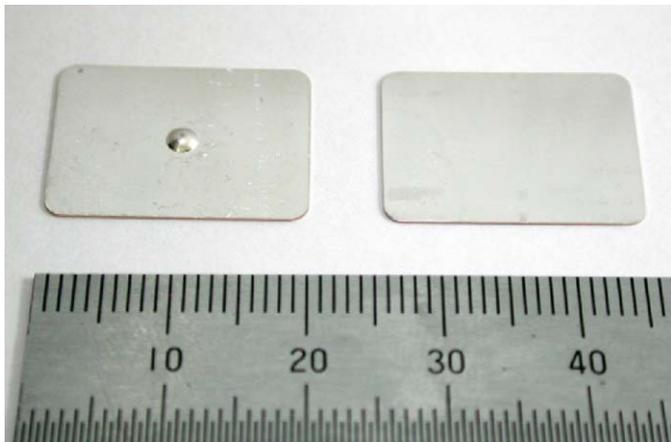
Fig. 2. The rider and flat samples used in the present study.

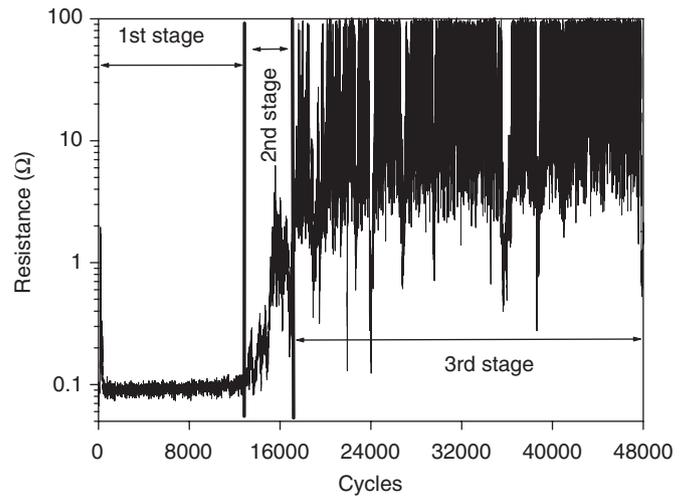
Fig. 4. Change in contact resistance of the tin-plated copper alloy contact across the contact zone as a function of fretting cycles.

The change in contact resistance of tin-plated copper alloy contact across the contact zone as a function of fretting cycles is shown in Fig. 4. There observed to be a hump in the initial stages followed by a low contact resistance up to the first few thousand cycles. Beyond that there observed to be a rapid increase in contact resistance. The observed results correlate well with those of other researchers [12–20]. The initial hump is due to the presence of a thin film of tin oxide on the surface of the tin-plated copper alloy contact, which is removed in a very short span of time. The low contact resistance values observed up to the first few thousand cycles is due to the conducting

Based on the change in contact resistance as a function of fretting cycles, Fig. 4 is classified into three segments, designated as stages I, II and III. To assess the fretting damage, nature of oxide film and the mechanism of failure at the contact zone at different stages, three individual tin-plated copper alloy samples are run for 8000, 16,800 and 48,000 cycles, respectively, corresponding to the three stages mentioned in Fig. 4. Surface characteristics of these three samples are performed by SEM, EDX and X-ray dot mapping.

Hence the observed changes in the contact resistance of tin-plated copper alloy contacts as a function of fretting cycle (Fig. 4) could be attributed to changes in the contact zone as evidenced by the surface analytical studies. Accordingly, the early stages of oxidation occur around 8000 cycles. With increase in fretting cycles from 8000 to 16,800, the oxidation of the contact zone is responsible for the gradual increase in contact resistance. However, beyond 16,800 cycles as the accumulation of the debris and oxide particles continues to build up at the interface, the contact resistance starts to increase rapidly and becomes erratic beyond a level.

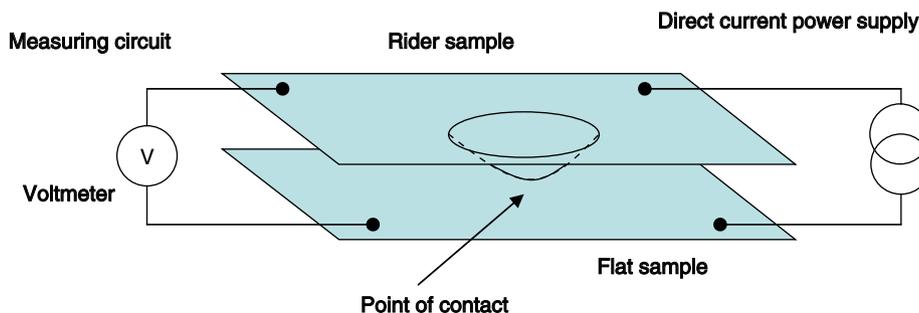
Fig. 3. The geometry of the rider and flat samples and the circuit used to measure the contact resistance.

A periodic relative displacement with amplitude of  $\pm 90 \mu\text{m}$  and a frequency of 10 Hz were applied between the rider and flat contacts loaded by a constant normal force of 0.5 N. The contact area is defined to be a point contact by “sphere plane” geometry. An electric current of 100 mA was applied by an electrical circuit. The contact resistance was continuously measured as a function of fretting cycles (Fig. 3). All tests were performed in unlubricated conditions at  $25 \pm 1^\circ\text{C}$  and at  $45 \pm 1\%$  RH.

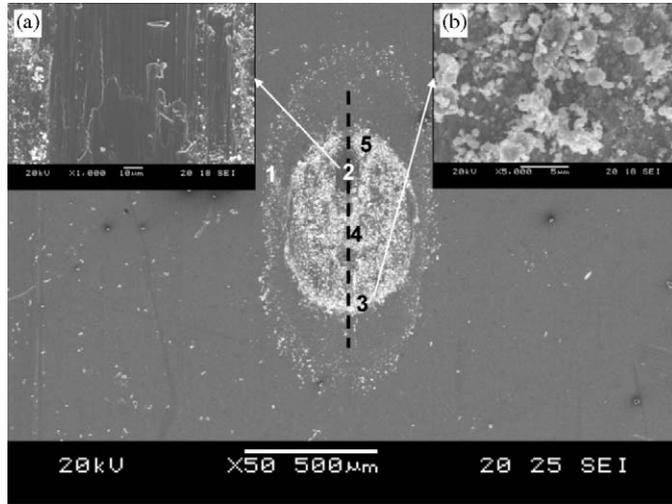
Fig. 5. Surface morphology of the tin-plated copper alloy contact after 8000 fretting cycles. (a) occurrence of adhesive wear (region marked as ‘2’ in Fig. 5). (b) Magnified view of the bright particles observed at the outer region of the fretted zone (marked as ‘3’ in Fig. 5).

The surface morphology of the tin-plated copper alloy contact run for 8000 fretting cycles is shown in Fig. 5. The fretting direction is vertical (indicated by the dotted line in Fig. 5). It is evident from Fig. 5 that the area of the fretted region is small, oval/elliptical shaped and is shallow in nature. The bright debris particles that are ejected laterally during the fretting motion are observed outside the fretted zone along the sliding direction (marked as '1' in Fig. 5). A closer look at the morphology indicates the occurrence of adhesive wear (marked as '2' in Fig. 5), characteristic of transfer of material between the mated contacts (inset 'a' in Fig. 5). The bright particles observed on the outer region of the fretted zone (marked as '3' in Fig. 5) are believed to be tin oxides (inset 'b' in Fig. 5).

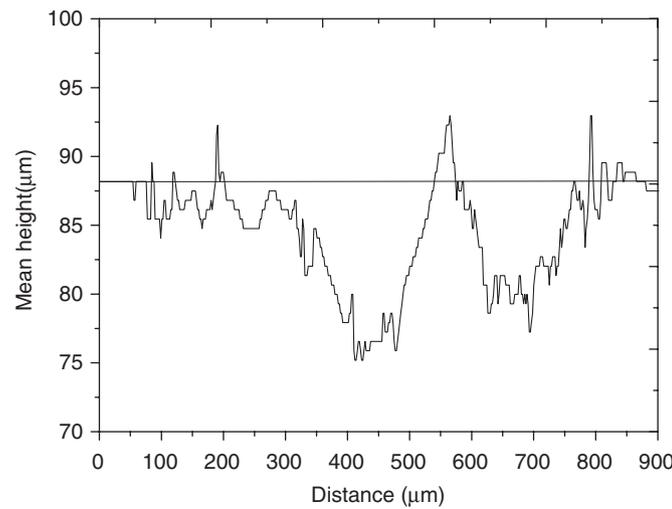
Fig. 6. Surface profile across the fretted zone after the tin-plated copper alloy sample was run for 8000 fretting cycles.

The surface profile of the fretted zone reveals the presence of some peaks and valleys (Fig. 6). The details of the roughness parameters are given in Table 1. The peaks in the surface profile could be attributed to the accumulation of debris, or transfer of the coated layer between the mated surfaces and the valleys could be attributed to the formation of grooves. The peaks observed in the surface profile also support the adhesive wear pattern observed in Fig. 5 (inset 'a'). The valleys in the profile indicate that the wear depth is relatively less at this stage.

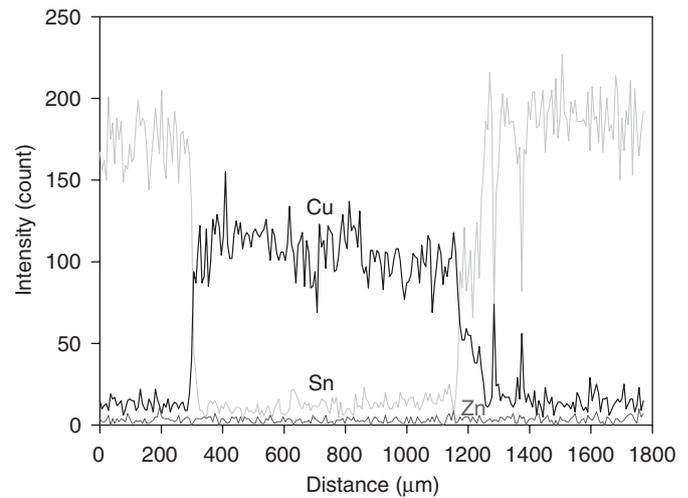
Fig. 7. EDX line scan performed across the fretted zone (indicated by the dotted line in Fig. 5) after the tin-plated copper alloy sample was run for 8000 fretting cycles.

The EDX line scanning performed across the fretted region (indicated by dotted line in Fig. 5) confirms the presence of tin and copper (Fig. 7). The intensity of oxygen is not appreciable to be detected in the line scan of the overall fretted zone. Within the fretted zone the intensity of tin is decreased whereas the intensity of copper is increased, suggesting that during fretting the tin coating is removed and the base metal is exposed in most of the areas. X-ray dot mapping of the fretted zone (Fig. 8) substantiate the observations of EDX line scanning.

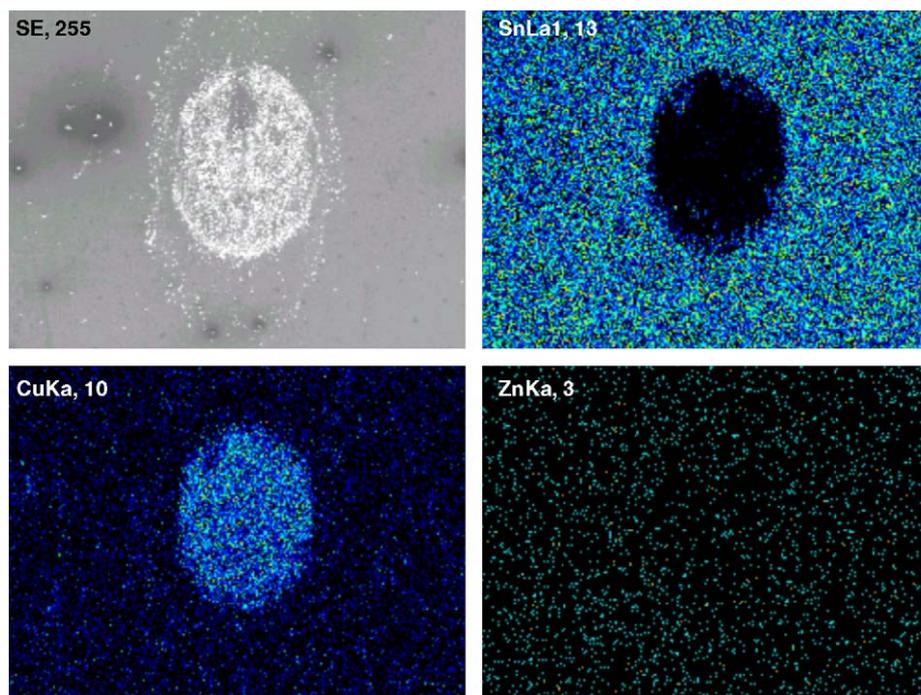
Fig. 8. X-ray dot mapping of copper, tin and zinc performed across the fretted zone after the tin-plated copper alloy sample was run for 8000 fretting cycles.

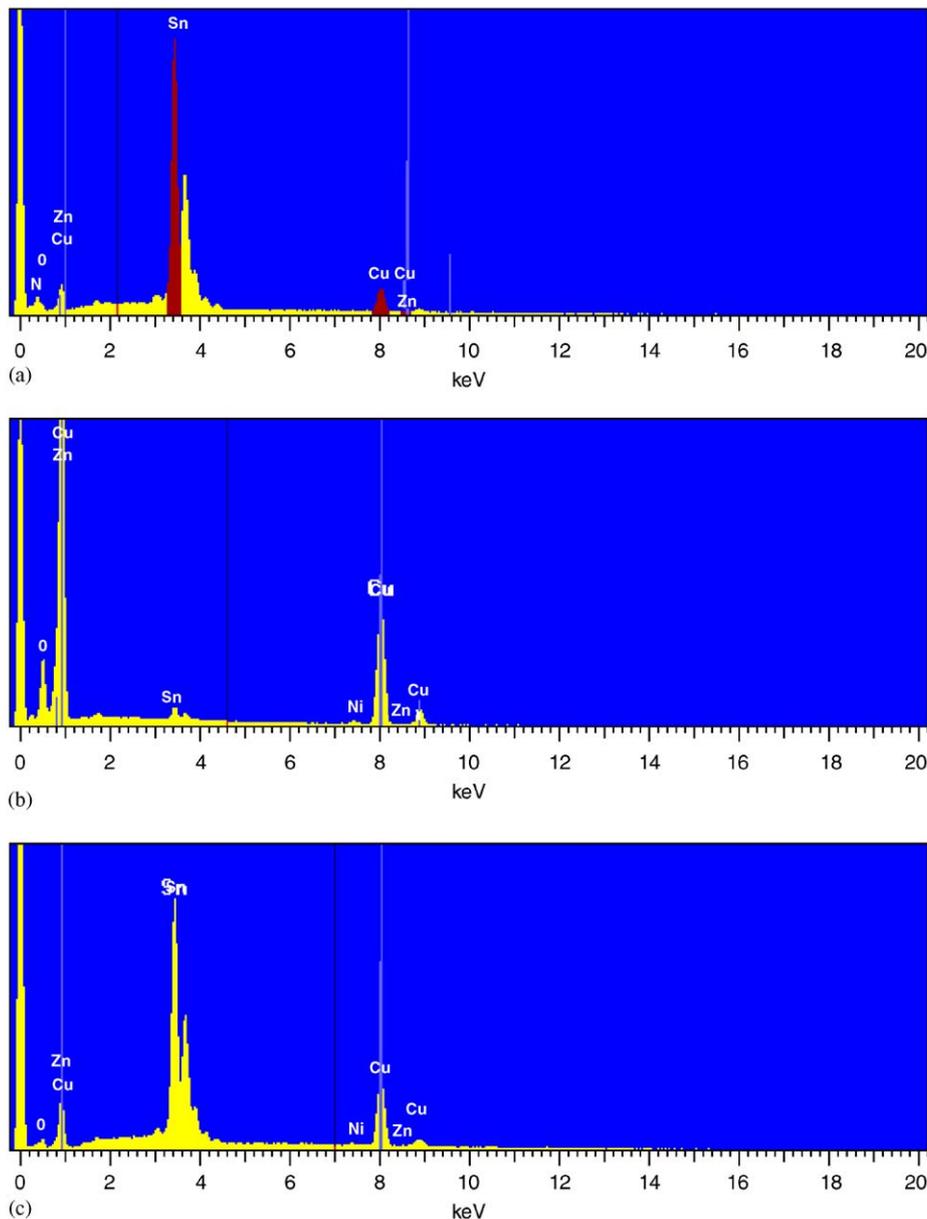
Fig. 9. EDX pattern of the tin-plated copper alloy sample run for 8000 fretting cycles (a) Entire fretted region (indicated by the dotted line in Fig. 5); (b) the bright white particles present at the central region of the fretted zone (marked as '4' in Fig. 5); (c) the bright white particles present at the edge region of the fretted zone (marked as '5' in Fig. 5).

The EDX pattern of the fretted region (indicated by dotted line in Fig. 5) indicates the presence of copper and

tin as the predominant elements (Fig. 9(a)). The EDX pattern taken on the bright white spots at the central region (marked as '4' in Fig. 5) of the fretted zone indicated that it is predominantly copper (53.10 at%) and oxygen (44.13 at%) with very little amount of tin (1.82 at%) (Fig. 9(b)). However, the EDX pattern taken on the bright white particles at the edge region (marked as '5' in Fig. 5) of the fretted zone indicates that it consists of a mixture of tin (43.81 at%) and copper (40.86 at%) with relatively lower concentration of oxygen (14.39 at%) compared to that observed at the central region (Fig. 9(c)). A small amount of nickel is also noticed in Fig. 9(b) and (c). This could have originated from the copper alloy beneath the tin coating. Although the intensity of oxygen is very weak to be observed in the line scanning of the overall fretted region, the EDX pattern taken at the bright white particles

at the central region of the fretted zone indicates the presence of appreciable amount of oxygen (44.13 at%), suggesting the early stage of formation of oxides of copper and tin.

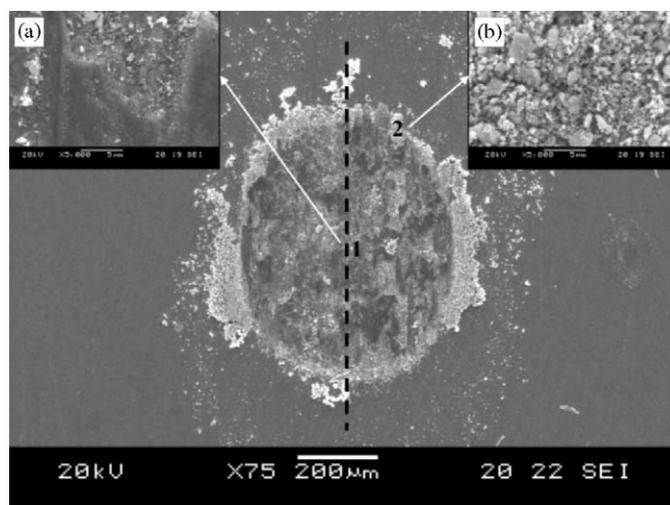
Fig. 10. Surface morphology of the tin-plated copper alloy contact after 16,800 fretting cycles. (a) Magnified view of the surface damage observed at the fretted zone. (b) Magnified view of the particles formed on the surface of the fretted zone.

The surface morphology of the tin-plated copper alloy contact run for 16,800 fretting cycles is shown in Fig. 10.

The fretting direction is vertical (indicated by the dotted line in Fig. 10). Though the shape of the fretted zone remains the same, examination of several regions of the contact zone reveals the occurrence of severe damage. The presence of cracks on the surface of the coated layer (inset 'a' in Fig. 10) and loose sheet/flake like debris (inset 'b' in Fig. 10) suggest the occurrence of delamination wear. Antler [25] has explained that delamination wear occurs in repeat-pass sliding when cracks become nucleated below the surface and it finally results in loosening of thin sheets of metal which become the wear debris. Zhang et al. [26] have also observed the formation of flake-like debris on tin-plated contacts. Shao and Zhang [27] have observed the formation of surface cracks on heat-treated tin-plated contacts, under both unlubricated and lubricated conditions. Braunovic [28] has suggested that flake-like debris is generally associated with the delamination wear.

The bright white particles observed both at the central and edge regions are tin oxide particles (insets 'a' and 'b' in Fig. 10). However, compared to the sample run for 8000 cycles, the size of the tin oxide particles are reduced, suggesting the entrapment and breakdown of the particles with the progressive increase in fretting cycles. The surface profile indicates that the wear depth is increased when the fretting cycle is increased from 8000 to 16,800 (Fig. 11 and Table 1). The formation of grooves in the fretted zone makes evident of the fact that significant damage has occurred for the sample run for 16,800 fretting cycles compared to the sample run for 8000 fretting cycles. The entrapment of the debris and oxide particles at the contact zone enables the formation of more grooves and supports

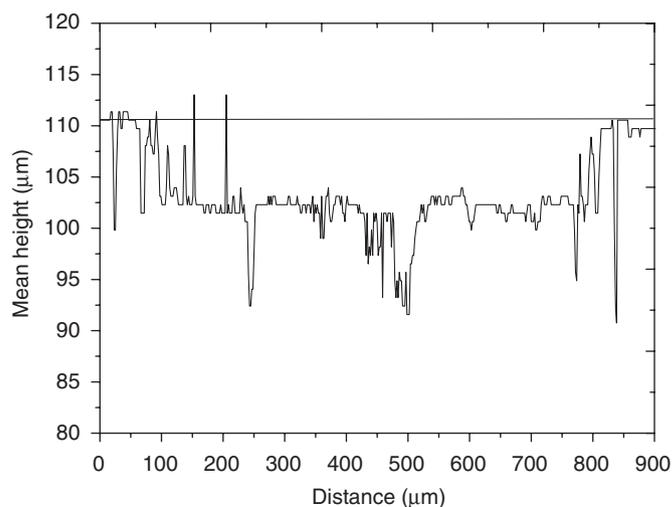
Fig. 11. Surface profile across the fretted zone after the tin-plated copper alloy sample was run for 16,800 fretting cycles.

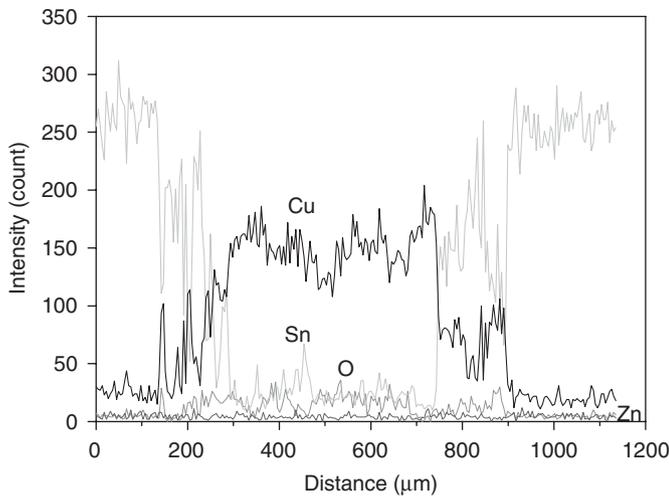
Fig. 12. EDX line scan performed across the fretted zone (indicated by the dotted line in Fig. 10) after the tin-plated copper alloy sample was run for 16,800 fretting cycles.

The EDX line scanning performed across the fretted region (indicated by dotted line in Fig. 10) confirms the presence of tin, copper, oxygen and traces of zinc (from the base metal) (Fig. 12). There is no significant change in the intensity of the zinc line throughout the region analyzed. Similar to the sample run for 8000 cycles, within the fretted zone, the intensity of tin is decreased whereas the intensity of copper is increased. However, in the sample run for 16,800 cycles, the intensity of oxygen is also increased at the fretted zone, suggesting the removal of the tin coating, exposure of the base metal and oxidation of tin and copper. X-ray dot mapping of the fretted zone (Fig. 13) substantiate the observations of EDX line scanning.

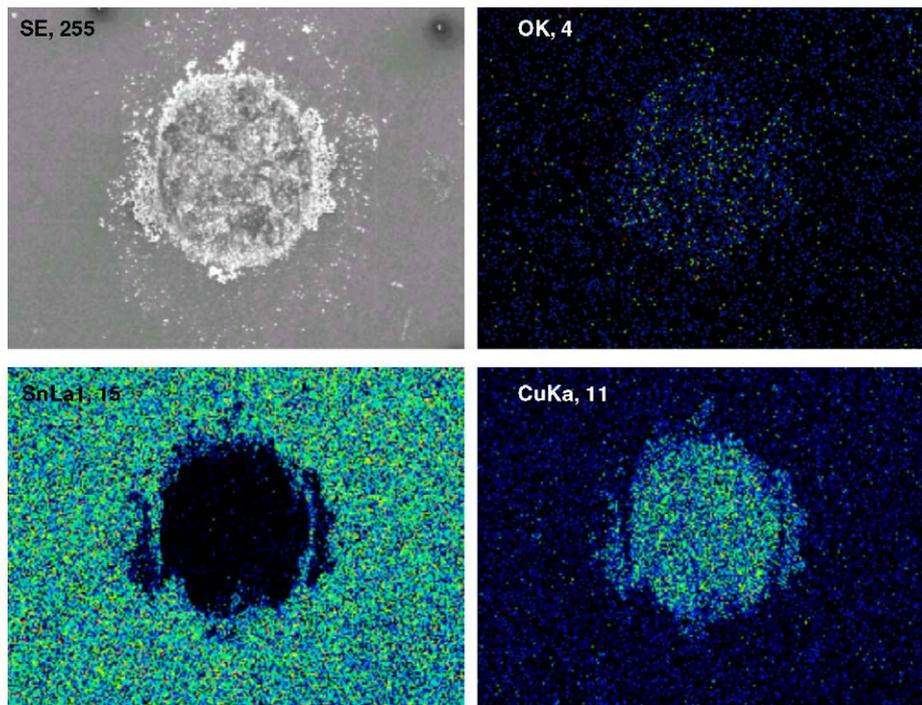
Fig. 13. X-ray dot mapping of copper, tin and oxygen performed across the fretted zone after the tin-plated copper alloy sample was run for 16,800 fretting cycles.

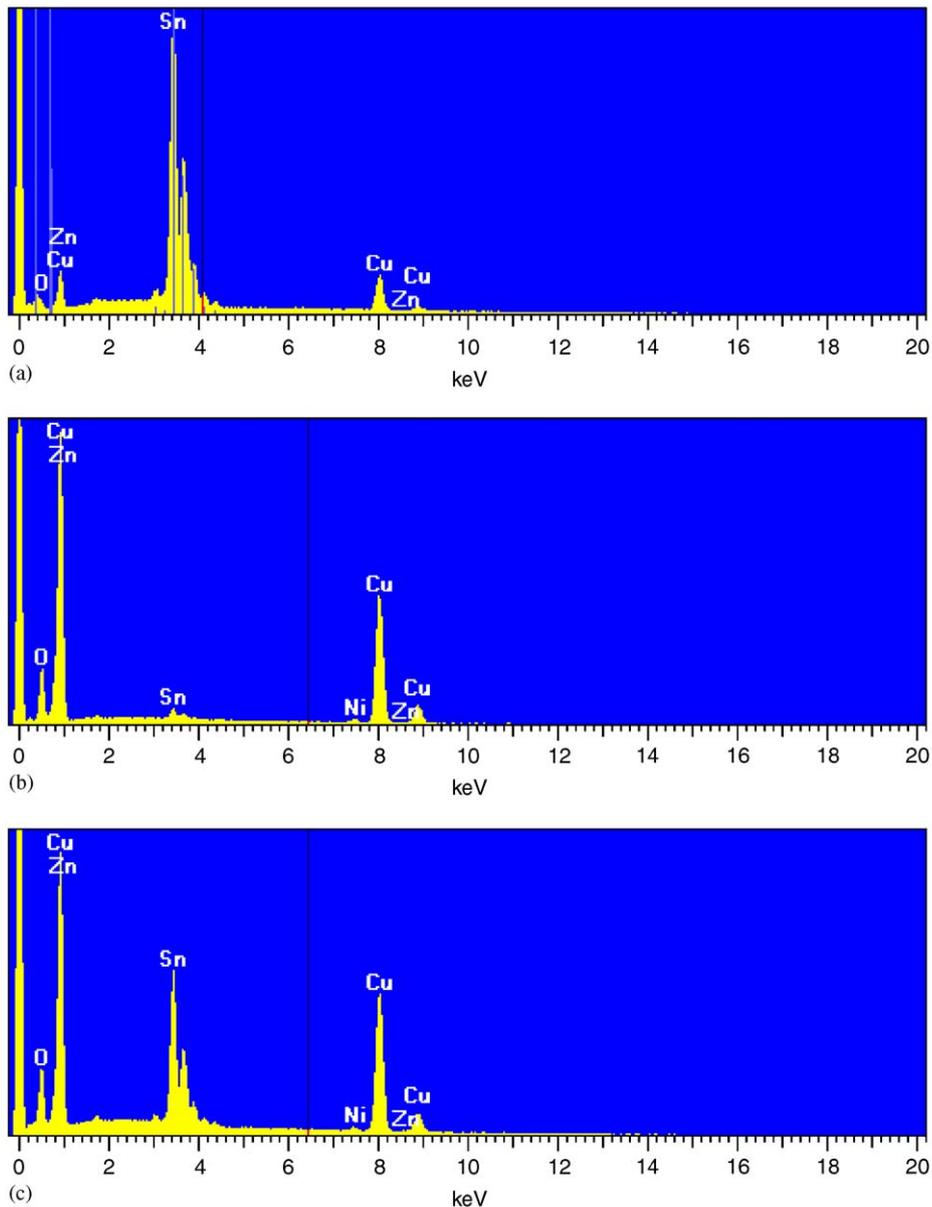
Fig. 14. EDX pattern of the tin-plated copper alloy sample run for 16,800 fretting cycles: (a) entire fretted region (indicated by the dotted line in Fig. 10); (b) the bright white particles present at the central region of the fretted zone; (c) the bright white particles present at the edge region of the fretted zone.

The EDX pattern of the fretted region (indicated by dotted line in Fig. 10) indicates the presence of copper, tin and oxygen as the predominant elements (Fig. 14(a)). The EDX pattern taken on the bright white spots at the central region (marked as '1' in Fig. 10) of the fretted zone indicated the presence of appreciable amounts of copper (59.91 at%) and oxygen (37.61 at%) and a small amount of tin (1.49 at%) (Fig. 14(b)). Although a similar trend is noticed in the EDX patterns taken at the edge regions (marked as '2' in Fig. 10), the amount of tin is relatively higher (14.32 at%) compared to those in central region (Fig. 14(c)). A small amount of nickel is also noticed in Fig. 14(b) and (c). As already mentioned, this could have originated from the copper alloy beneath the tin coating. EDX pattern taken at both the central and edge regions

indicates the presence of appreciable amounts of oxygen, suggesting the formation of oxides of copper and tin. However, the volume fraction of copper oxide is higher than that of tin oxide.

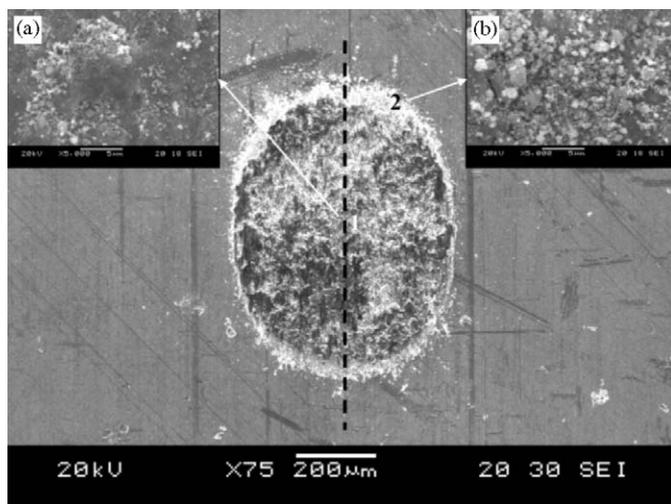
Fig. 15. Surface morphology of the tin-plated copper alloy contact after 48,000 fretting cycles. (a) Magnified view of the surface damage observed at the fretted zone. (b) Magnified view of the particles formed on the surface of the fretted zone.

The surface morphology of the tin-plated copper alloy contact run for 48,000 fretting cycles is shown in Fig. 15. The fretting direction is vertical (indicated by the dotted line in Fig. 15). The shape of the fretted zone remains the same. However, severe damage has occurred at the contact zone. The presence of cracks on the surface of the coated layer (inset 'a' in Fig. 15) and loose sheet/flake-like debris (inset 'b' in Fig. 15) suggests that the delamination wear is the main mechanism failure. Delamination wear occurs during repeat-pass sliding, which leads to the nucleation of cracks below the surface and finally results in loosening of thin sheets as wear debris [25]. The formation of surface cracks and flake-like debris on tin-plated contacts has been observed earlier by Zhang et al. [26] and Shao and Zhang [27]. Braunovic [28] has also suggested that flake-like debris is generally associated with the delamination wear. The bright white tin oxide particles are observed both at the central and edge regions (insets 'a' and 'b' in Fig. 15). However, compared to the samples run for 8000 and 16,800 fretting cycles, the size of the tin oxide particles are further reduced (inset 'a' in Fig. 15), confirming the breakdown of the particles with the progressive increase in fretting cycles. The surface profile also indicates that the wear depth is increased when the fretting cycle is increased from 16,800 to 48,000 (Fig. 16 and Table 1). The formation of grooves in the fretted zone makes evident of the fact that significant damage has occurred for the sample run for 48,000 fretting cycles compared to the sample run for

16,800 fretting cycles. The entrapment of the debris and oxide particles at the contact zone enables the formation of more grooves and supports the increase in wear depth with the increase in fretting cycles from 16,800 to 48,000.

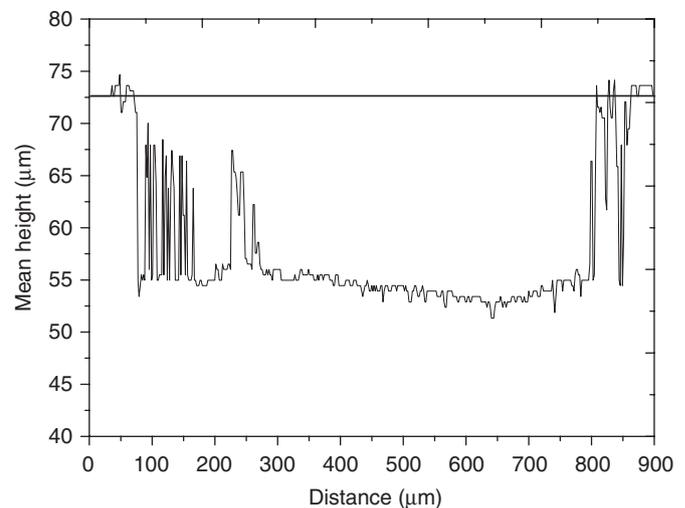
Fig. 16. Surface profile across the fretted zone after the tin-plated copper alloy sample was run for 48,000 fretting cycles.

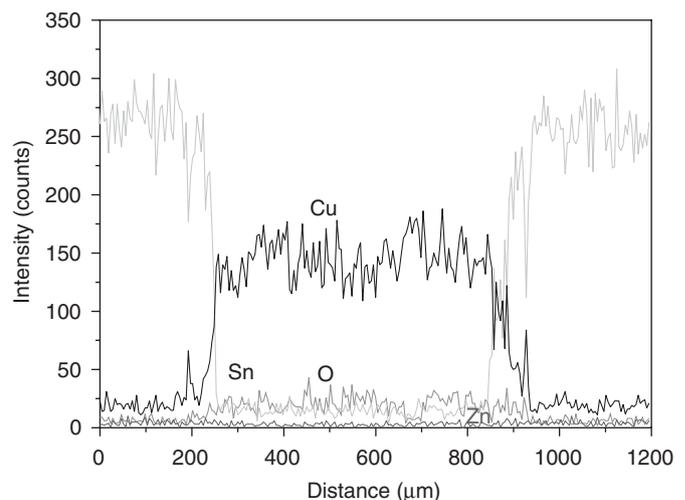
Fig. 17. EDX line scan performed across the fretted zone (indicated by the dotted line in Fig. 15) after the tin-plated copper alloy sample was run for 48,000 fretting cycles.

The EDX line scanning performed across the fretted region (indicated by dotted line in Fig. 15) confirms the presence of tin, copper, oxygen and traces of zinc (Fig. 17). Similar to the samples run for 8000 and 16,800 cycles, within the fretted zone, the intensity of tin is decreased whereas the intensity of copper is increased. Similar to the sample run for 16,800 cycles the intensity of oxygen is increased at the fretted zone, suggesting the removal of the tin coating, exposure of the base metal and oxidation of tin and copper. X-ray dot mapping of the fretted zone (Fig. 18) substantiate the observations of EDX line scanning. However, the oxygen dot map is relatively more

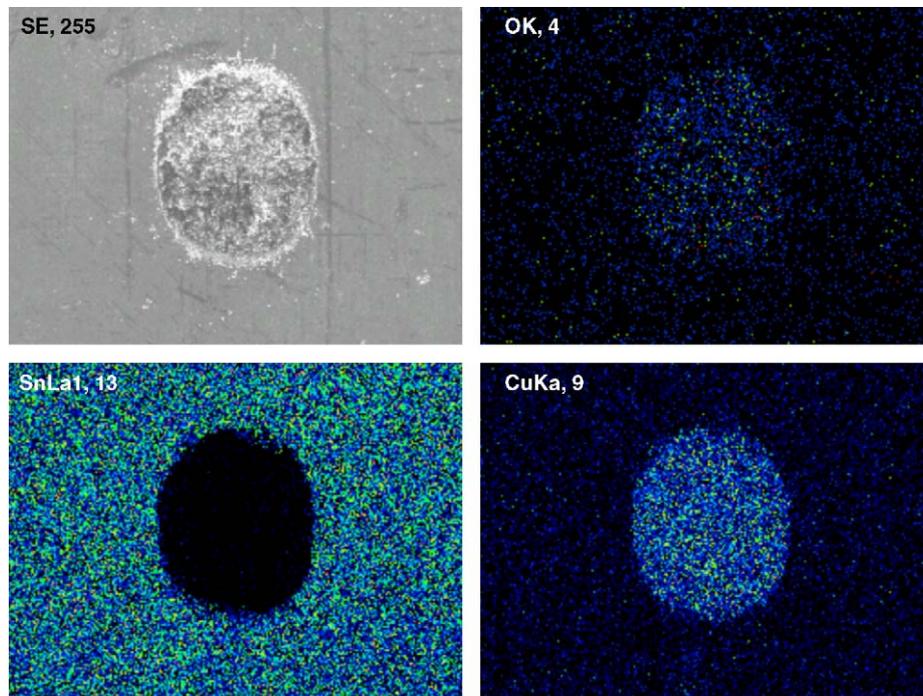
Fig. 18. X-ray dot mapping of copper, tin and oxygen performed across the fretted zone after the tin-plated copper alloy sample was run for 48,000 fretting cycles.

intense than that of the sample run for 16,800 cycles, suggesting an increased level of oxidation at this stage.

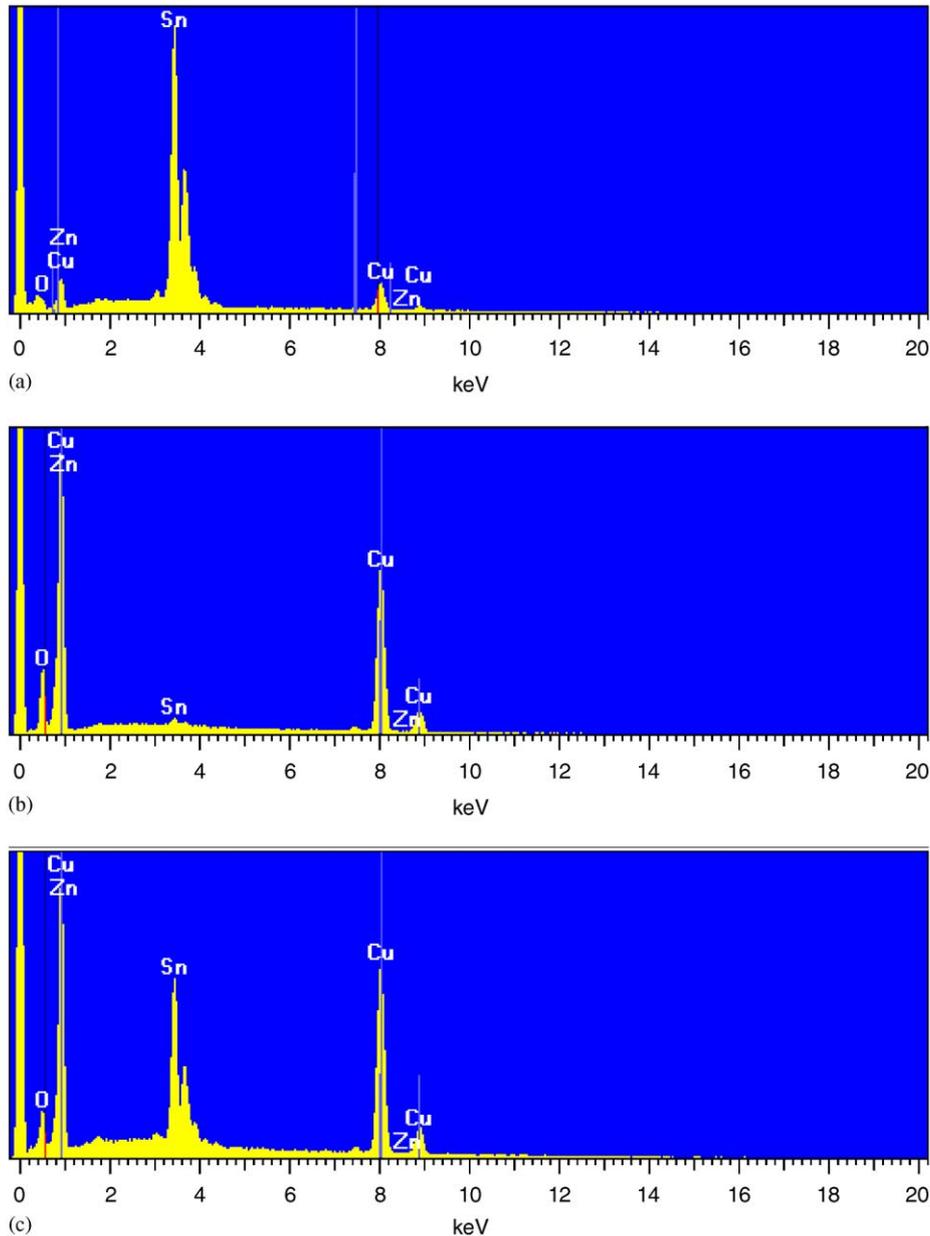
Fig. 19. EDX pattern of the tin-plated copper alloy sample run for 48,000 fretting cycles: (a) entire fretted region (indicated by the dotted line in Fig. 15); (b) the bright white particles present at the central region of the fretted zone; (c) the bright white particles present at the edge region of the fretted zone after 48,000 fretting cycles.

The EDX pattern of the fretted region (indicated by dotted line in Fig. 15) indicates the presence of copper, tin and oxygen as the predominant elements (Fig. 19(a)). The EDX pattern taken on the bright white spots at the central region (marked as '1' in Fig. 15) of the fretted zone indicates the presence of appreciable amounts of copper (62.51 at%) and oxygen (35.58 at%) and a small amount of tin (1.05 at%) (Fig. 19(b)). Although a similar trend is noticed in the EDX patterns taken at the edge regions, the amount of tin is relatively higher (16.06 at%) compared to those in central region (Fig. 19(c)). EDX pattern taken at both the central and edge regions indicates the presence of appreciable amount of oxygen, suggesting the formation of oxides of copper and tin. However, the volume fraction of copper oxide is higher than that of tin oxide.
