MICROSTRUCTURAL STUDIES IN FAILED SAMPLES

P. Prasad & R. Singh
National Metallurgical Laboratory
Jamshedpur 831007

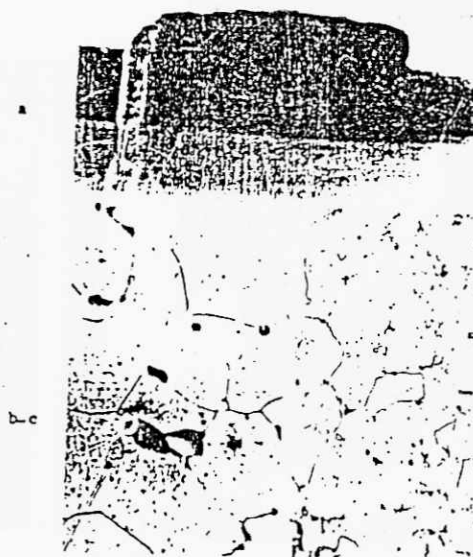
Fig 6: a) Thin lip rupture in low alloy steel superheater.
 b) Normal ferrite (white) and pearlite/bainite (black) structure in a alloy steel tubing material.
 c) Specimen exhibits elongated grain near rupture resulting from fast over heating below the recrystallization temperature.
 d) Specimen displays mixed structure near rupture as a result of overheating.
 e) Specimen displays completely transformed structure as a result of overheating.

Fig.6 shows a failed water wall tube due to overheating. For microstructural examination samples are taken from several locations e.g. from rupture lip, diametrically opposite to the rupture zone and far away from the rupture zone. Several samples must be studied because the microstructure may vary along the length of the tube. Under the figure microstructures are given with their descriptions. The elongated grains may be noted, which indicates that the failure is essentially of ductile type. This type of failure is also called fish-mouth opening or thin wall lip rupture.
