National Workshop on Boiler Corrosion, 11-12th April, 1995, NML Jamshedpur, INDIA

BOILER CORROSION - METALLURGICAL ASPECT

R.N. GHOSH National Metallurgical Laboratory Jamshedpur 831 007

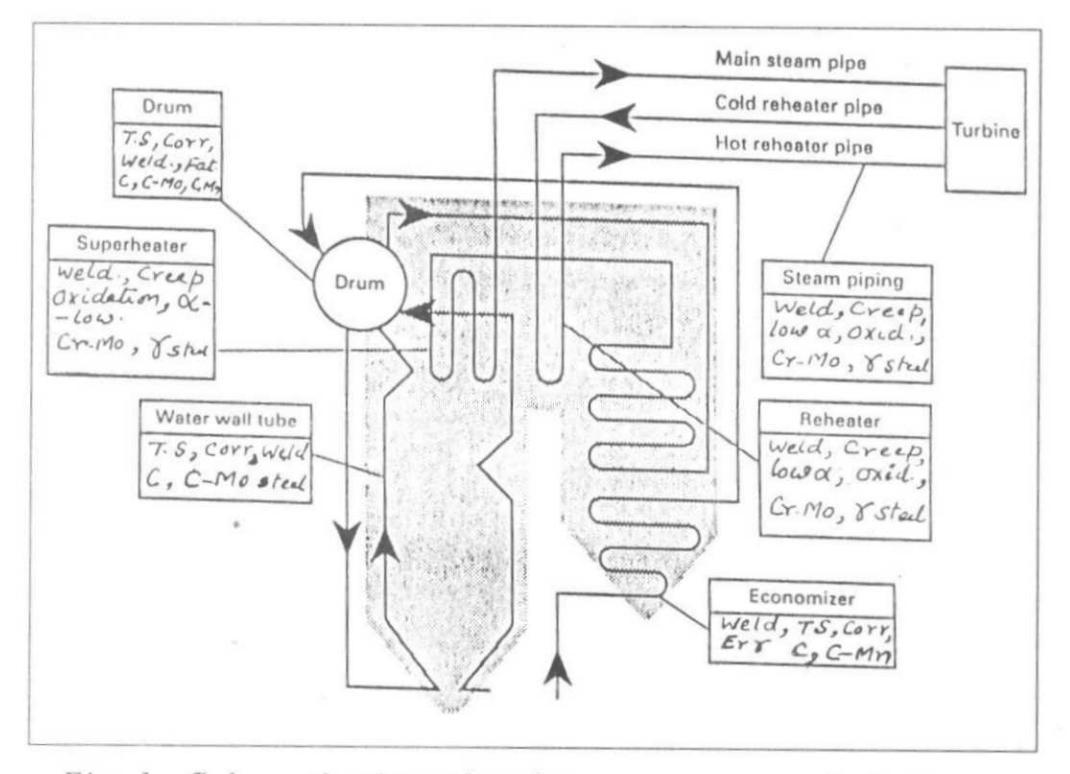
Fig. 1 : Schematic view of various components of a boiler

The types of steel used in various parts of a boiler are given in Fig.1. Possibly the best way to describe the metallurgical aspect of boiler design is to discuss why in spite of judicious selection of material some of the components fail in service. A survey conducted by one laboratory over a period of 12 years based on 413 investigations indicate overheating as the main cause of failure. Table-2 gives a summary of this survey. However defective material does not always cause a component to fail soon after being put into service. Even massive defects were found to be present in some areas without causing fracture to occur until after considerable period of service. This is because boiler design is inherently conservative.

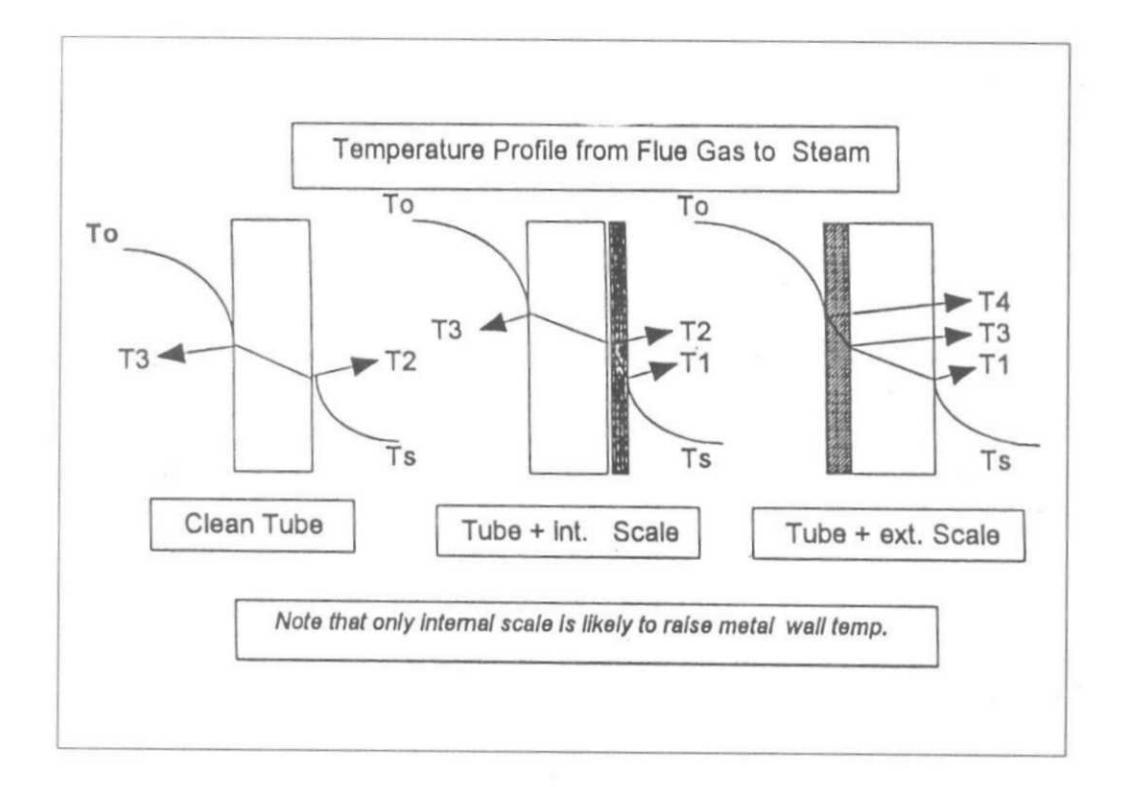
Fig. 2 : Temperature profile across the tube-wall showing the effect of scale formation of metal temperature

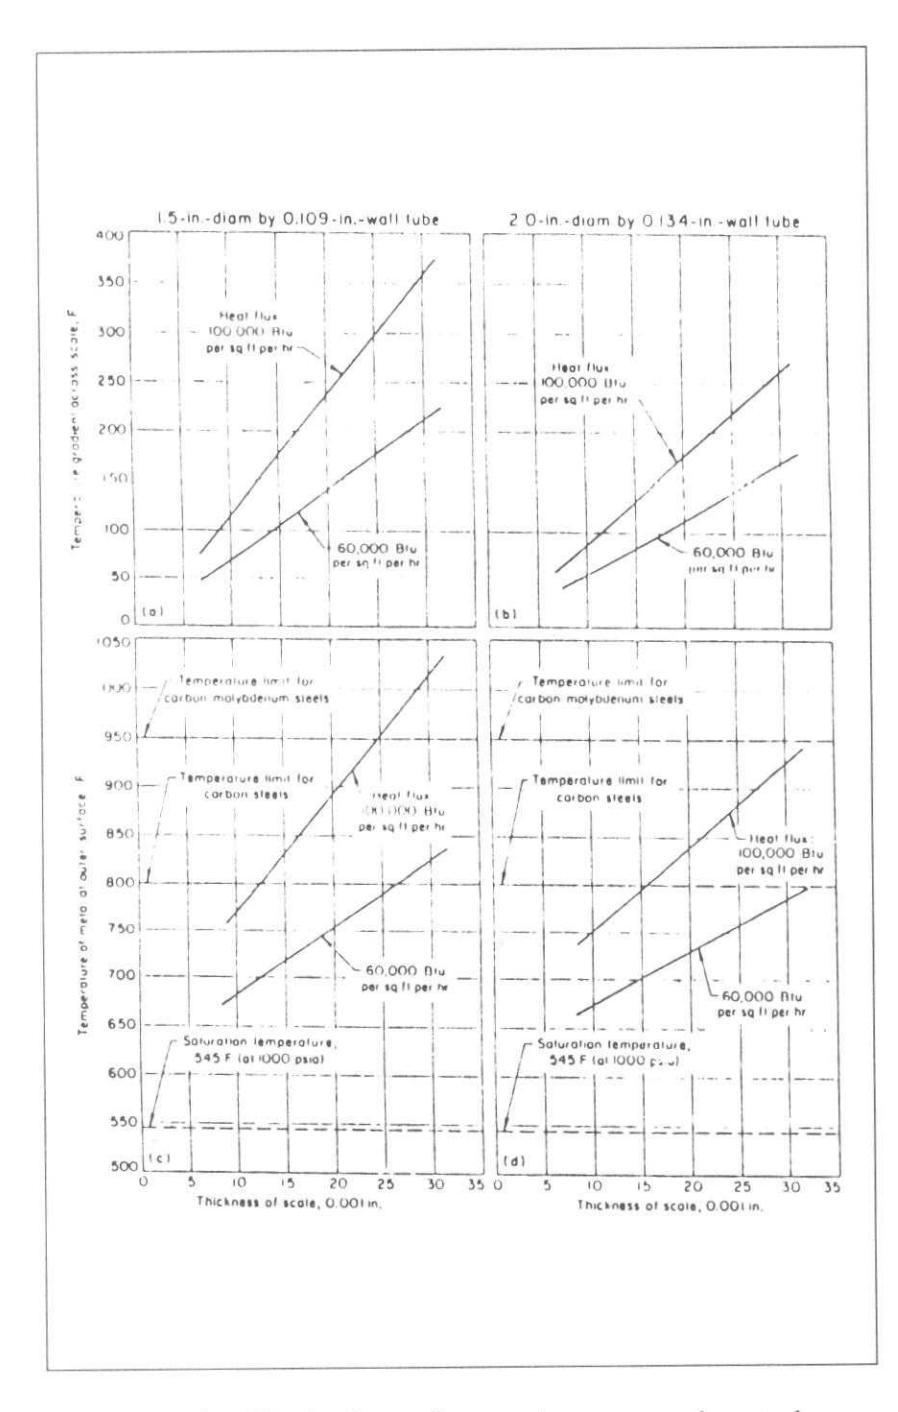
Fig. 3 : Variation of steam/water and metal temperature at different levels of heat flux

(a) and (b) : The effect of scale thickness on the temperature gradient across the scale; (c) and (d) : The effect of Scale thickness on the temperature of the metal at the outer surface of the tube. Th graphs are based on a continuous, uniform scale, with a thermal conductivity of 14.4 W/m . K (10Btu . in./h . ft^2 . ^oF) on tubes in the film-boiling regrino of 690-kPa (100-psi) system (saturation temperature 285°C, or 545°F).

When waterside deposits are presents tube wall temperature increases in the region of deposits. Figure 3 shows the effect of scale thickness on metal wall temperature. The increase is more pronounced in case tubes of smaller diameter. It can even go beyond the recommended limit for the steel. Therefore it is necessary to keep the water side surface free of adherent scale particularly in the regions of high flux.

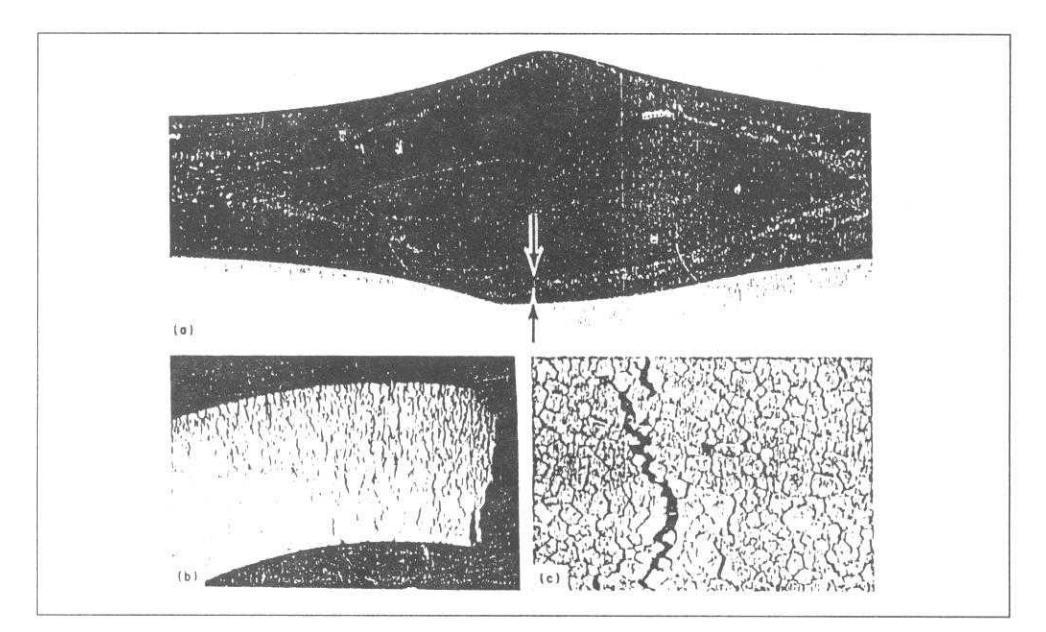
Fig. 4 : Characteristic thin-lip rapture and associated microstructural features

Type 321 stainless steel (ASME SA-213, Grade TP321H) superheater tube that failed by thick-ip stress rupture (a) Overall view showing a typical fishmouth rupture. Approximately ¹/₂ x. (b) Unetched section fro location between arrows in (a) showing extensive transverse cracking adjacent to the main fracture (at right). Approximately 4¹/₂ x. (c) Specimen etched electrolytically in 60% HNO₃ (nitric acid) showing intergranular nature of cracking. 100x

Overheating results from restriction of flow within a heated tube or from localized heating of the tube wall. Mild restriction of flow favours a small degree of overheating. This leads to failure by stress rupture. Such failures are characterized by thick tip rupture with little ductility (Fig. 4).

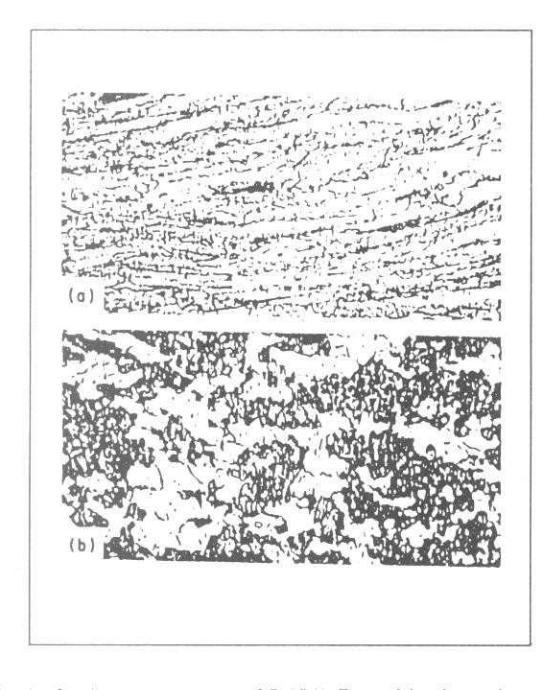
Typical microstructures of 0.18% C steel boiler tubes that ruptured as a result of rapid overheating (a) Elongated grains near tensile rupture resulting from rapid overheating below the recrystallization temperature. (b) Mixed structure near rupture resulting from rapid overheating between Ac₁, and Ac₃ amd sinseqiemt qienching by escaping water or steam. Both etched with 2% nital, (250x).

Fig. 8 : Typical microstructural change as a result of rapid over heating

Rapid overheating of boiler tubes made of carbon and low alloy steel usually results in failure because of decrease in yield strength. If failure takes place below recrystallization temperature microstructure near fracture would exhibit elongated grains. Rupture that occurs at temperatures greater than AC₁ may exhibit pearlitic/bainitic areas formed as a result of quenching effect of escaping water or steam on partly austenitic structure existing at the time of rupture.

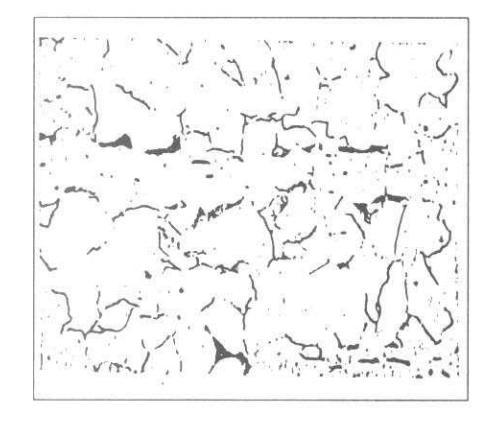
Micrograph of an etched specimen from a carbon steel boiler tube. Decarburization and discontinuous intergranular cracking resulted from hydrogen damage ((250x) speheroidization (light, globular), both of which are characteristic of tertiary creep, (250x) (b) Intergranular separation adjacent to facture surface (top). 50x Moltled areas in both specimens are regions where pearlite has decomposed into ferrite and spheroidal carbides. Both etched with 2% nital

(a) Voids (black) in grain boundaries and

Fig. 9 : Typical microstructural change as a result of prolonged overheating below critical temperature

Such overheating significantly alters the structure and properties of the steel tube. Prolonged overheating at temperatures below AC₁ (the temperature at which austenite begins to form) in carbon and low alloy steel causes decomposition of pearlite (or Bainite) into ferrite and spheroidal carbides. This weakens the tube material. If continued overheating persists it could cause formation of voids at grain boundaries and eventual grain separation, resulting in stress rupture failure.

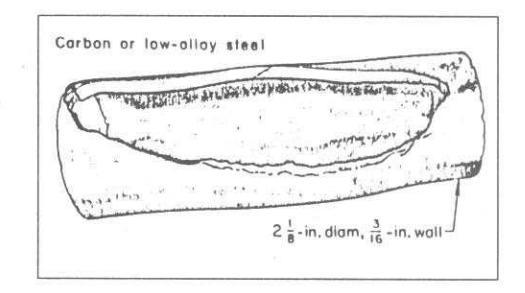
A Window Fracture :Typical results from hydrogen damage in carbon or low-alloy steel boiler tubes

Fig. 10 : *Typical microstructural changes and nature of tube rupture as a result of hydrogen damage* Enrichment of the surface by Al or Cr can also improve corrosion resistance. This can be attained by a number of methods. Diffusion coating, flame or plasma spraying has been used to apply high Cr, high Al, or Fe-Al-Cr alloy coatings on water wall tubes. Although such alloys exhibit excellent corrosion resistance in laboratory testing, there are many technical problems concerning reproducibility, ease of fabrication and joining are required to be tackled before their commercial use.

Hydrogen damage takes place primarily in steel components. Discontinuous intergranular cracking and decarburization are its characteristic features. Such cracking results from precipitation of hydrogen or methane. Tubes that have undergone such damage often exhibit window type fracture.
