**3 International Symposium** <u>on Surface Protective Coatings</u>

## PROTECTIVE COATINGS FOR STEEL BARS IN REINFORCED STRUCTURES

D.D.N.Singh and Rita Ghosh National metallurgical Laboratory, Jamshedpur

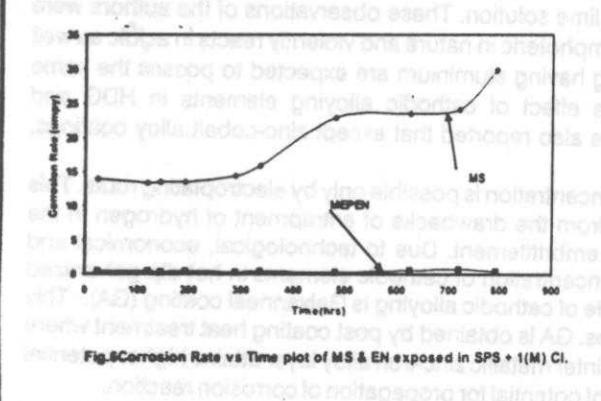
The results generated in our laboratory have established that medium phosphorus electroless nickel coating (MEPEN, with around 8% Phosphorus) performs excellently well in controlling the corrosion, if steel rebars in chloride contaminated concretes. Some results generated in our lab are shown in Figure 6. It is observed from the plots shown in this figure that the corrosion rate of MEPEN remains in the range of 0.1-1.0  $\mu$ m per year ( $\mu$ mpy) throughout the test period. This indicates that the coating is fairly stable in simulated concrete pore solution having very high level of chloride ion (1M) and attains a stable passivity. Mild Steel (MS), on the other hand, initially (up to 300 hours) exhibits a stable corrosion rate of the order of 15.0  $\mu$ m per year ( $\mu$ mpy) and then gradually increases with time. After 650 hours of exposure, a sharp increase in corrosion rate is

observed and goes above 30 µmpy, indicating the formation of non-protective corrosion product on its surface. XRD analysis showed that these corrosion products were a mixture of akaganite and hematite, which are unstable phases and do not impart barrier protection to steel surfaces. This type of corrosion products were also observed by many earlier workers on steels exposed in concrete environment<sup>134-36</sup> and does not require detail discussion. The corrosion products accumulated on the surface of the MEPEN electrode exhibited the presence of Ni<sub>2</sub>O<sub>3</sub>, Ni<sub>5</sub>P<sub>2</sub>, NiCl<sub>2</sub> and CaH<sub>2</sub> as confirmed from XRD studies.

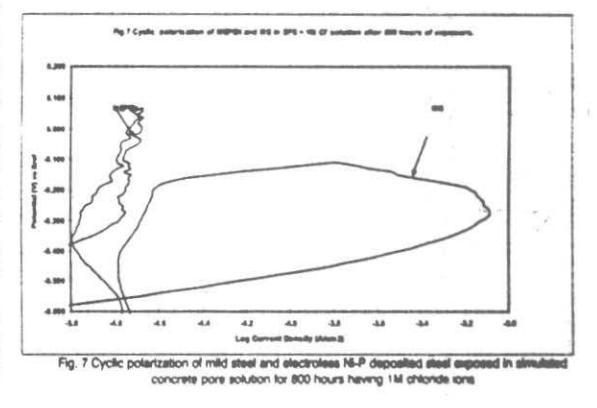
Cyclic polarization experiments also confirmed that MEPEN was almost immune to the pitting attack by chloride ions present in SPS (Figure 7). This fact was further corroborated from its breakdown potential. The deposited coating did not exhibit any pitting tendency even up to 1.0 V anodic to its corrosion potential. XRD studies of corrosion products formed on MEPEN exhibited the presence of Ni<sub>2</sub>O<sub>3</sub> and Ni<sub>5</sub>P<sub>2</sub> phases with small peaks of NiCl<sub>2</sub> and CaH<sub>2</sub>. We have shown that the phosphorus present in the coating forms insoluble Ni<sub>5</sub>P<sub>2</sub> compound and blocks the defects present in passive oxide of the metal. Siconolfi and Frankenthal<sup>(3n</sup> have also reported that the presence of phosphorous in Ni(OH)<sub>2</sub> may alter its defect structure. The insignificant role of chloride in destabilizing the coating as noted in the above results is attributed to observed dense passive film of Ni<sub>2</sub>O<sub>3</sub> embedded with Ni<sub>5</sub>P<sub>2</sub>.

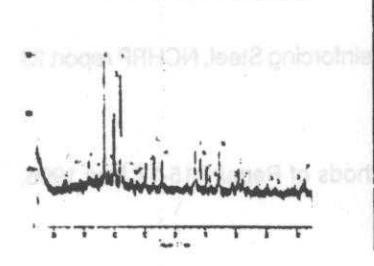
Fig 11 XRD Spectra of corrosion product of HDG

The XRD spectra recorded for the corrosion products of the two coatings exhibited the presence of dominant phases of ZnH<sub>2</sub> for both the coatings. Few peaks of other than ZnH<sub>2</sub> phase were also observed in corrosion products of GA coating. These peaks corresponded to Zn-Fe compounds (Figure 11). Scanning Electron Microscopy and Energy Dispersive X-ray Analysis (EDXA) of corrosion product of GA coatings revealed platelet type of structure (Figure 12). However, when these platelets were further resolved at higher magnifications (X 3000), acicular type of structures were found to be embedded in between the major corrosion products (Figure 13). The microstructure of corrosion
