CORROSION RESISTANCE PERFORMANCE OF FUSION BONDED EPOXY COATED REBARS

D. D. N Singh and Rita Ghosh

Corrosion Protection Division, National Metallurgical Laboratory. Jamshedpur.

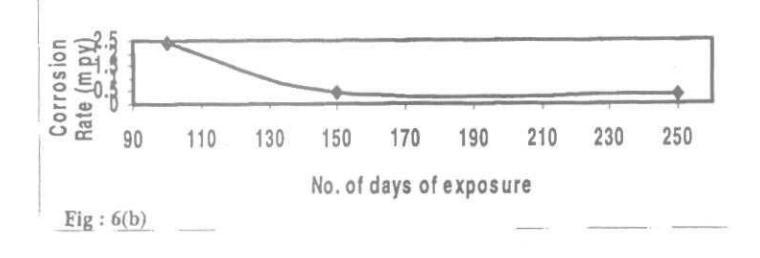
Variation in aparent corrosion rate with time for FBECR embedded in mortars having 0.5% Cl⁻

The loss in electrical resistance and increase in water absorption by the coating with passage of time is expected to increase the corrosion rate of rebars with time. This is found true in case of rebars embedded in mortars having chloride ions. In the absence of chloride ion, however a decrease in corrosion rate with time has been noted. (Fig.6a and 6b). These aspects can be explained by considering the fact that in the absence of any chloride ion, alkalinity of concrete helps in the formation of protective iron oxide film on the steel rebars. In the presence of chloride ions, the protective oxide reacts with chloride ion to form soluble iron complex⁽²⁷⁾. When iron chloride complex diffuses away from the bar to an area of greater alkalinity and concentration of oxygen it reacts with hydroxyl ions to form $Fe(OH)_2$, which frees the complexed chloride ions to continue the corrosion process in the presence of moisture and oxygen⁽²⁸⁾,

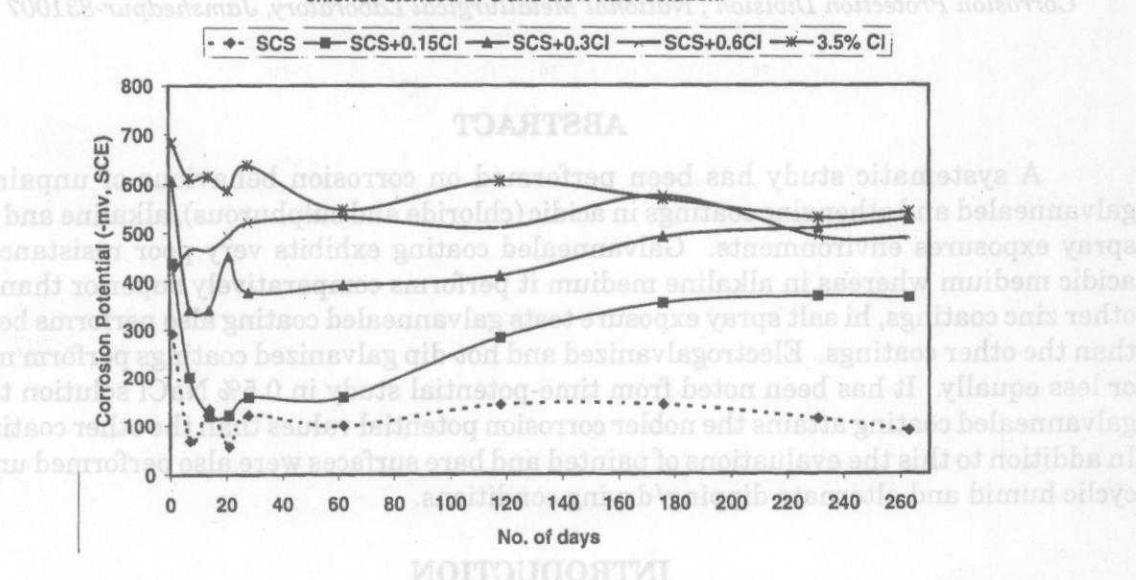
Fig : 8 Change in corrosion potential with passage of time for FBECR immersed in chloride blended SPS and 3.5% NaCl solution.

The fact that the defects in epoxy coating are increasing with the passage of time of exposure is also evident from the corrosion potential-time plot for various systems. It is reported that a coated interface maintains the outstanding corrosion protection if it attains the corrosion potential in an electrolyte very similar to that of the base metal in the same medium⁽³⁰⁾. The systems exhibiting a nobler potential after exposure to an aggressive electrolyte indicate the development of defects in the coating. In the presnt system of FBECR directly exposed to SPS or embedded in mortars in the absence and the presence of chloride ions, have a definite trend of change in corrosion potential with passage of time, (fig.8). It is evident from fig.8 that the FBECR exposed in SPS has more stability of corrosion potential in comparisn to the solution having chloride ions. In pure SPS solution, bare steel exhibits corrosion potential of the order of -300 mv (SCE). It is evident from the fig. 10 that after a period of 263 days of exposure in the solution, the corrosion potential has drifted to - 87my. In the presence and the absence of chloride ions, the onset of enobling in potential takes place within 07 days. After a continuous increase in potential, it again starts to move in negative direction and ultimately after a certain period of exposure the potentials attain the values of bare steel. It is interesting to note that the exposure time for onset of negative movement of the potential after moving in positive direction varies with chloride content in SPS. For pure SPS, this time is 140-days where as for SPS having 0.15%, 0.3% chloride ions and 3.5% NaCI solutions, the values are > 263 days, 62 days and 21 days respectively. These changes in potential are directly related to the cathode/anode surface area ratio of a coated material. An increase in cathode / anode area ratio results due to the poorer performance of the coating and moves the potential in positive direction. A larger cathode area is a consequence of a delamination process which results in due to the weakening of coating/substrate bond. A shift in potential, therefore, more nobler than the corrosion potential of base metal is an indication of deterioration of the coating.
